2018 Annual Landfill Inspection Report

CCR Landfill

**Turk Power Plant
Southwestern Electric Power Company
Fulton, Arkansas**

Document Number: GERS-18-057

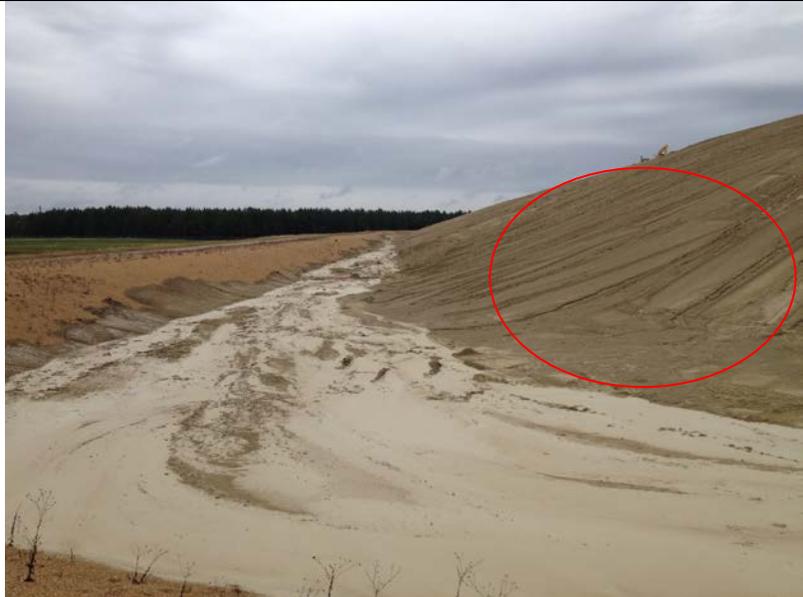
Photo # 1

1. Cell 1 is the active disposal area. No ponding of surface water was observed in the disposal area of the landfill. The material was well compacted as it was placed and has been moisture conditioned to stabilized in place. The height of the fill was well above the base liner. There was minor erosion of the CCR material in the active area on the northeast side of Cell 1. (Photo #1)
2. No final cover has been constructed over any portion of the active Cell.
3. A perimeter ditch was constructed within Cell 1 to control runoff from the landfill. The ditch is located below the uncovered slopes of the disposal operation. Deposition of CCR material was observed in the ditches as a result of the sediment-laden runoff. (Photo #1 & #2)

Landfill Cell 1 - View of the northeast side of the active landfill and the perimeter ditch. Minor erosion circled in red.

3. Cell 1: The perimeter ditch that has been constructed inside of Cell 1 to control runoff is being filled with sediment from the CCR material. The CCR material will need to be removed from the perimeter ditch to maintain the design hydraulic capacity and prevent runoff from overflowing the slopes.
4. Leachate pond: Vegetation growth was noted at the outlet structure to the located at the northwest corner of the pond and the inlet structure at the southeast corner of the pond. The vegetation around these structures will need to be removed to ensure proper operation of the structures.

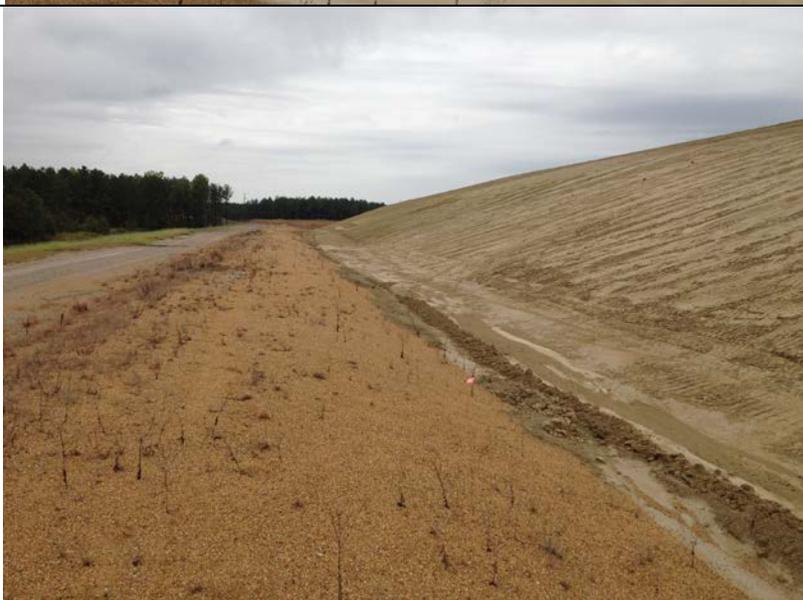
Photo # 2

Landfill Cell 1 - The perimeter ditch is working as intended to prevent runoff from leaving cell. View of buildup in northeast perimeter ditch.

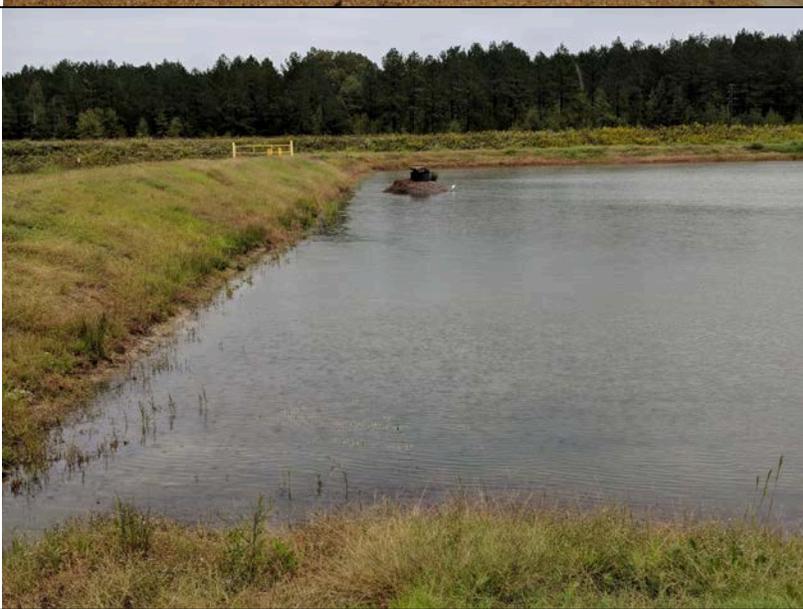
Photo # 3

4. The storm water pond is located to the east of Cell 1 and receives non-contact storm water runoff from areas outside the active Cells of the landfill. The pond appeared to be functioning as designed. (Photo #3)
5. The storm water ditches are located around the perimeter of the landfill, which a majority of are formed by the landfill perimeter ditch. The storm water ditches were in good condition with no obstructions or erosion observed. These ditches are lined with the artificial turf used on the perimeter berm. The storm water ditch located south of the landfill appeared to be ponding water in some low areas of the ditch. (Photo #4)

Storm water pond - pond functioning as designed.

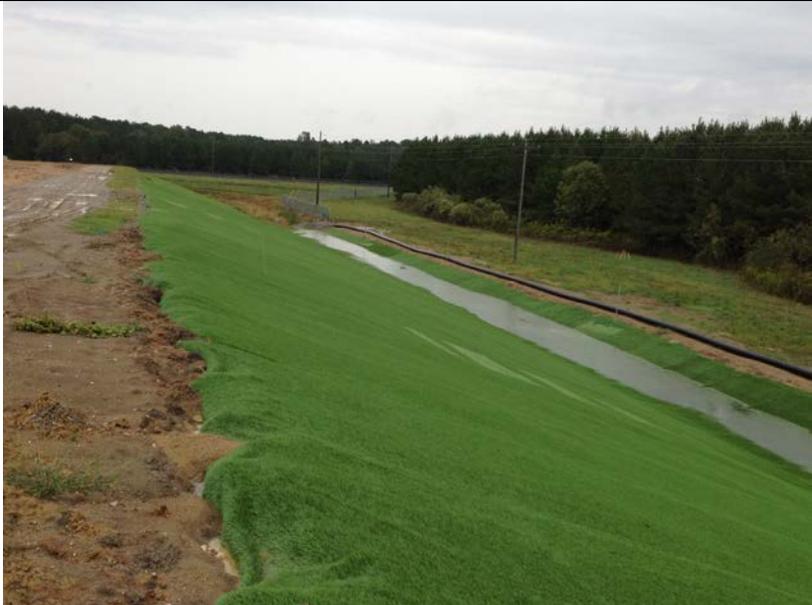
Photo # 4

Storm water ditches – ditches south side of the landfill, some areas holding water

5. Cell 1: minor erosion of the CCR material is occurring on the northeast corner of the CCR material. Cell 1 should be monitored for erosion and as the landfill reaches its final elevation the process should be started to install the final cover.
6. Cell 1: the storm water ditch on the south end of the Landfill Cell 1 appeared to be ponding water. This should be monitored to determine if the artificial turf is being separated from the

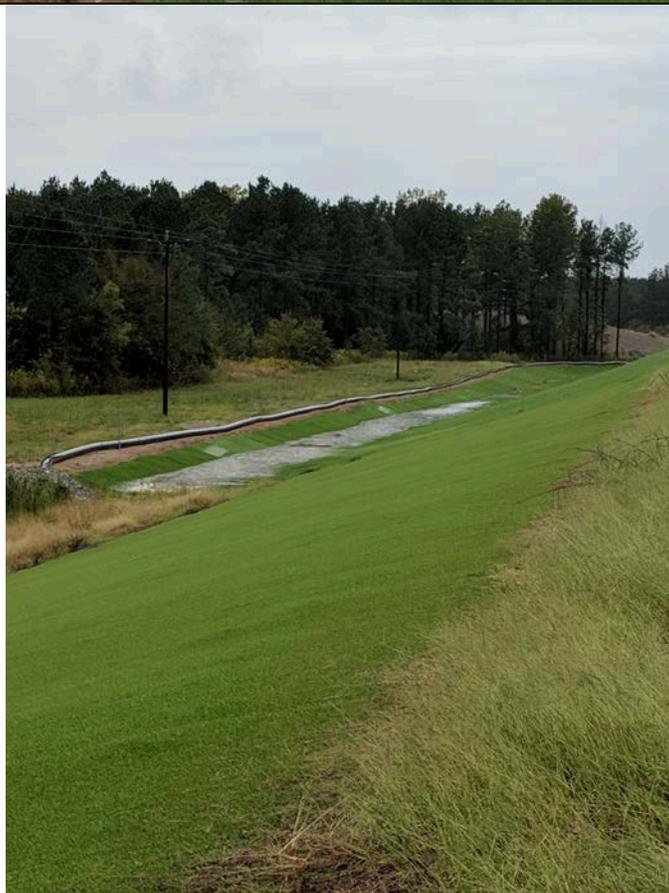
Photo # 5

6. The crest of the perimeter was in fair condition. There were a no ruts, cracks or settlement observed at the road surface.
7. The perimeter dike was in good condition and was mowed the week of September 23rd. There are sections along the east and south sides with artificial grass cover and this cover appears to be functioning as designed. There was no erosion or signs of structural instability noted. (Photo #5)

Perimeter berm - berm with artificial grass cover

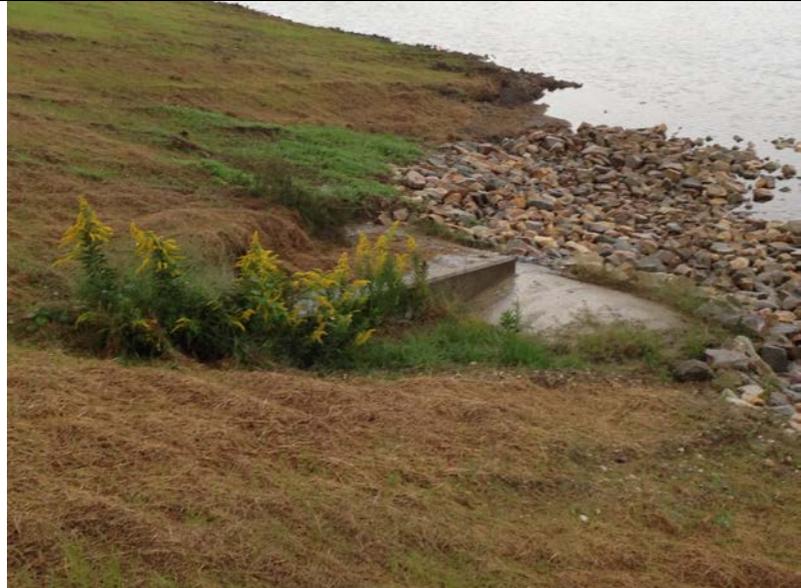
Photo # 6

was being generated at the time of the inspection with the previous rain events. The leachate inlet pipe had vegetation growth around the pipe concrete structure and debris near the pipe outlet. The pond surface was at a normal level. (Photo #6 & #7)

Leachate pond - inlet structure, vegetation growth occurring above structure

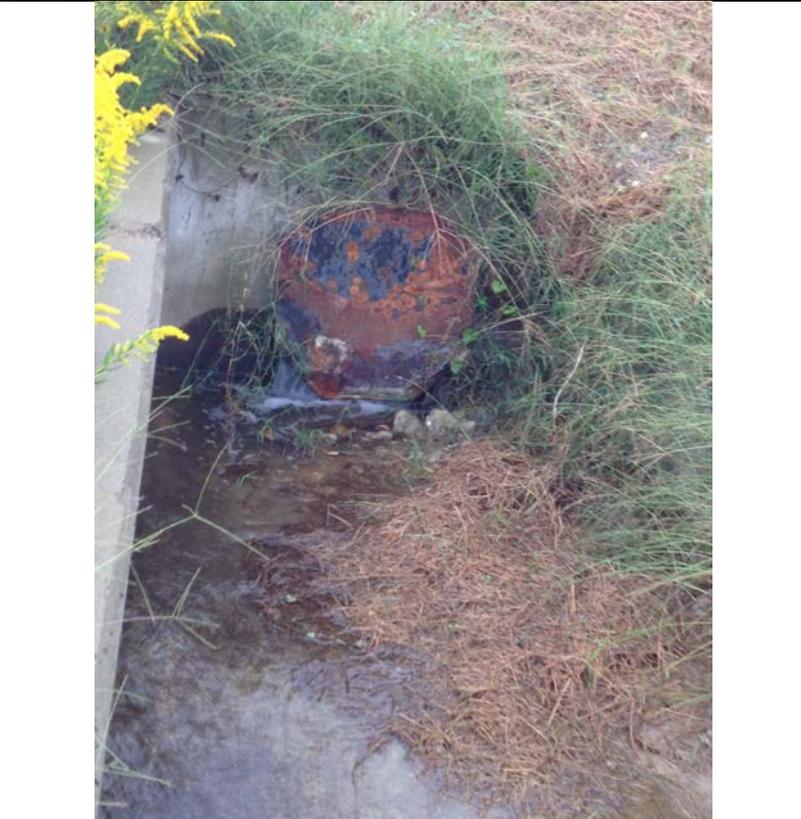
Photo # 7

Leachate pond - inlet structure, vegetation growth and debris near pipe outlet

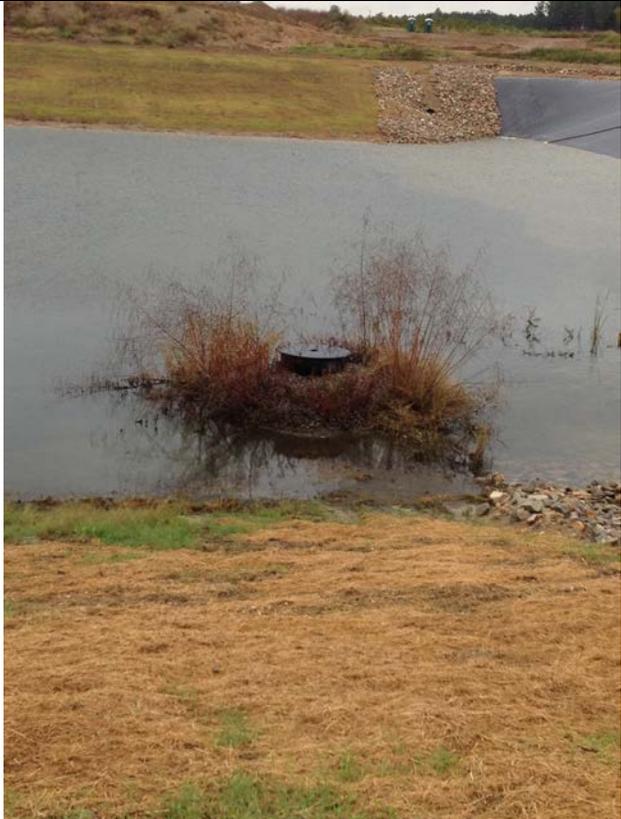
Photo # 8

9. The outlet structure had vegetation growth around the immediate structure, this is a minor maintenance item. (Photo #8)
10. As noted in the 2017 landfill inspection a slip of the cover soil was observed on a portion of the south side slope. A repair was performed to regrade and compact the cover soil over the liner. The slip is currently being monitored by the plant for any future movement. (Photo #9)
11. A significant slip of the cover soil on the west slope was observed in the landfill inspection for 2017. This slip was investigated by a consulting engineer and based on recommendations the plant has repaired the slip. The repair included removal of the cover soil over the liner and placement of rip rap at the transition on the north and south end of the repaired section. (Photo #10)

Leachate pond - outlet structure, vegetation growth occurring around structure

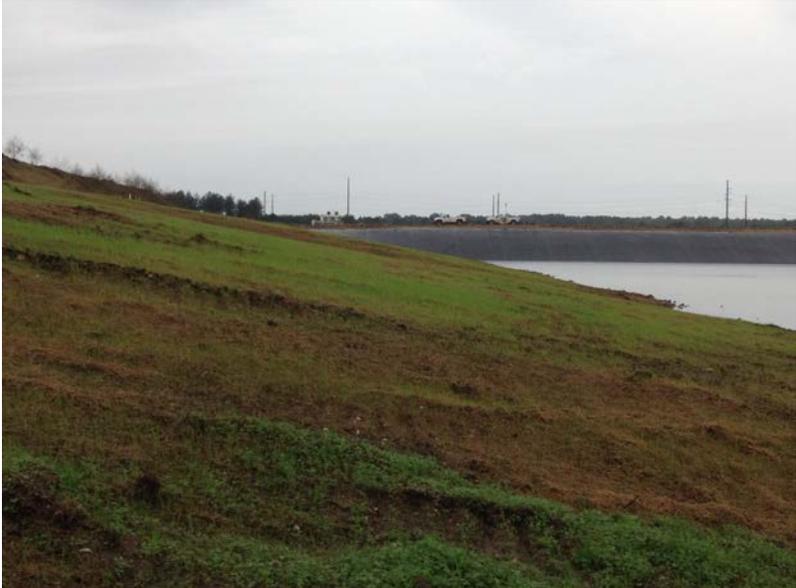
Photo # 9

Leachate Pond – South slope slip repair

7. Leachate Pond: the cover soil slips located on the south side slope of the leachate pond was repaired earlier this year and should be monitored for any subsequent movement. During the inspections recommendations were given to place stakes (no more than 12" deep) along the slope where the slip occurred. These stakes should be surveyed for movement on a weekly basis between December and May (rainy season) and monthly for the other time of the year.

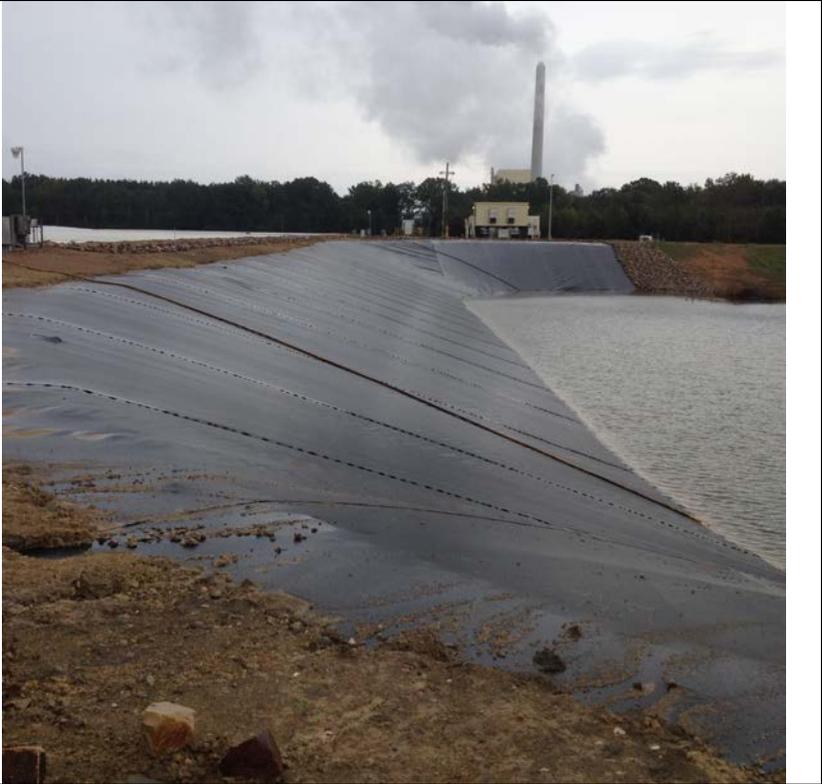
Photo # 10
Leachate pond – West slope
slip repair
