2019 Annual Landfill Inspection Report

Amos FGD Landfill

**John E. Amos Plant
Appalachian Power Company
Putnam County, West Virginia**

Document ID: GERS-19-020

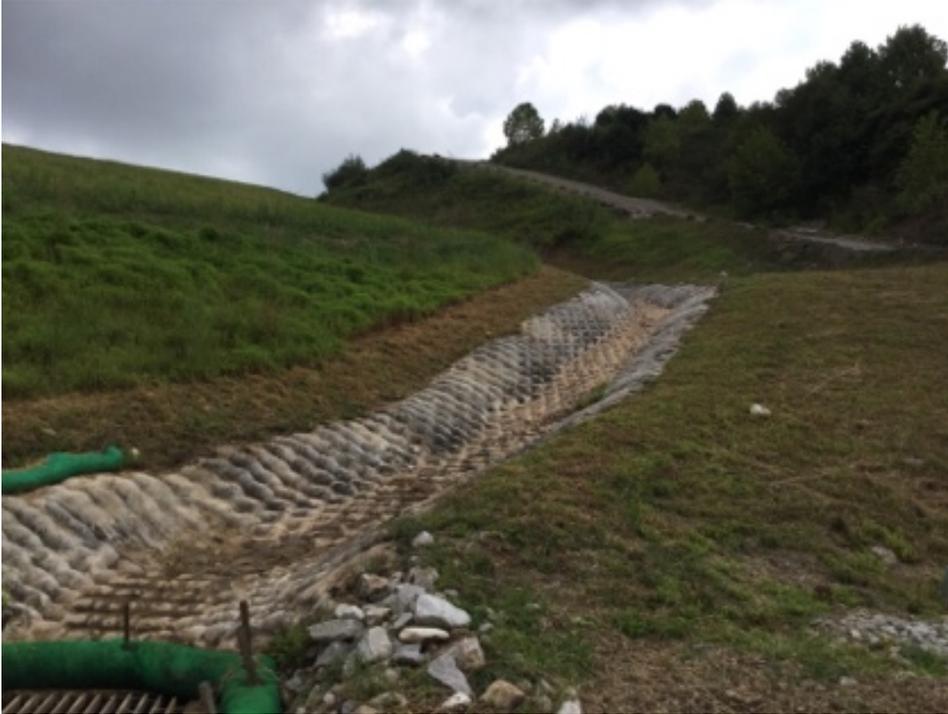
2. The northern portion of Sequences 3 has interim cover installed. Generally the interim cover was in good condition with vegetation and no erosion. The most recent areas of interim cover are scheduled to be seeded and mulched. (Photo 3)
3. The perimeter channel along the north side of sequence 3 had ditch checks and silt sox established within the channel that were functioning properly to retain sediment. The installation of riprap in this channel was an interim measure and the channel is designed to have a fabric liner as erosion protection. (Photo 4)

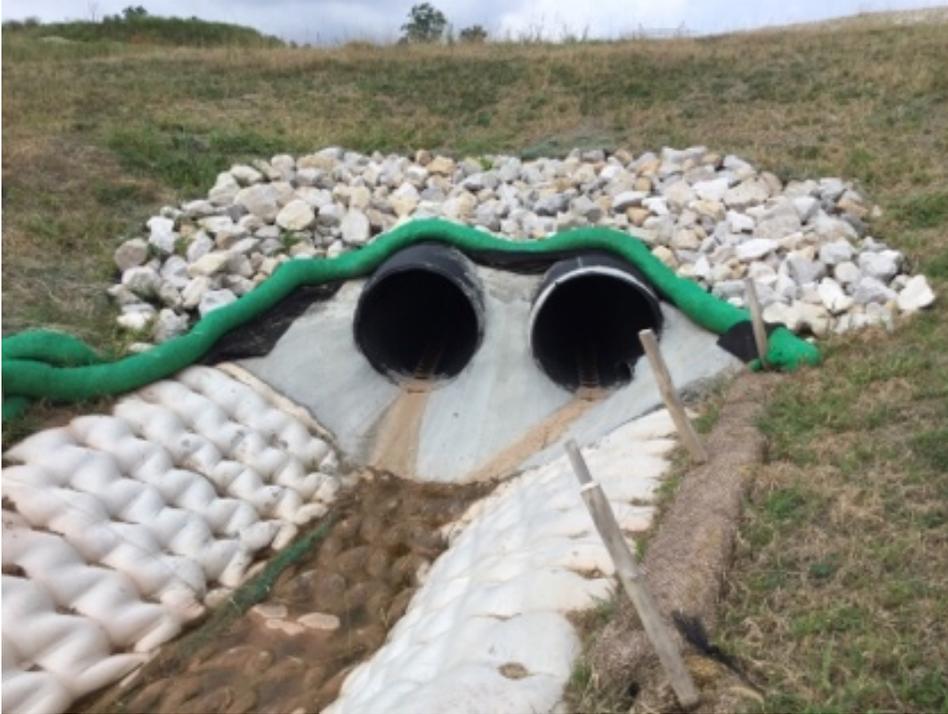
Photo #: 7

Notes: Culverts at bench road on northside of west slope of south valley area

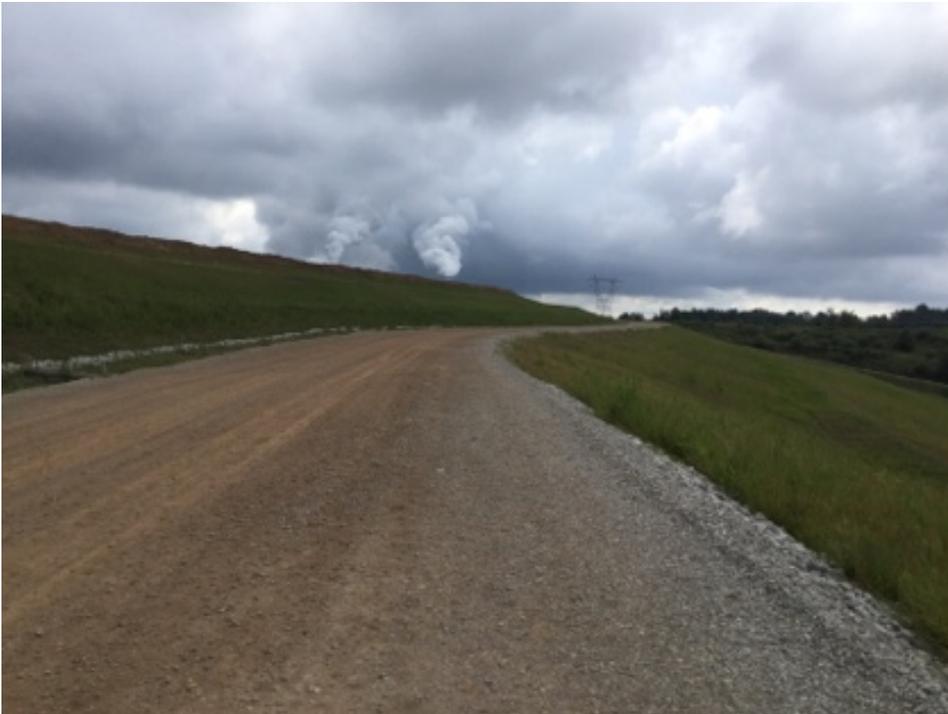
Photo #: 8

Notes: 930 bench access road

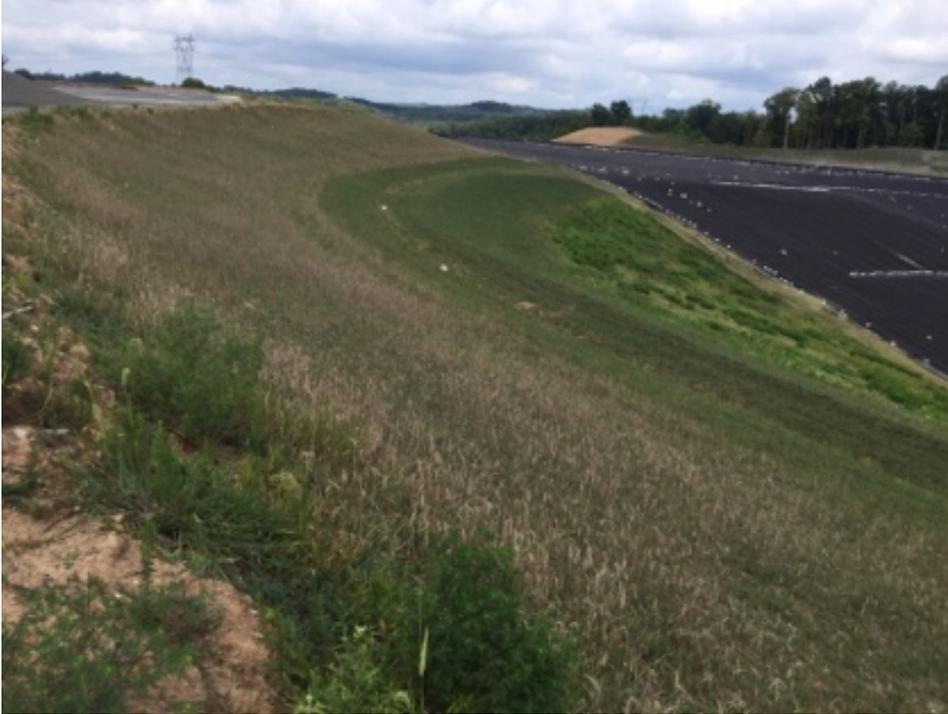
Photo #: 13

Notes: Temporary cover on north face active area with Sequence 4 in background

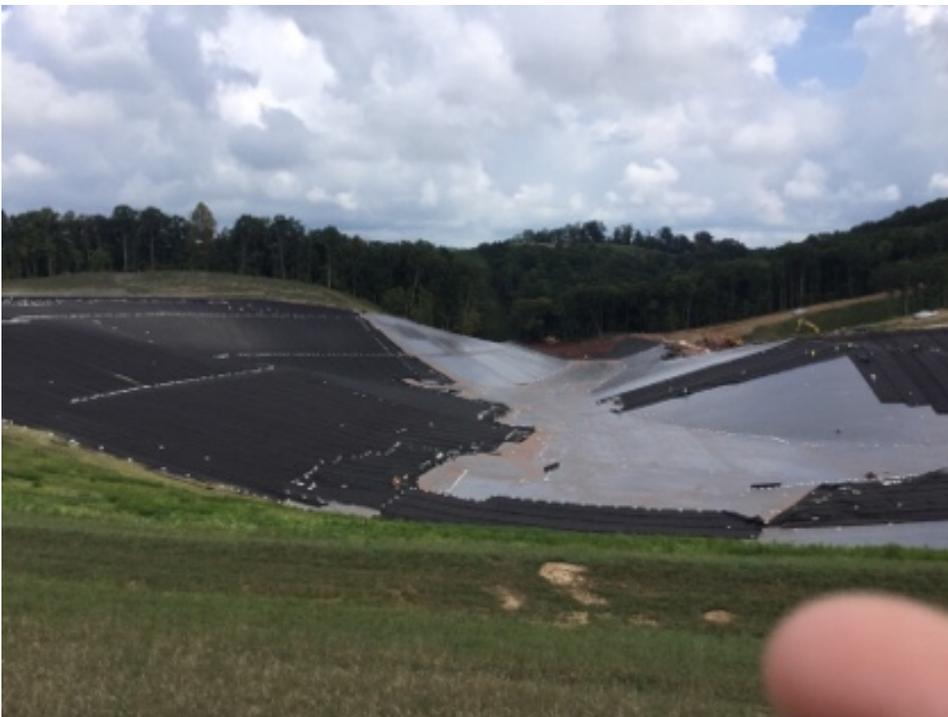
Photo #: 14

Notes: Sequence 4 can construction

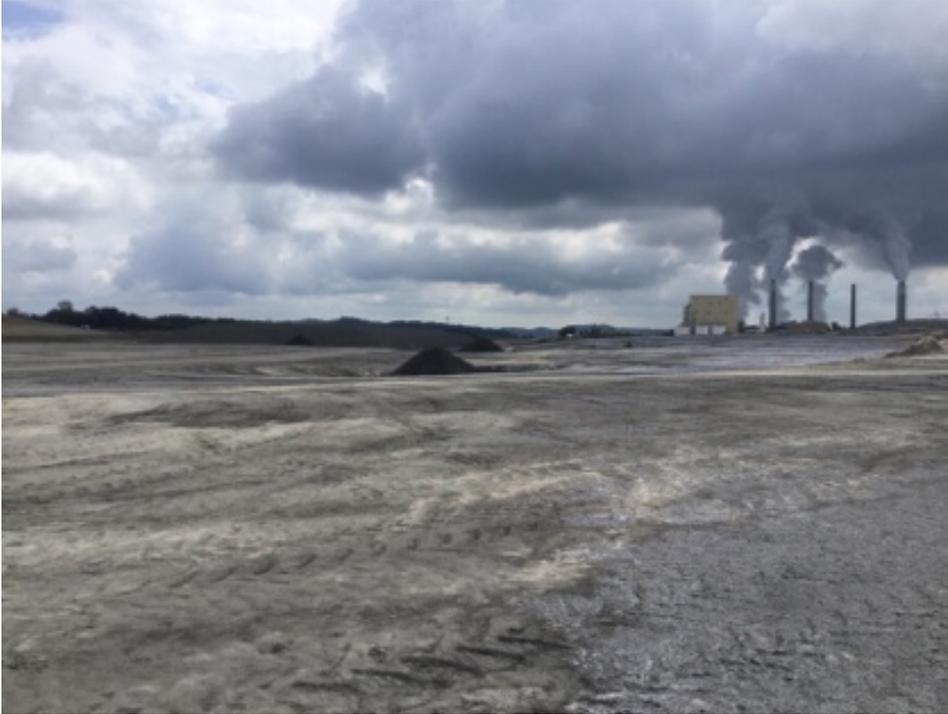
Photo #: 15

Notes: General condition of Active area

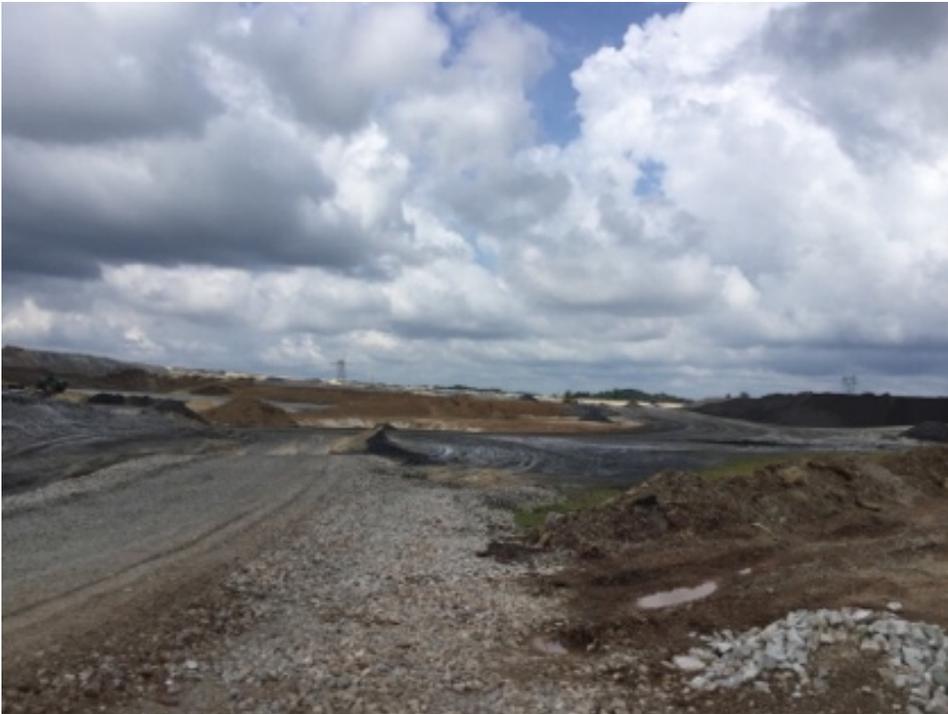
Photo #: 16

Notes: General condition of Active area
