# **2019 Annual Dam and Dike Inspection Report**

## **Fly Ash Pond and Bottom Ash Pond Complex**

**Big Sandy Plant  
Kentucky Power  
Lawrence County, KY**

**GERS-19-029**

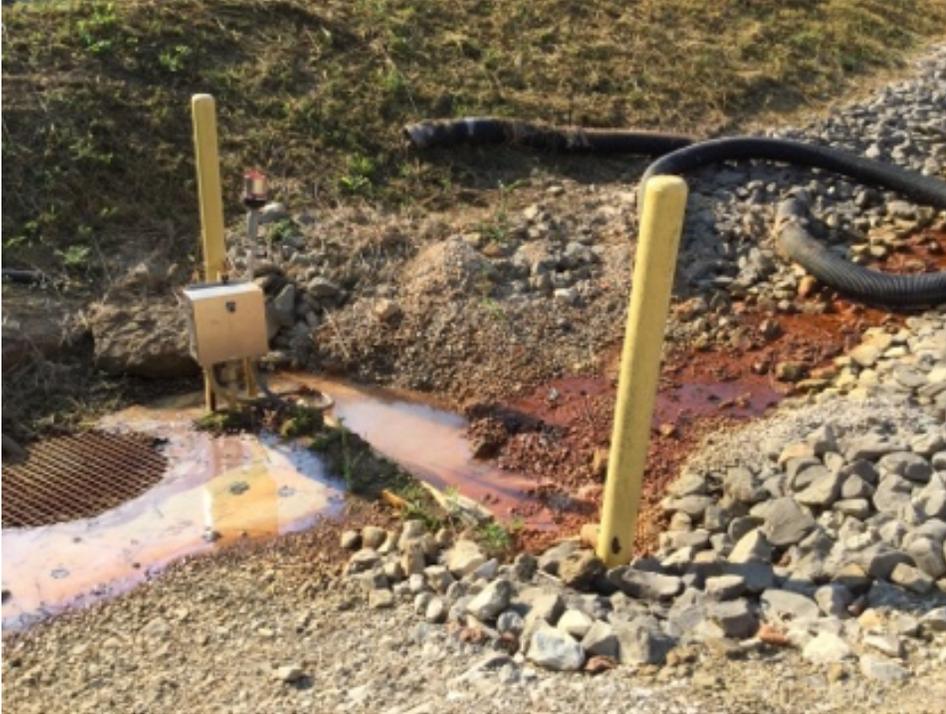
Photo #: 19

Notes: General condition of red water sump

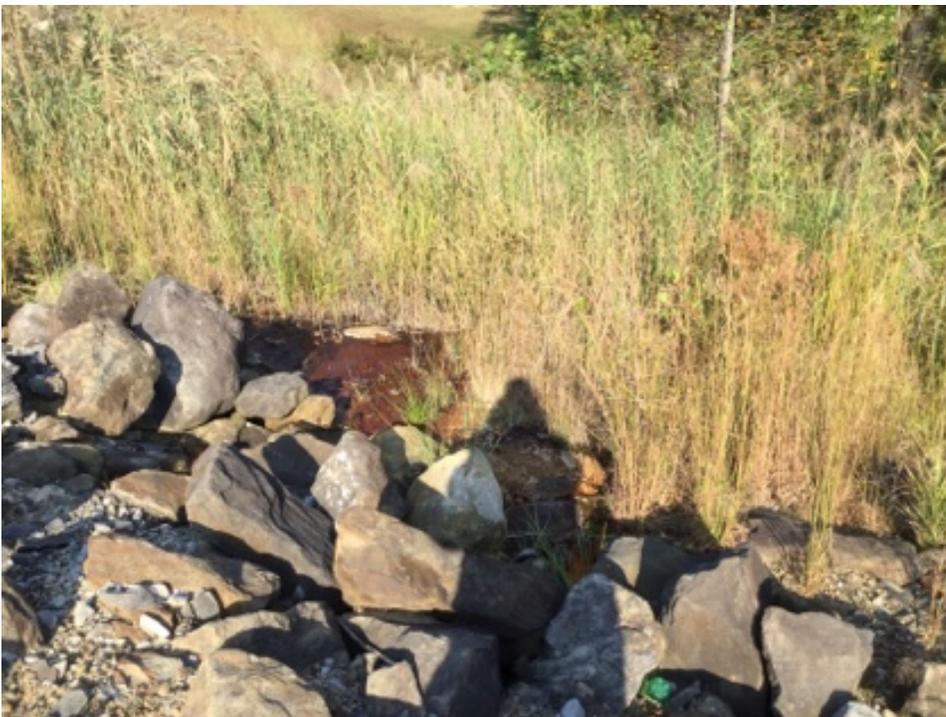
Photo #: 20

Notes: Area across road from red water collection that drains to down slope to 018.

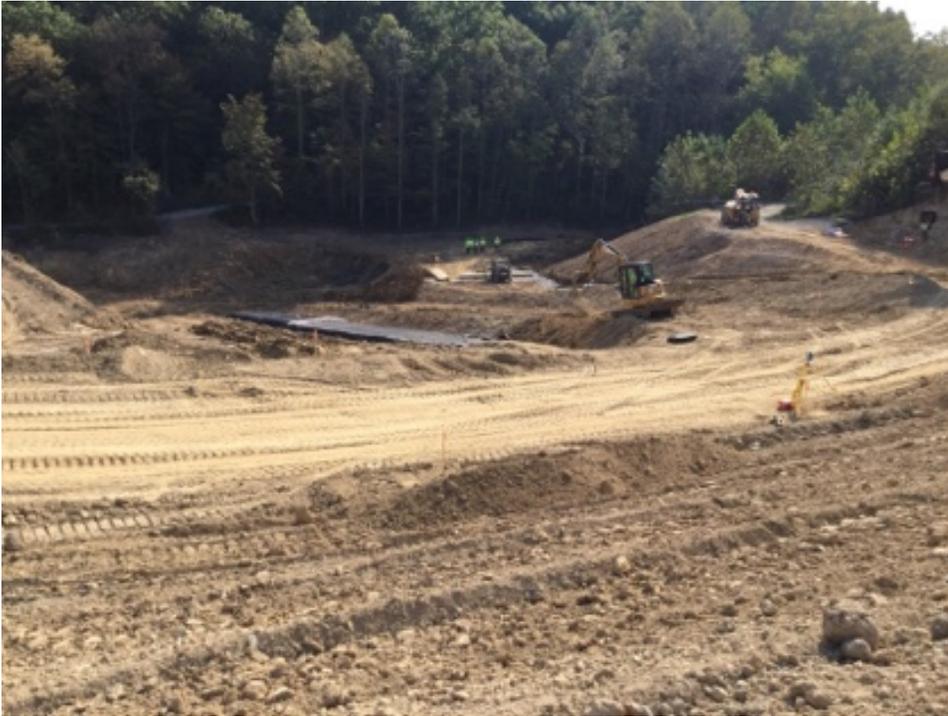
Photo #: 27

Notes: Initial construction of new discharge structure in subgrade downstream of saddle dam

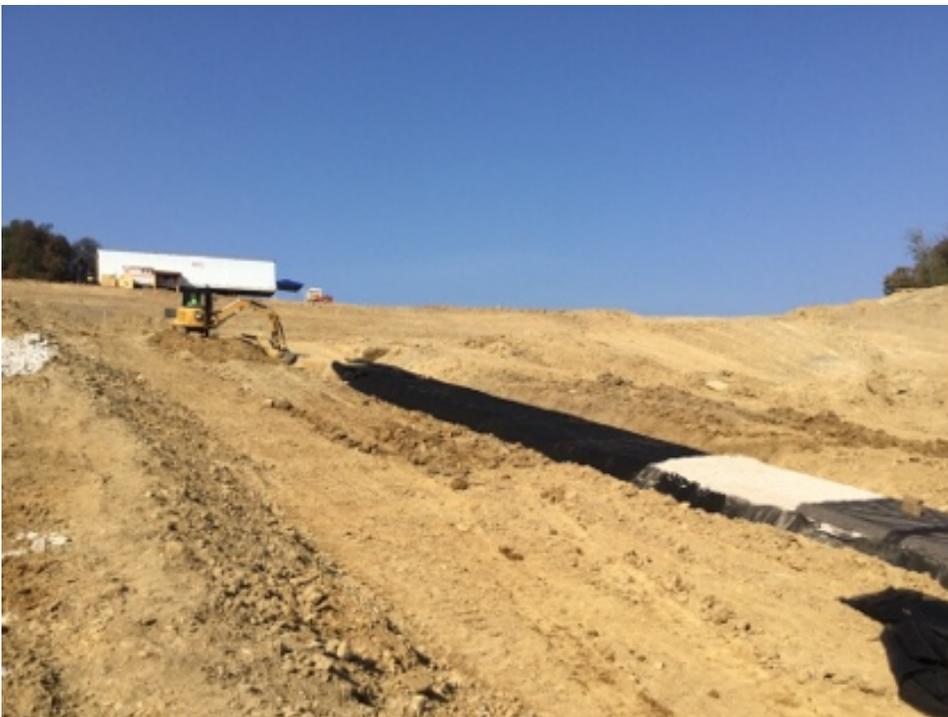
Photo #: 28

Notes: Initial construction of new discharge structure in subgrade downstream of saddle dam
