2019 Annual Landfill Inspection Report

Mitchell Plant

**Kentucky Power Company and Wheeling Power Company
Moundsville, West Virginia**

Document ID: GERS-19-014

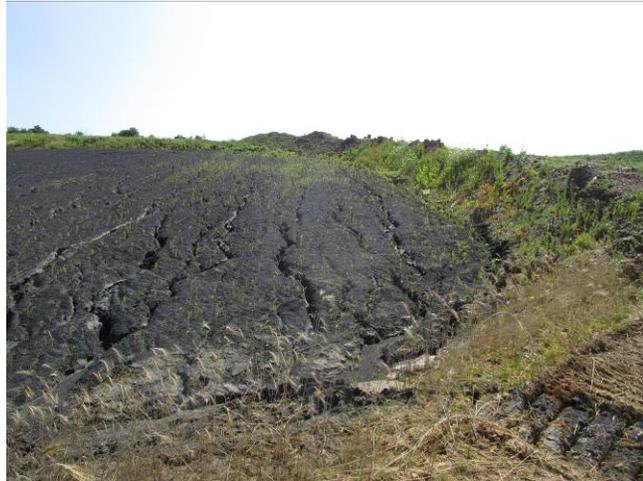
1. During the inspection, parts of Phase 2 area was actively receiving CCR materials. CCR material is dumped, spread out with a dozer and compacted with a smooth drummed roller. 6-inch deep erosion rills were noted along the northern slope of the temporary cover in the Phase 2 area. Plant personnel indicated that erosion of this temporary cover is an on-going maintenance issue and usually addressed after rain events. There was no evidence of standing water, slope instabilities or uncontrolled seepage.

Photograph 1: View of the erosion rills on the protective cover material on the north and east face of the Phase 2 area.

- 1) Continue to repair the erosion rills in the temporary ash cover on the north slope of Phase 2 area of the landfill after rain events.
- 2) Periodically remove the vegetation growing in the riprap-lined areas on the upstream slope and downstream toe area of the south pond dam.
- 3) Continue to perform routine maintenance on the leachate pump system components and remove any debris accumulation (leaf litter, sticks, etc.) as necessary for proper operation of the pumping system.
- 4) Tree trunk fell on the corrugated pipes is to be removed and the corrugated pipes are to be evaluated for reuse or replacement

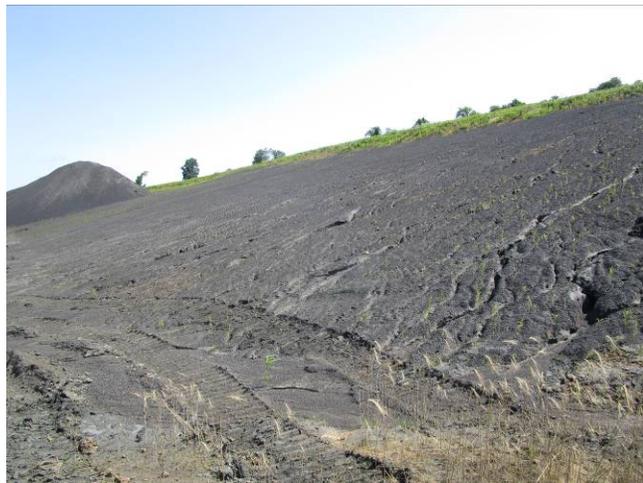
Photograph 2: View of the erosion rills on the protective cover material on the north and east face of the Phase 2 area.

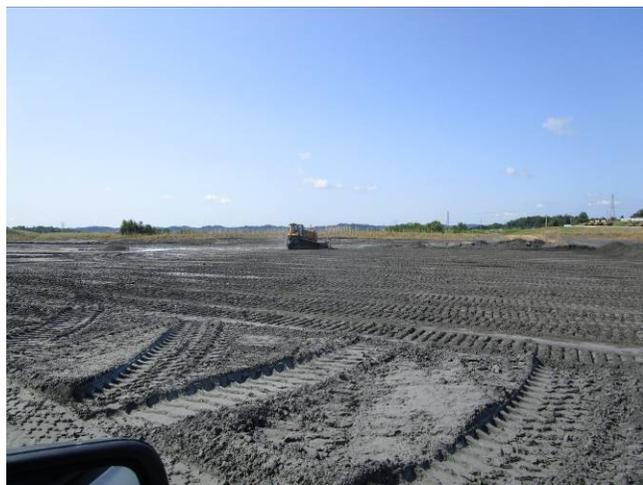
Photograph 3: Overview of the landfill area, facing east.

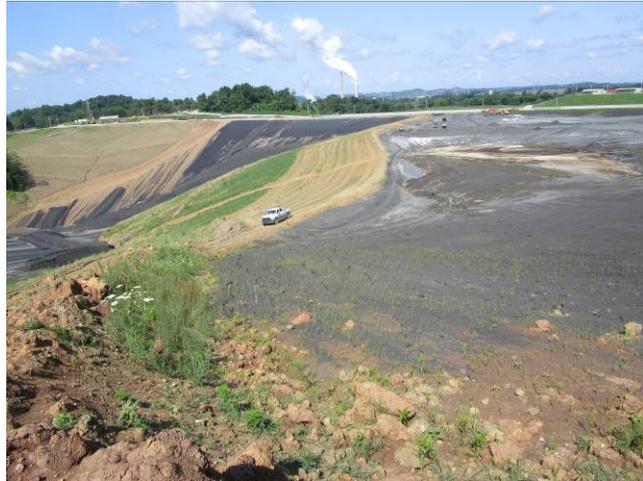
1. At the time of inspection, the clay berm south of phases 1 and 2 was recently mowed with good established grass cover.
2. There was no evidence of uncontrolled leachate, slope instability or ponding water on the clay berm area.

Photograph 4: Overview of the clay berm, facing west. The bare soils define the recently placed clay material.

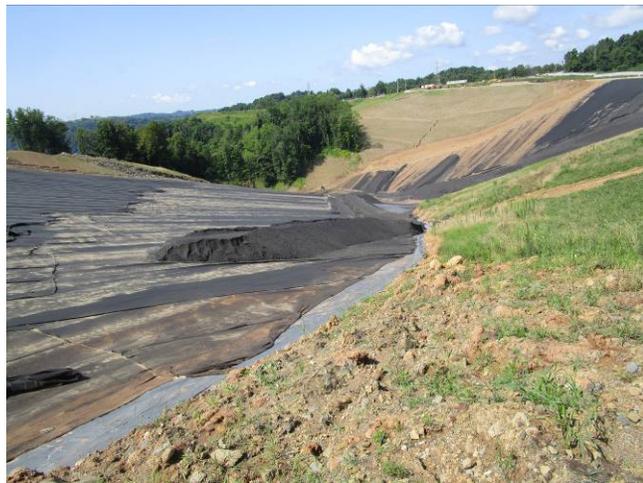
Photograph 5: View of the erosion occurring in the eastern groin of the clay berm area and the limits of the new construction.

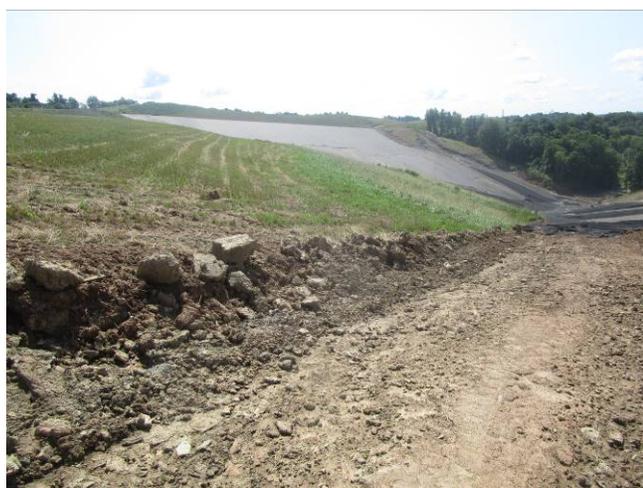
Photograph 6: View of the erosion rill on the dirt access road on the clay berm.

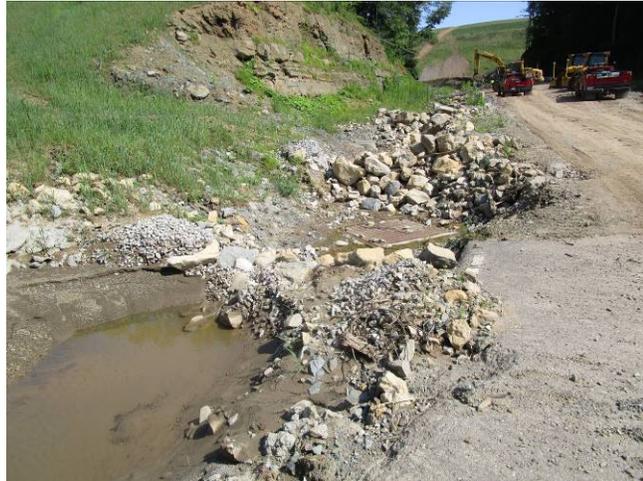
Photograph 7: View of Check dams.

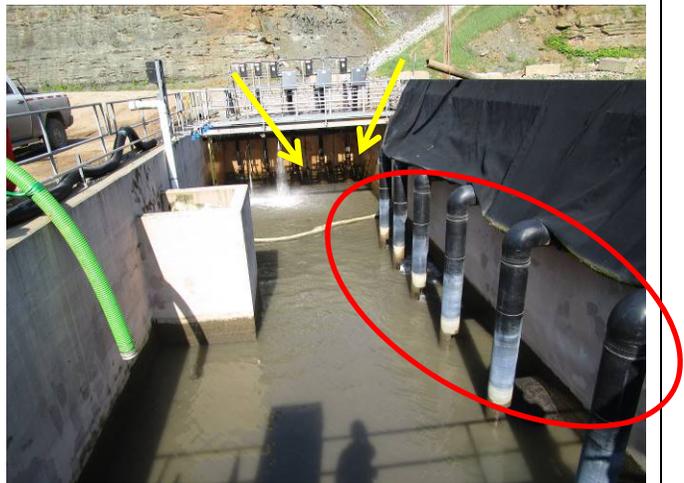
1. The leachate collection pipes are exposed at the ground surface in the area between the toe of the clay berm and the leachate lift station. There was no evidence of leachate leaking through defects or imperfections in the leachate collection pipes in this area where the pipes were exposed for visual inspection.
2. The leachate lift station was observed to be in good condition. The pumps and backup power generator appeared to be in good working order.
3. The water level in the leachate sump was about 10 feet below the elevation of the overflow structure.

Photograph 8: View of the leachate collection sump. The leachate collection pipes are circled in red, and the leachate pumps are indicated by the yellow arrows.

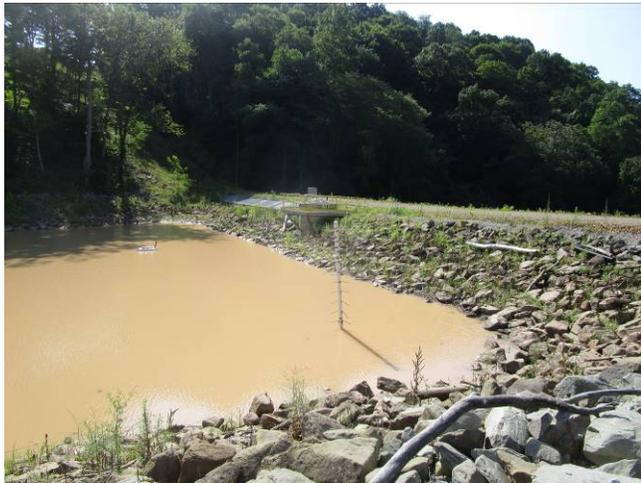
6. Some minor vegetation was starting to grow amongst the riprap on the upstream slope of the south pond.
7. The principal spillway outlet was observed to be in good condition. Some brush vegetation was becoming established in the riprap around the principal spillway outlet area.

Photograph 10: View of the upstream slope of the south pond dam.

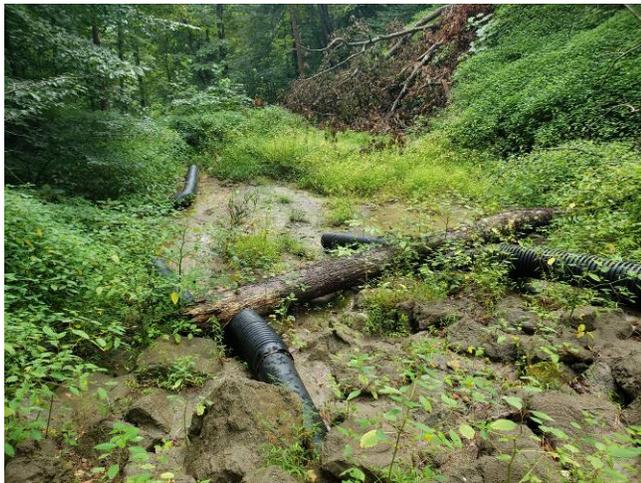
8. There are two, 12-inch-diameter perforated HDPE underdrain pipes which outlet at the downstream toe of the south pond dam. A section of corrugated plastic pipes had been secured to the HDPE pipes with screws to extend the outlet of these underdrain pipes. 2-foot diameter tree trunk fell on the corrugated pipes resulting in shearing off one of the pipes (left) and squeezing the other pipe. Both of these pipes were observed to be dry at the time of the inspection, however it is judged that they were 10-20% obstructed.

Photograph 11: View of the downstream toe area, showing the outlet of the underdrain pipes.

Note the 18-inch tree trunk fallen on the corrugated pipes.

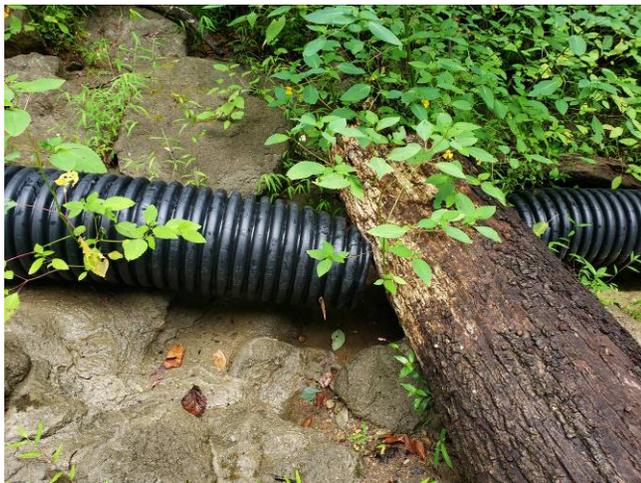
Photograph 12: View of the downstream toe area, showing the outlet of the underdrain pipes.

Note: Pipe at the left side of the slope was sheared off by the fallen tree.

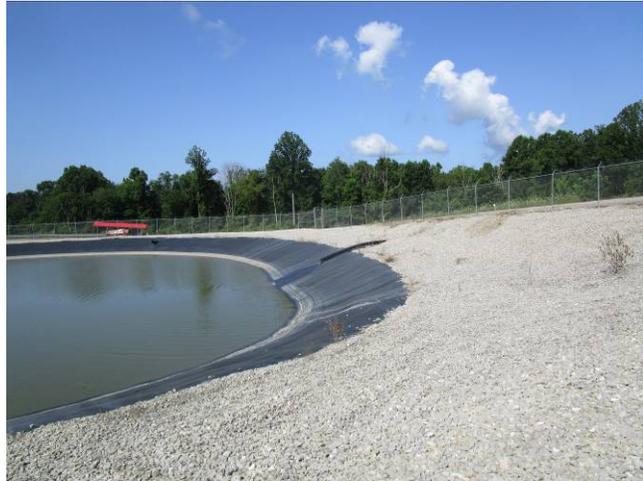
1. The water level in the leachate collection pond was approximately El. 1220 feet above mean sea level.
2. The geomembrane liner at the leachate pond appeared to be in good condition, with no evidence of tears, rips, holes or signs of flotation.
3. The overflow pipe at the leachate collection pond was observed to be unobstructed.

Photograph 13: View of the leachate collection pond.

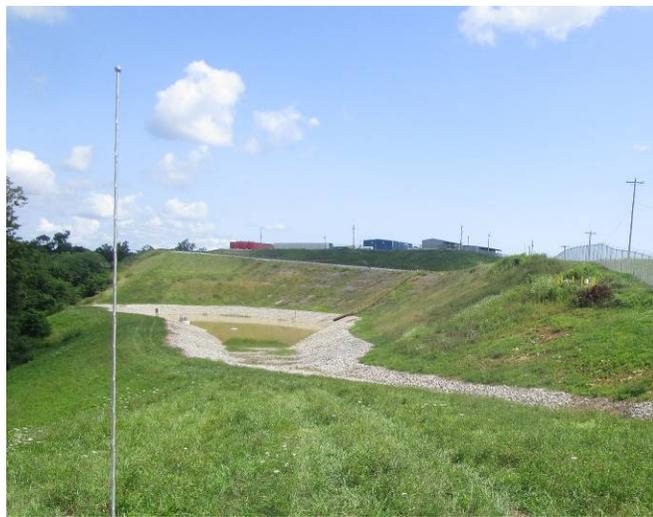
1. The pool level in the west pond is about 7 feet below the top of the principal spillway riser. The trashrack and anti-vortex plate were in good condition and securely fastened to the principal spillway riser.
2. The grass cover on the downstream slope of the west pond embankment was observed to be in satisfactory conditions.
3. The emergency spillway of the west pond was observed to be unobstructed.
4. It should be noted that the riprap armoring for the west pond emergency spillway does not protect the downstream slope of the embankment, however the height of the embankment in this area does not appear to be more than 5 feet.
5. A surface drainage culvert is extended down the sloping natural ground to the waterline, on the eastern edge of the pond.

Photograph 14: View of the west pond dam.

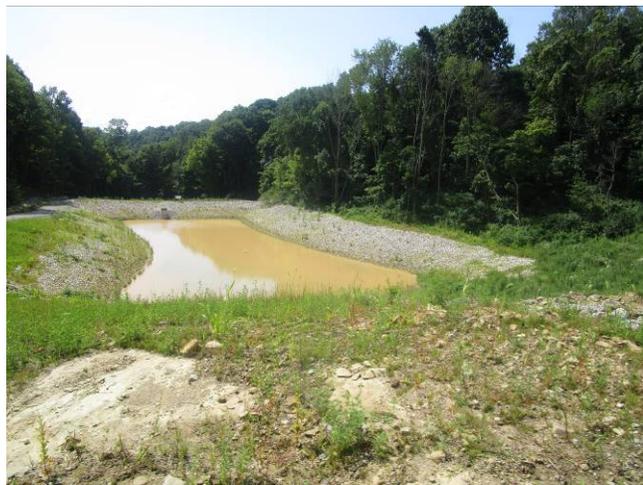
1. The pool level in the east pond is about 10 feet below the top of the principal spillway riser. The trashrack and anti-vortex plate were in good condition and securely fastened to the principal spillway riser.
2. The grass cover, at areas where there is no riprap, on the downstream slope of the east pond embankment was observed to be in satisfactory conditions.

Photograph 15: View of the east pond dam.

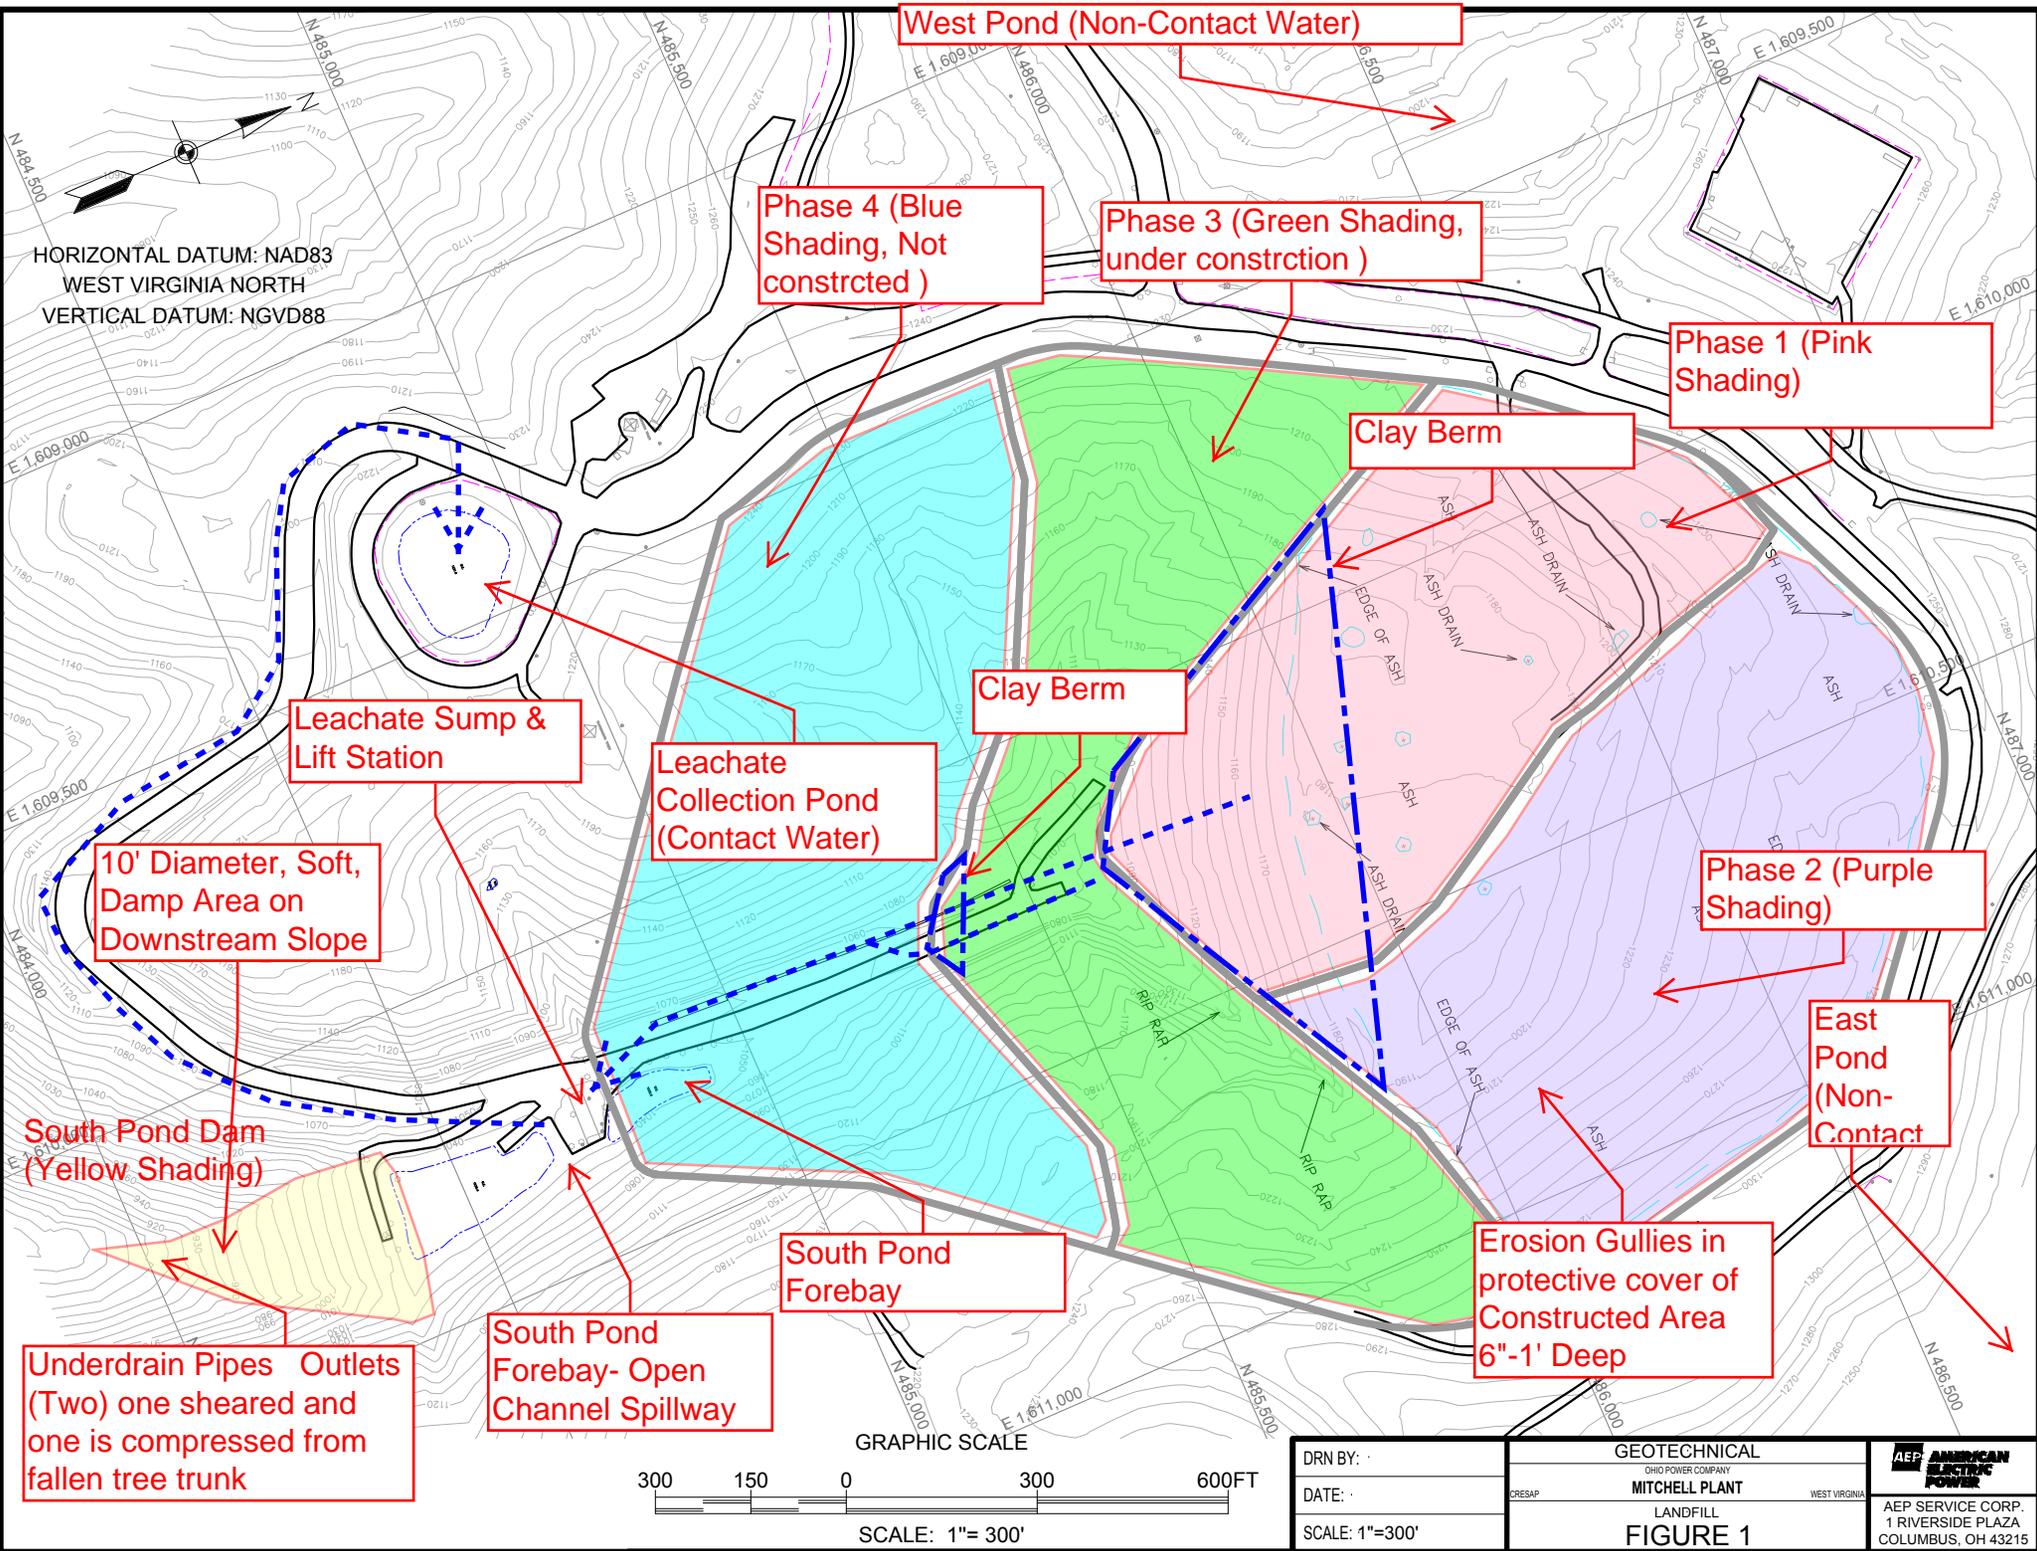
GEOTECHNICAL	
OHIO POWER COMPANY	
MITCHELL PLANT	
LANDFILL	WEST VIRGINIA
FIGURE 1

10' Diameter, Soft, Damp Area on Downstream Slope

Erosion Gullies in protective cover of Constructed Area 6"-1' Deep

Underdrain Pipes Outlets (Two) one sheared and one is compressed from fallen tree trunk

- 1) Monitor the soft, damp area on the downstream slope of the south pond, about 1/3 of the down the slope, near the center of the embankment for any signs of changing seepage conditions, muddy seepage, or slope instabilities.
- 2) Continue to monitor the sediment accumulation in the storm water sedimentation ponds (including the south pond forebay) and plan to periodically remove the sediments as necessary to retain the design storage capacity of the ponds.
