2019 Annual Landfill Inspection Report

FGD Stackout Area

**H.W. Pirkey Plant
Southwestern Electric Power Company
Hallsville, Texas**

Document ID: GERS-19-025

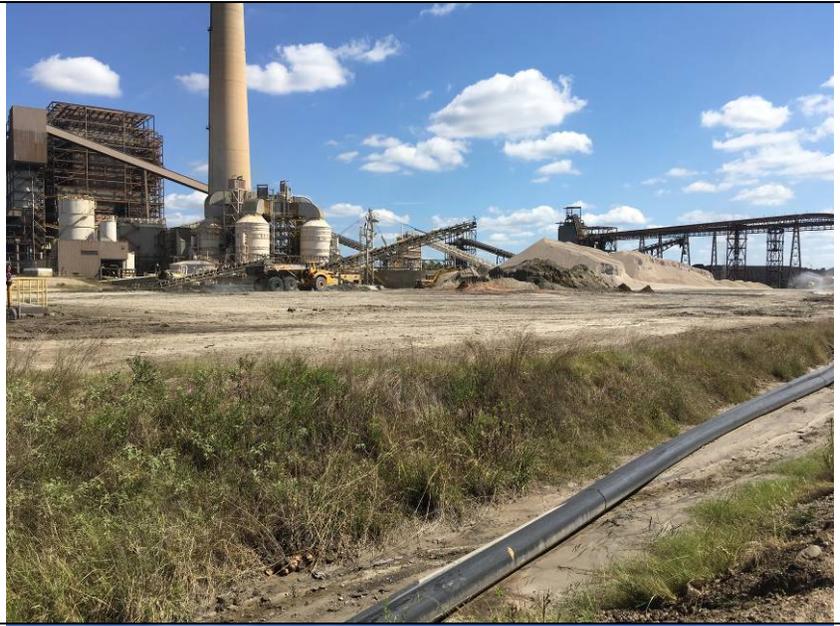
Photo # 1

View of the FGD Stackout Area.

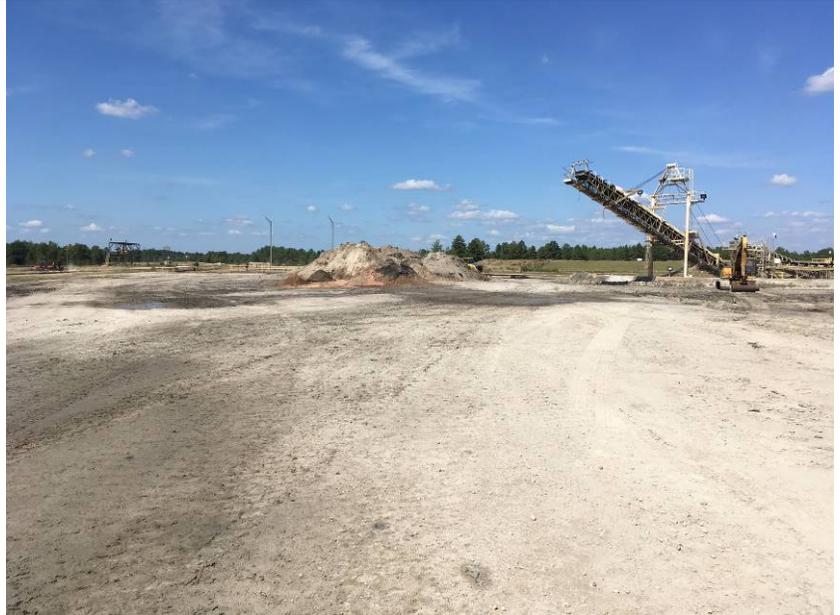
Photo # 2

View of the FGD Stackout Area.

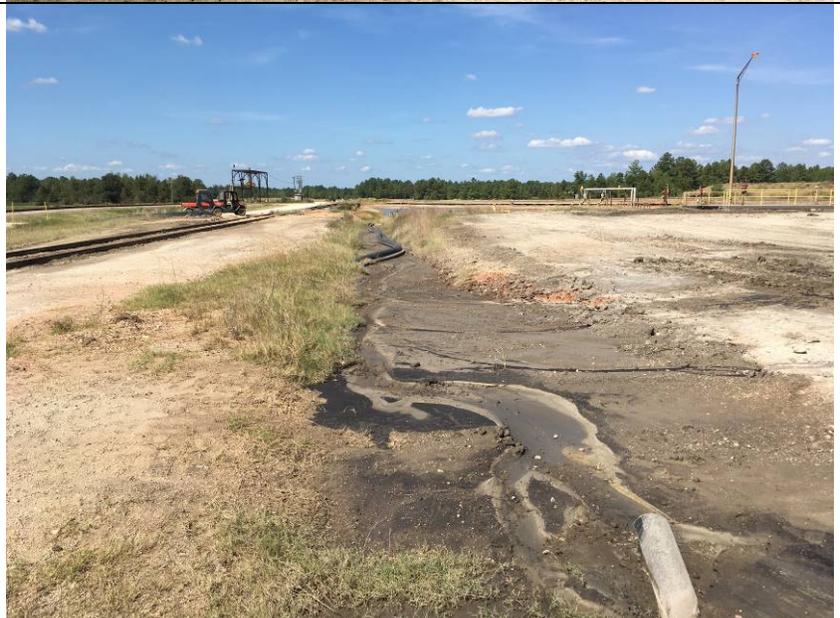
Photo # 3

View of the western perimeter ditch just north of berm with a geomembrane cover, facing north.

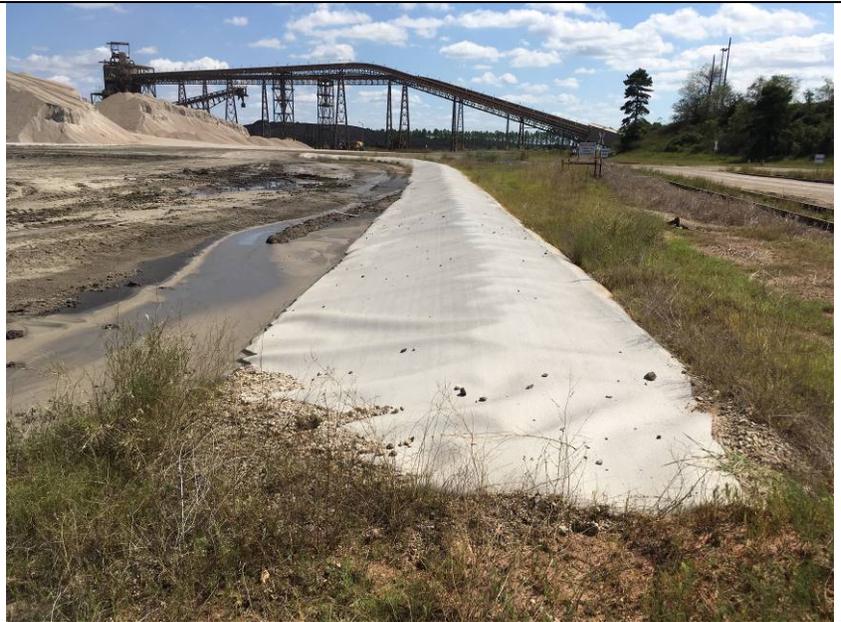
Photo # 4

1. The gravel berm with a geomembrane cover appeared to be in good condition. There was no evidence of holes, air/water pockets, or other signs of distress noted on the geomembrane.

View of the western gravel berm with a geomembrane cover, facing south.

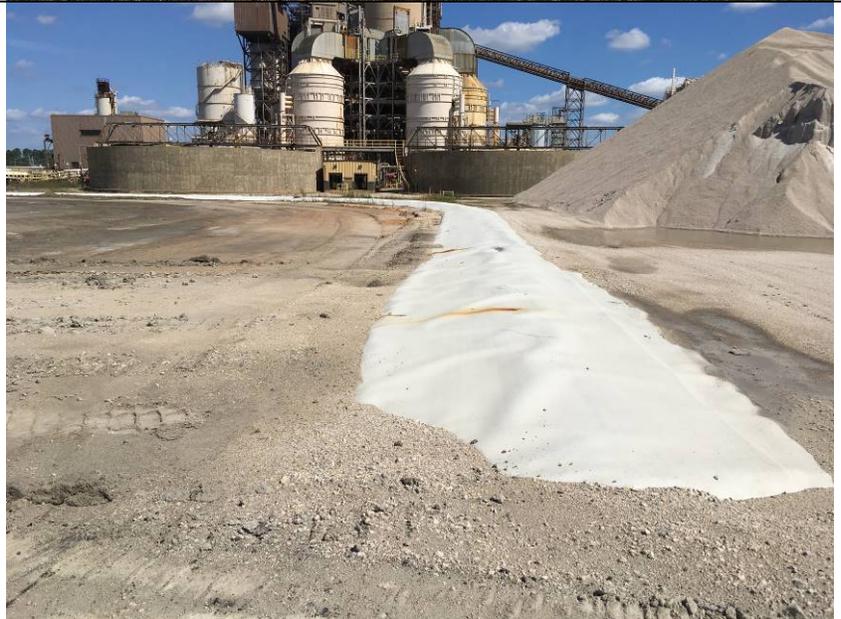
Photo # 5

View of the southern gravel berm with a geomembrane cover, facing east.

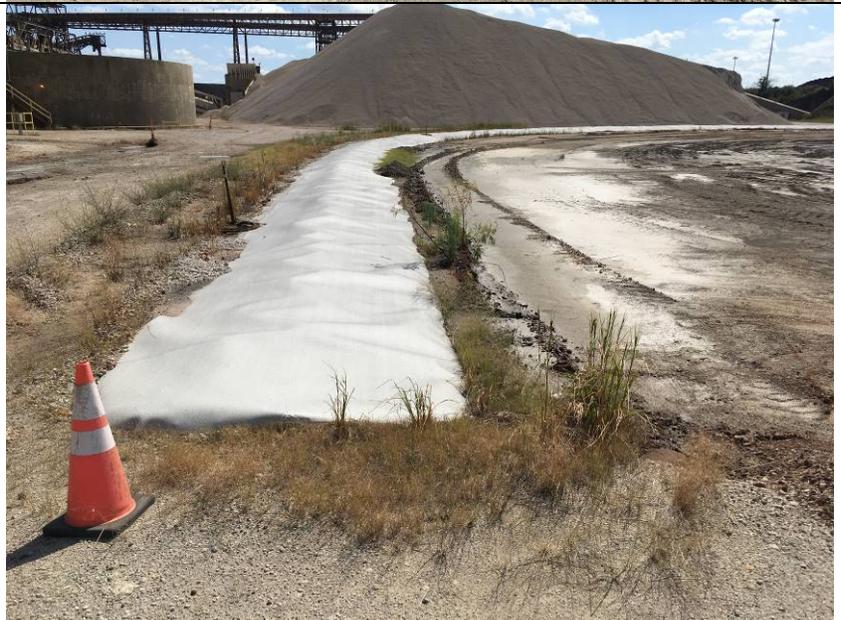
Photo # 6

View of the eastern gravel berm with a geomembrane cover, facing south.

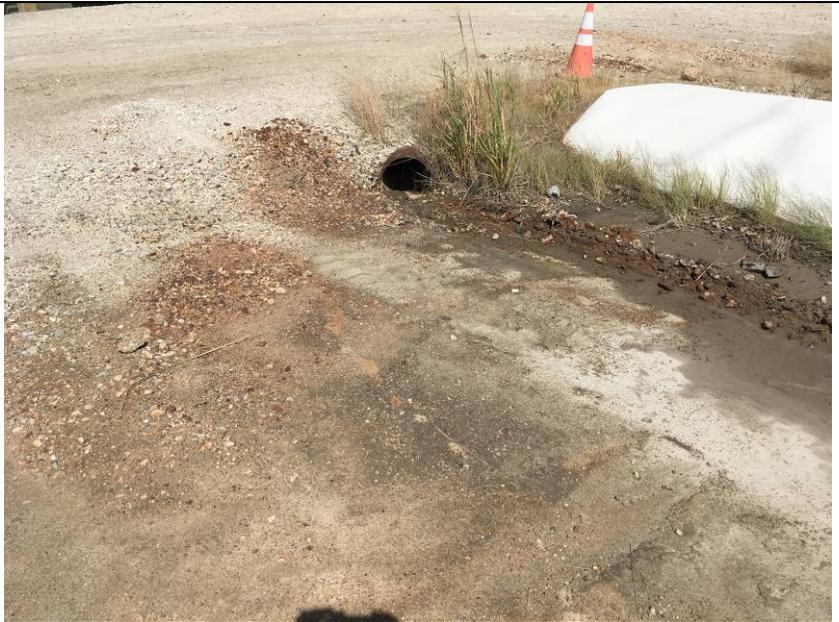
Photo # 7

View of the inlet culvert pipe that lets water from the stackout area into the drainage ditch under the conveyor system.

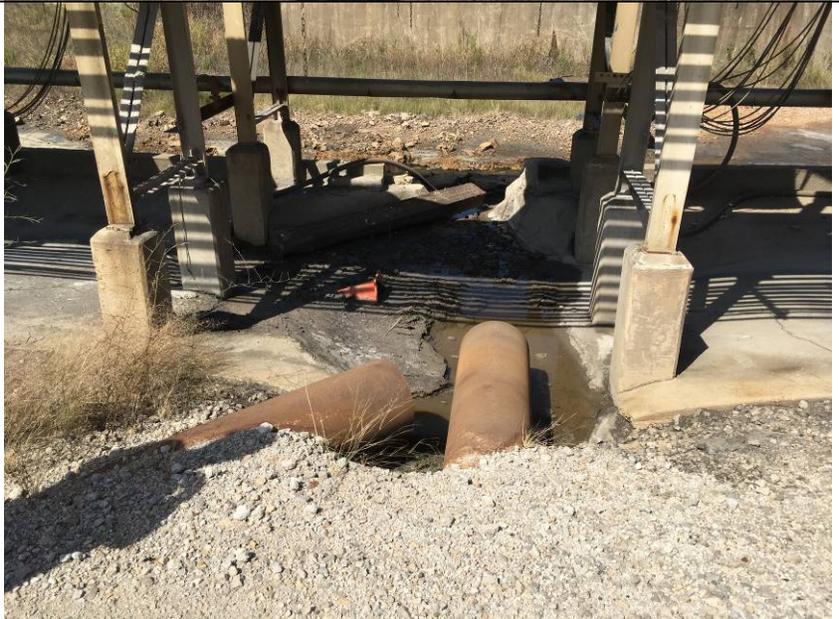
Photo # 8

View of the outlet area of the steel culverts under the conveyor system which feeds the radial arm stacker.

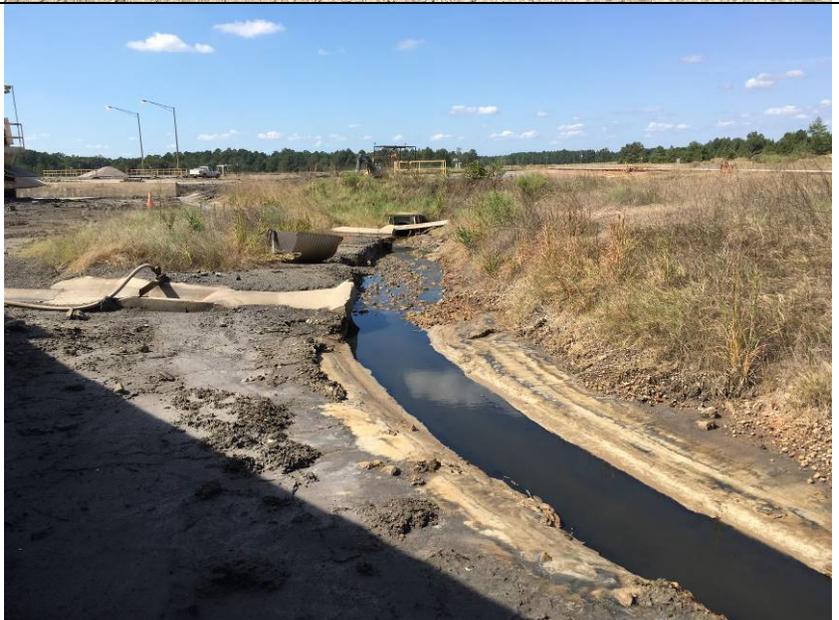
Photo # 9

View of the drainage ditch and culvert which directs runoff into the auxiliary surge pond. This culvert is downstream of the notch in the curb shown in Photo #8
