2019 Annual Landfill Inspection Report

**Rockport Plant
Indiana Michigan Power Company
Rockport, Indiana**

September 2019

Document ID: GERS-19-023

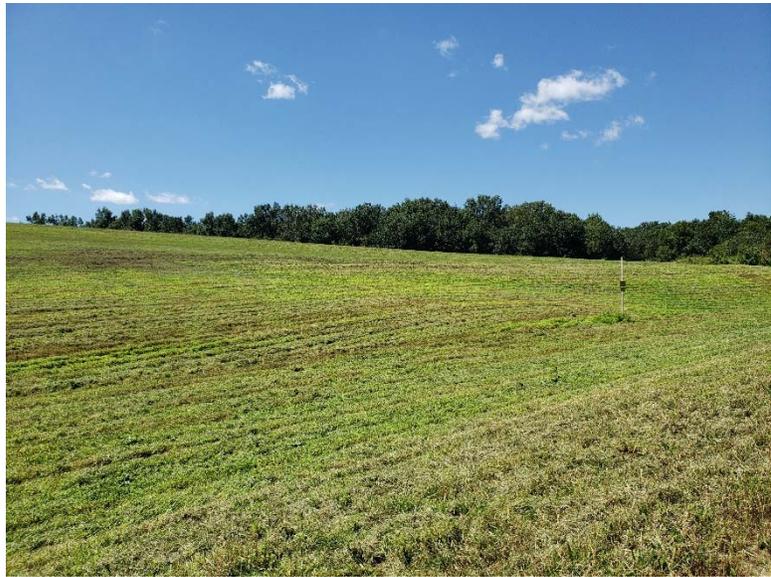
Photo # 1

1. The closed landfill area was observed to have a thick grass cover over the entire capped area that had recently been mowed. Drainage and runoff from the closed area was observed to be working as designed. There were no signs of settlement, signs of movement or distress of the landfill area. Access roads on top and adjacent to the landfill area were in good condition. The closed landfill area was in good condition and well maintained (Photo #1).

Closed Landfill Areas –
Closed area observed to be in
good condition.

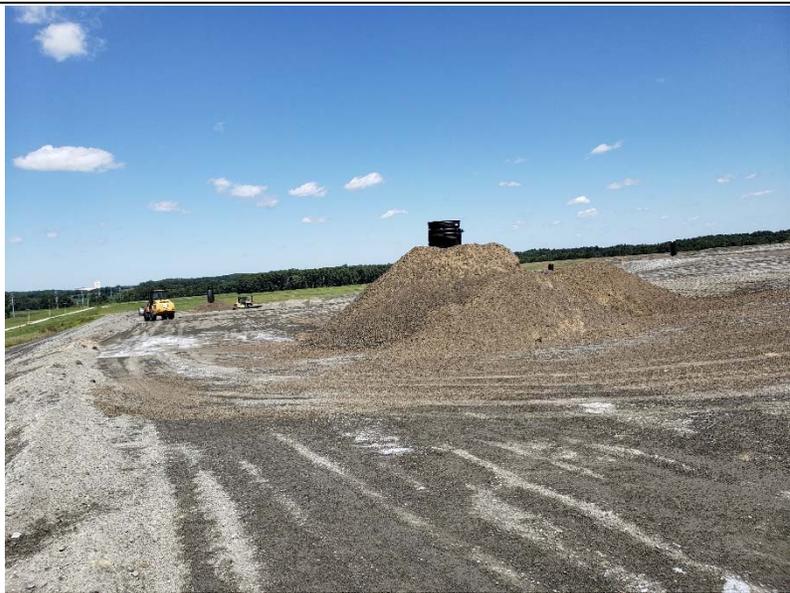
Photo # 2

2. During the inspection, ash was being placed in the active disposal areas and the ash was being compacted as it was placed. The chimney drains were functioning as designed and there was no pooling of water around the drains (Photo #2 and Photo #3).
3. On the perimeter dike to the south of Cell 2 and 3 minor thinning of the vegetation cover was observed. The thinning of the vegetation was only on the surface and no erosion was noted below the vegetation.

Active Landfill Disposal Areas –
Good overall condition for
internal waste surfaces and
drainage features.

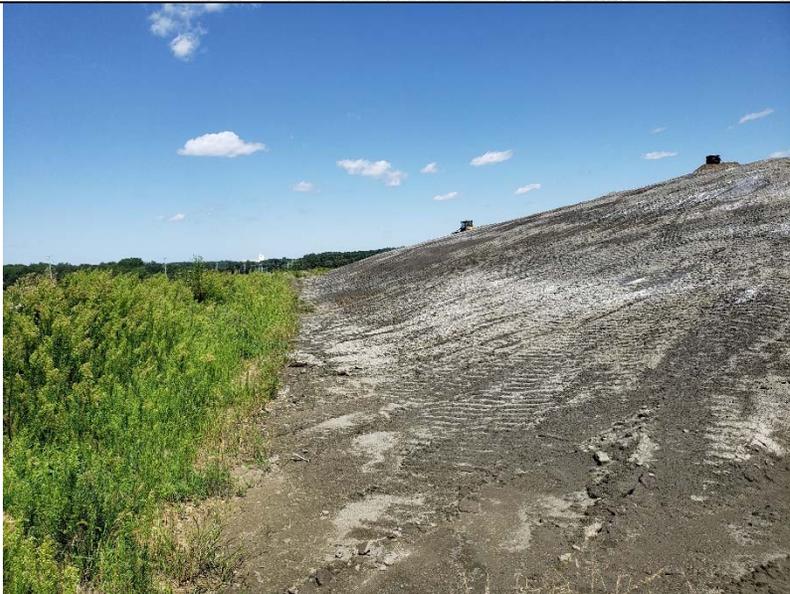
Photo # 3

Active Landfill Disposal Areas –
Good overall condition for
internal waste surfaces and
drainage features.

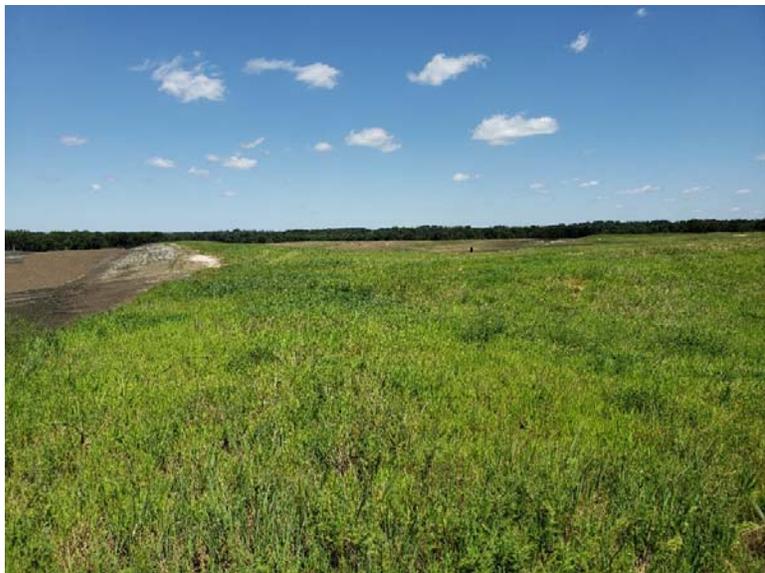
4. Cell 1A was well vegetated and was recently mowed. There were no signs of depressions, cracks, sloughs or other signs of distress. In general the area was in good condition.
5. There are some areas of minor thinning of the vegetation cover. The thinning was only of the surface vegetation and no erosion was observed (Photo #4).

Photo # 4
2015 Construction Area –
Good overall condition, east
of cell 1.

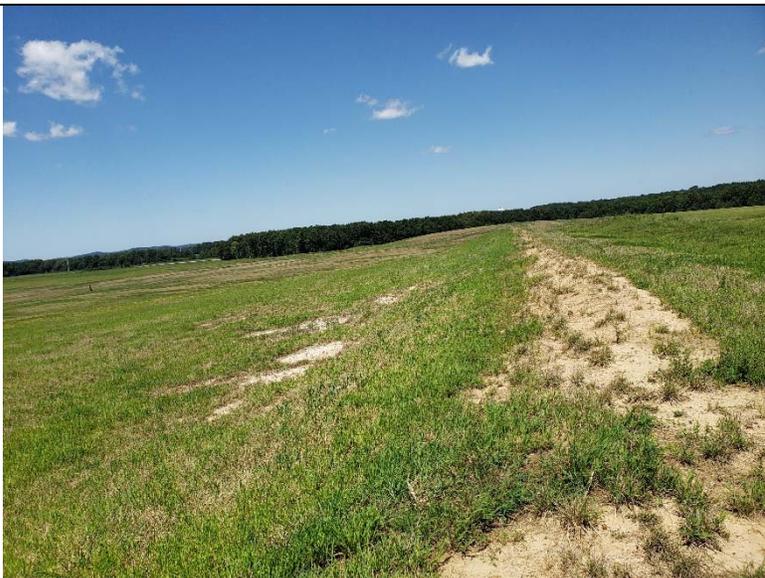
6. The surface of Cell 4A and 5 has a soil and vegetative layer which was placed as protective cover in 2017. In general the surface was in fair condition with minor thinning of the vegetation cover was observed (Photo #5 and Photo #6).

Photo # 5
2015 Construction Area –
Minor erosion of the perimeter
dike south of cell 5.

- 1) Reseed thinning vegetation on the external south slopes of the Active Landfill Area (Photo #5 & #6).

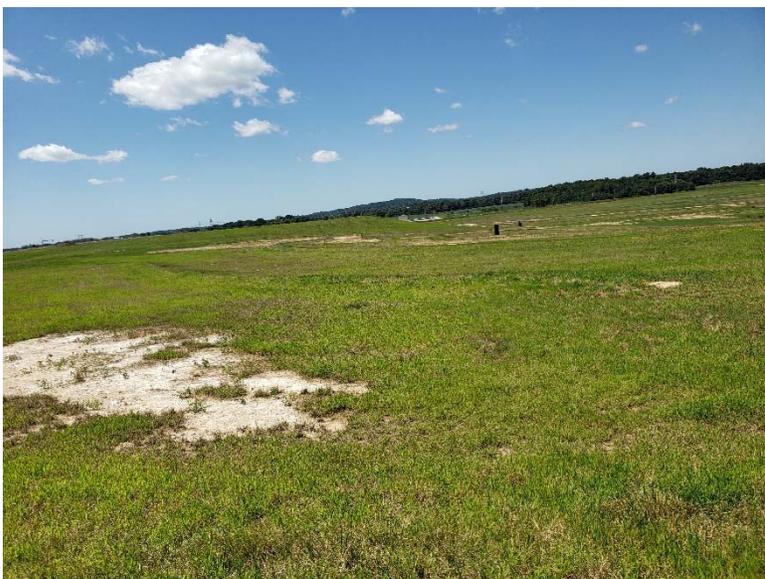
Photo # 6
2015 Construction Area –
Minor erosion of the perimeter
dike south of cell 5.

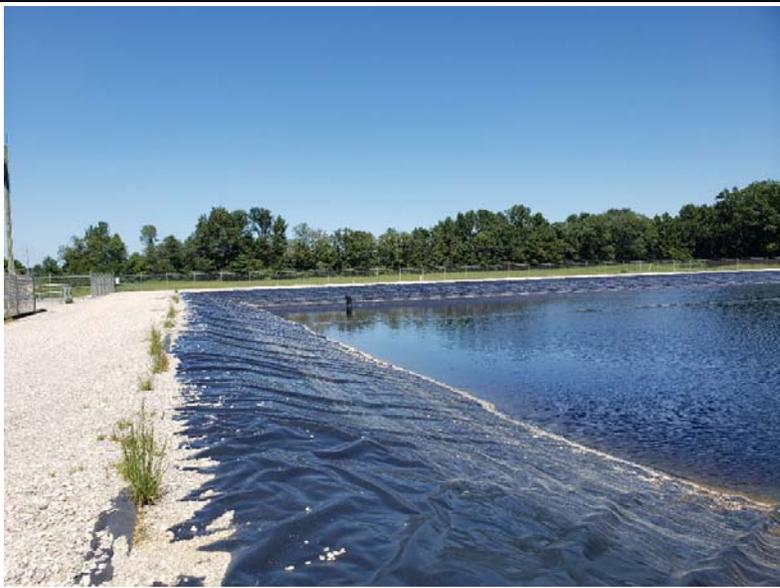
8. The North Pond was generally in good condition. At the time of the inspection both cells were filled. The concrete lined cell did not appear to have any signs of damage, cracks or spalling. There were no signs of blockage of the inlet and outlet piping. The fence surrounding the leachate pond was in good condition (Photo #7).

Photo # 7
North Leachate pond
(exposed liner portion).

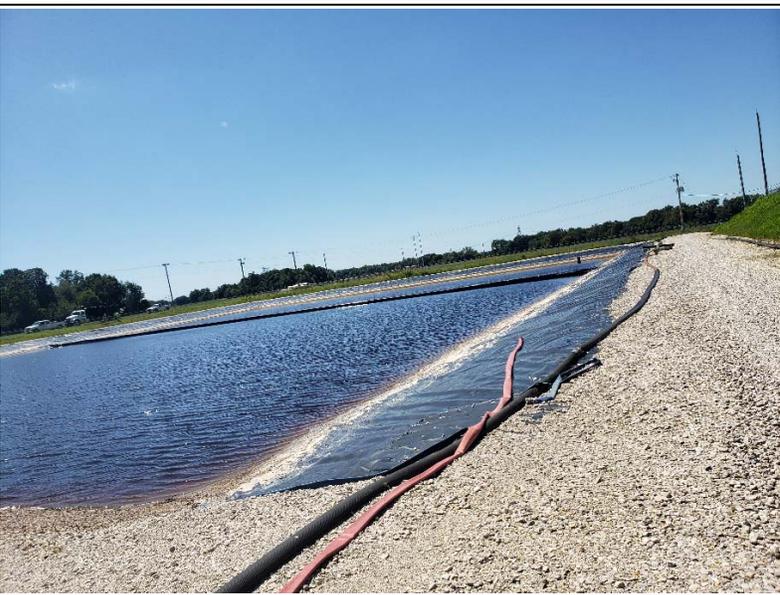
9. The West Pond exposed lined portion was generally in good condition. At the time of the inspection the West Pond exposed lined portion was filled. The exposed lined section was in good condition with no signs of tears or holes. The inlet and outlet pipes were clear with no blockage (Photo #8).

Photo # 8
West Leachate pond – West
pond exposed liner portion.

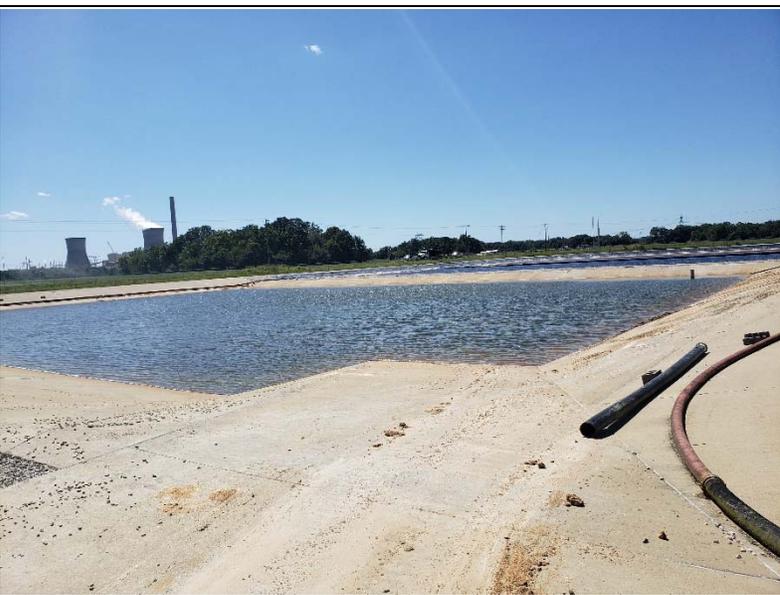
10. The West pond concrete lined portion was being used for leachate effluent treatment during the inspection to reduce sulfate in the leachate. The concrete lined section in general is in good condition with no signs of damage (Photo #9).

Photo # 9
West Leachate pond
(concrete lined portion) –
Concrete exposed portion
being used to remove mineral
precipitation from sulfate
reduction.

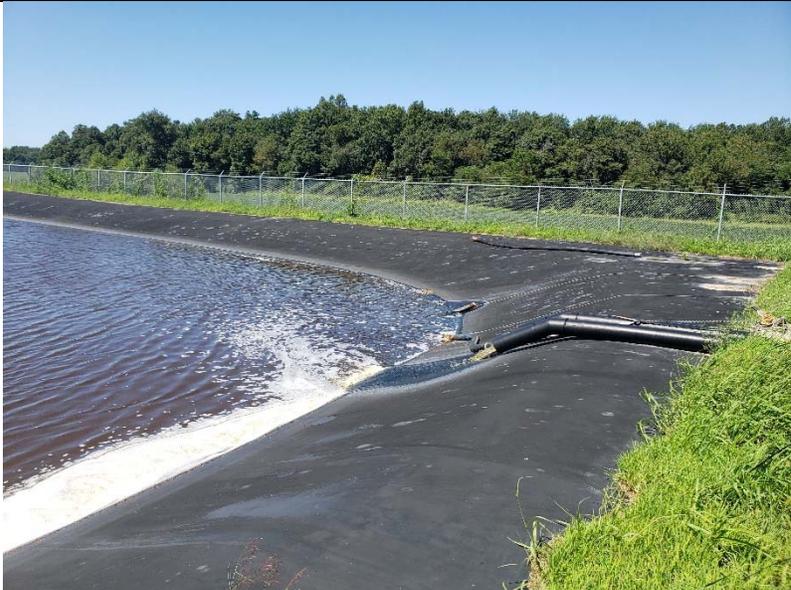
11. The 002 Pond was generally in good condition. At the time of the inspection the 002 pond was filled. The embankment structure of the pond was in good conditions. The inlet and outlet pipes were clear with no blockage (Photo #10).

Photo # 10
002 Pond –Northeast corner
of pond.
