# **2019 Annual Dam and Dike Inspection Report**

**Bottom Ash Pond Complex**

**Rockport Plant  
Indiana Michigan Power Company  
Rockport, Indiana**

**Document ID: GERS-19-022**

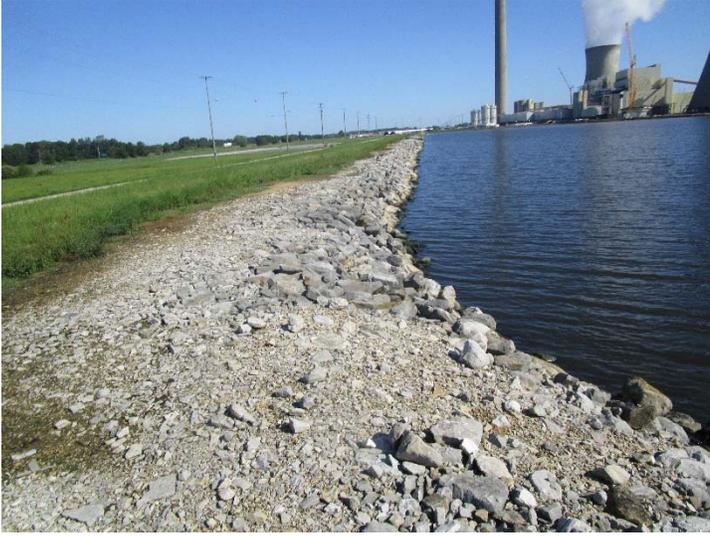
2. The interior slopes showed no signs of distress such as sloughing, bulges or erosion. The rip rap protection along the slope that was visible appeared in good condition and has not deteriorated.

Photo #1W – interior slope of west dike

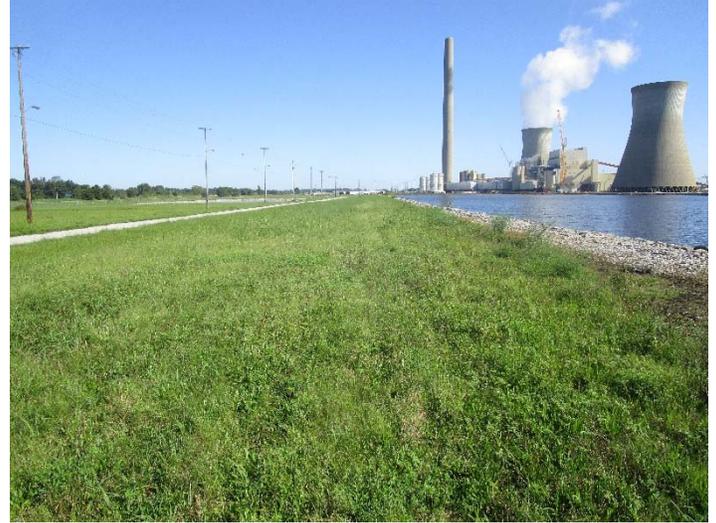
5. There were no seepage or wet areas observed along the embankment.
6. The crest of the west dike appeared in good and stable condition with no signs of distress such as settlement or ruts, and no erosion.

Photo #2W – crest of west dike

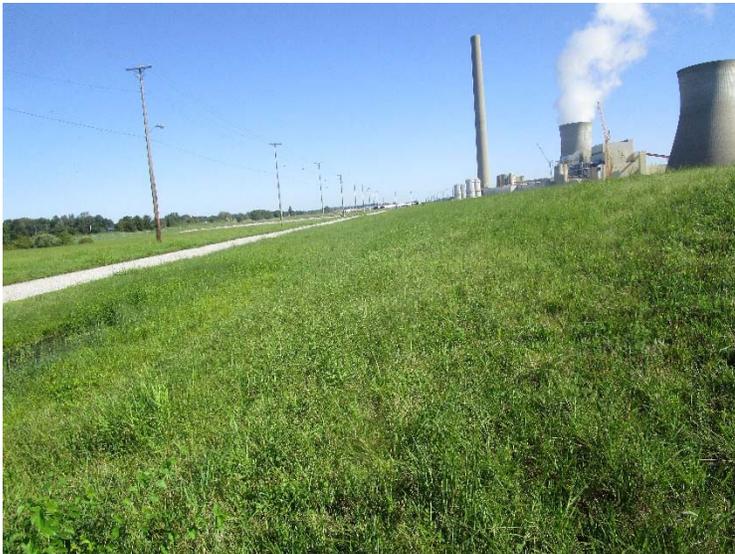
4. The outboard slope of the WBAP was in good condition. There were no signs of movement or misalignment, sloughing or bulges. The inspection was conducted prior to mowing, but the vegetation was not excessively high.

Photo #3W – toe of west dike

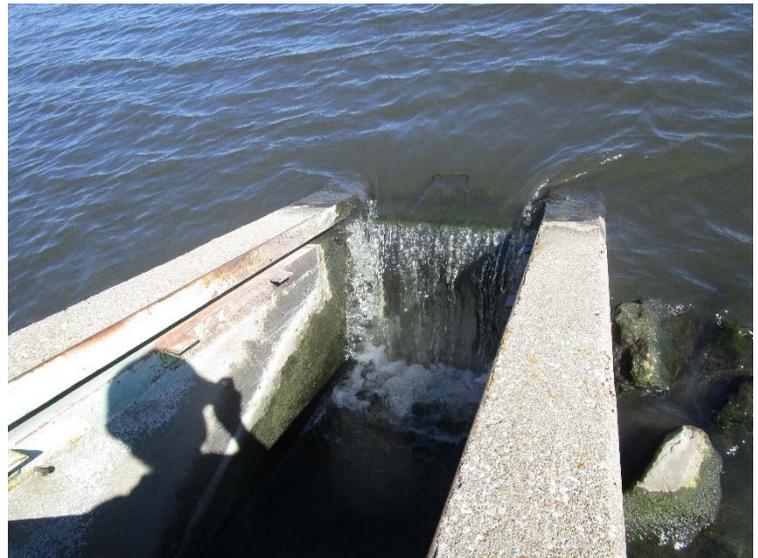
7. Flow was discharging into the low level drain structure. While this structure is typically used for draining the pond, it appears to be functioning as part of the primary discharge for the pond. The structure appeared in good condition. Flow was unobstructed.

Photo #4W – low level drain operation at full pond

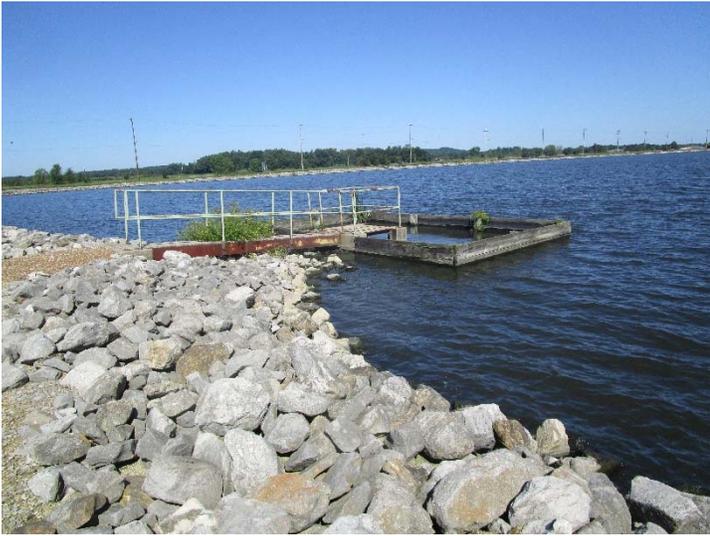
8. The primary discharge structure was in good condition and functioning properly. Flow was entering from all 3 sides of the box weir structure. The skimmer structure was in good condition.

Photo #5W – main discharge structure.  
p.s. the vegetation shown in the photo  
was removed during the inspection

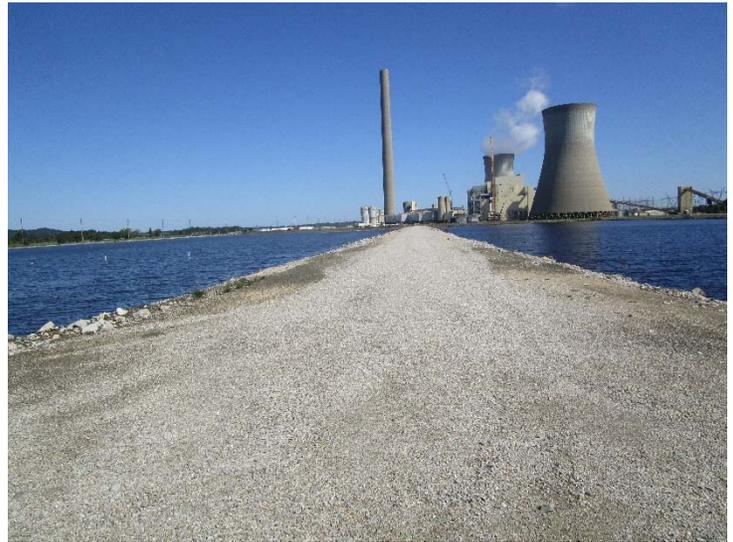
3. The splitter dike between the two ash ponds appeared to be in good condition and showed no signs of distress. The splitter dike separating the WBAP from the WWWP was also in good condition and showed no signs of distress.

Photo #6W– splitter dike between ash ponds

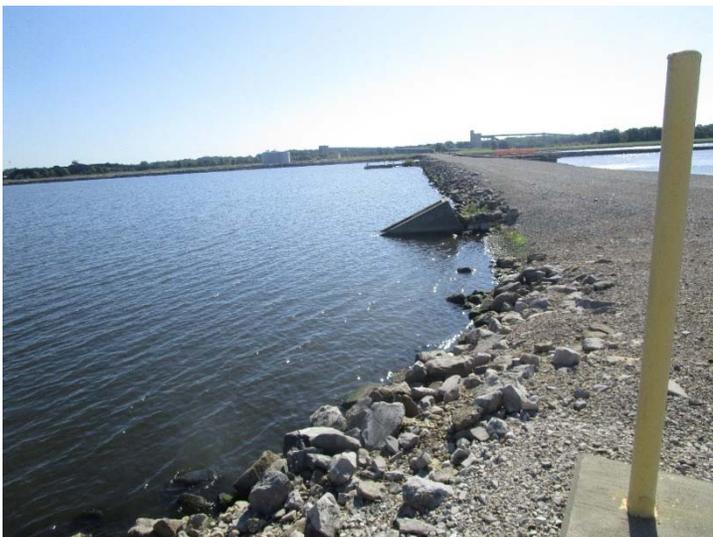
Photo #7W– discharge structures at full  
pond

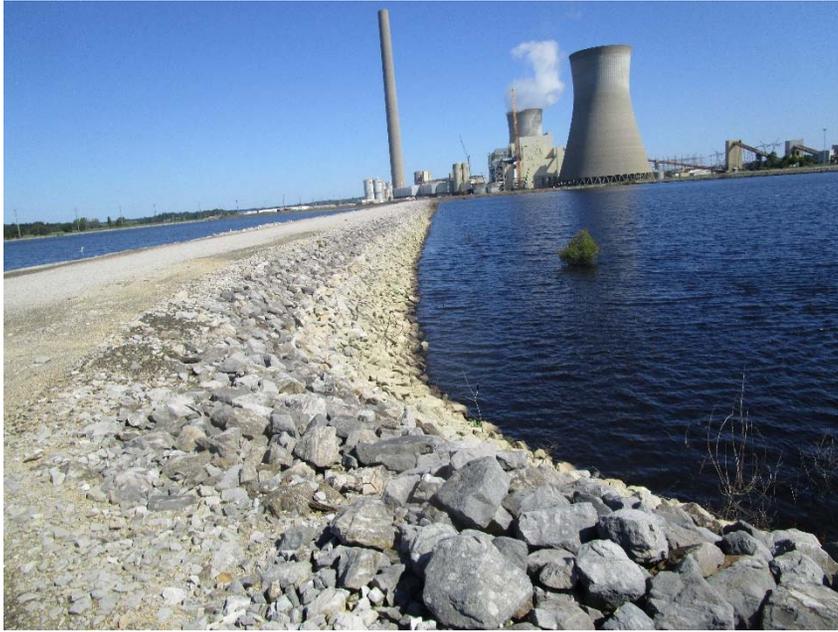
2. The interior slopes showed no signs of distress such as sloughing, bulges or erosion. The rip rap protection along the slope appeared in good condition and has not deteriorated.

Photo #1E –Interior West Slope of East ash pond

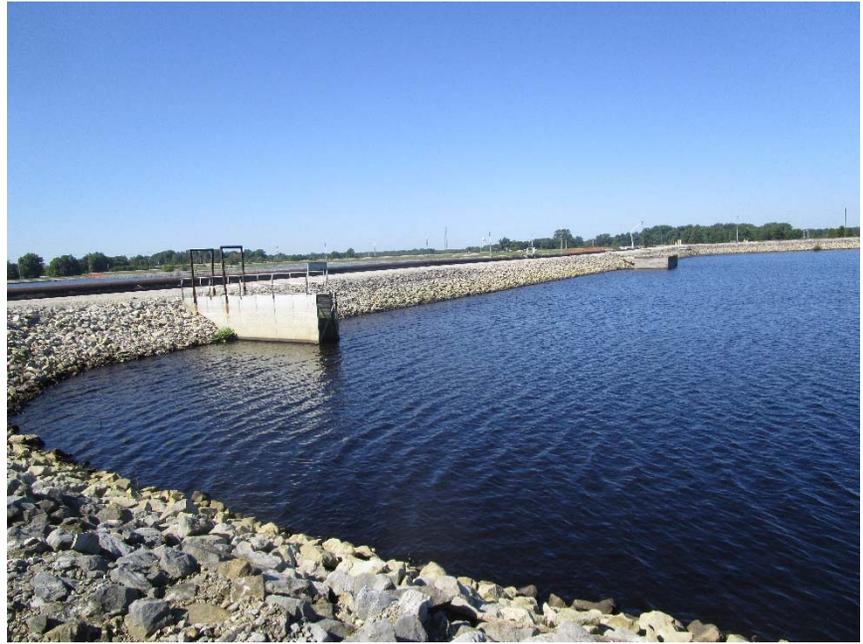
5. The primary discharge structure was in good condition and functioning properly. Flow was entering from all 3 sides of the box weir structure. The skimmer structure was in good condition.

Photo #2E – South Interior Slope- Discharge Structures

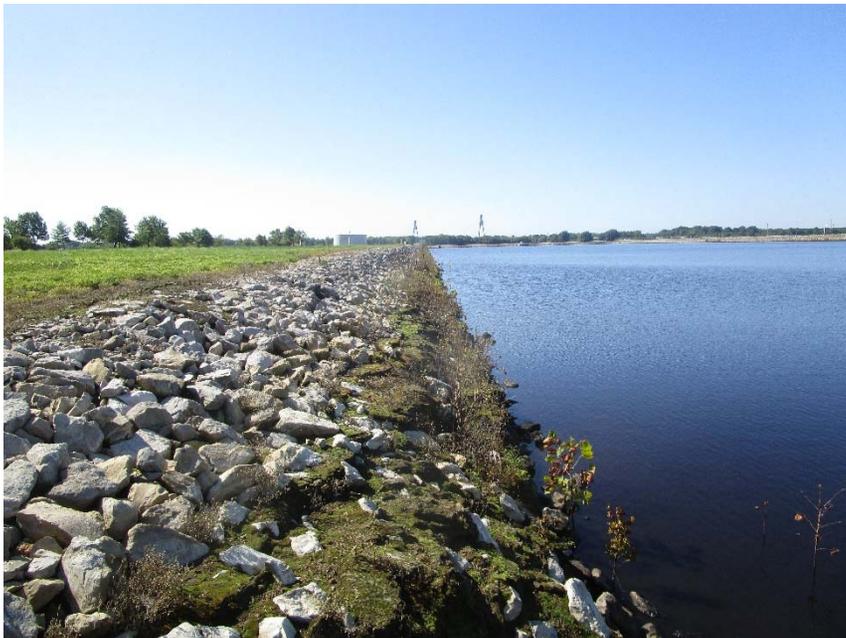
Photo #3E – Interior of east slope and ash pond

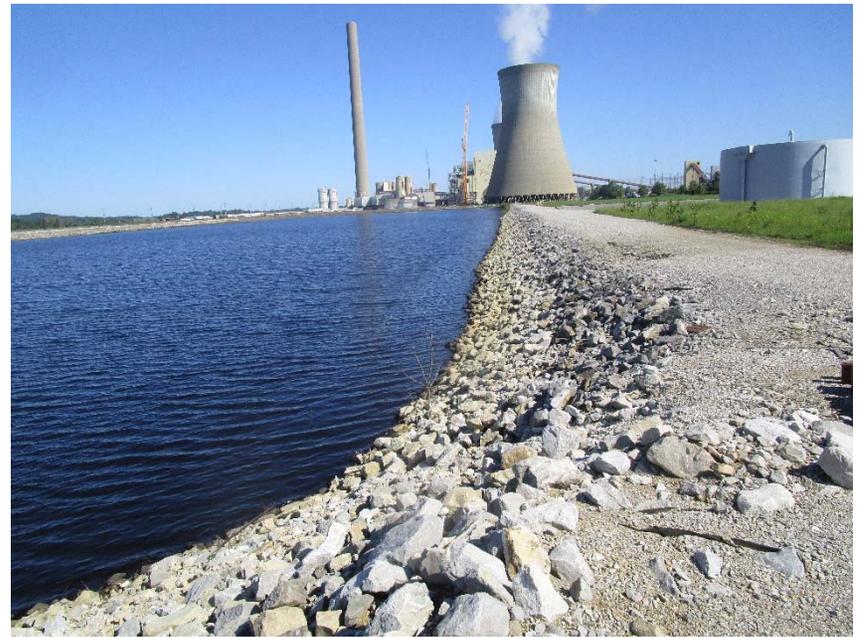
Photo #4E – Interior of east slope Looking North

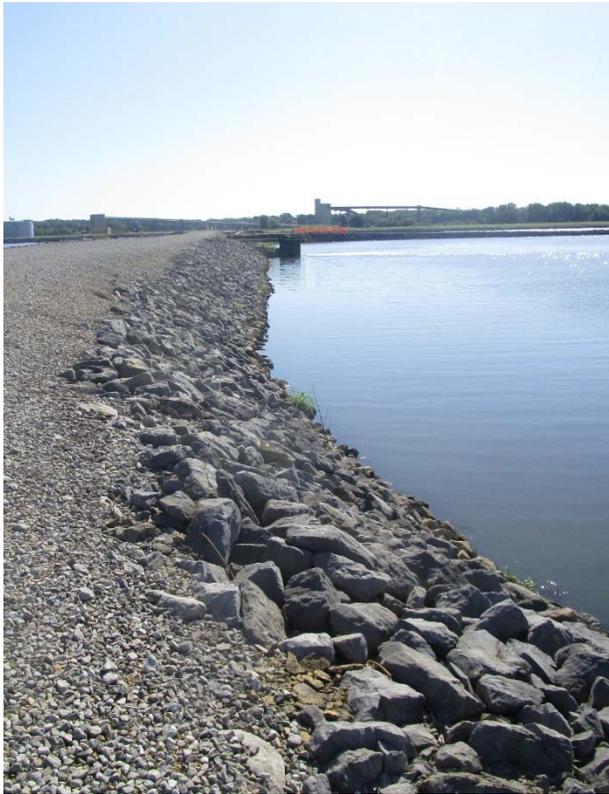
Photo #1WW – interior north slope of West WW pond

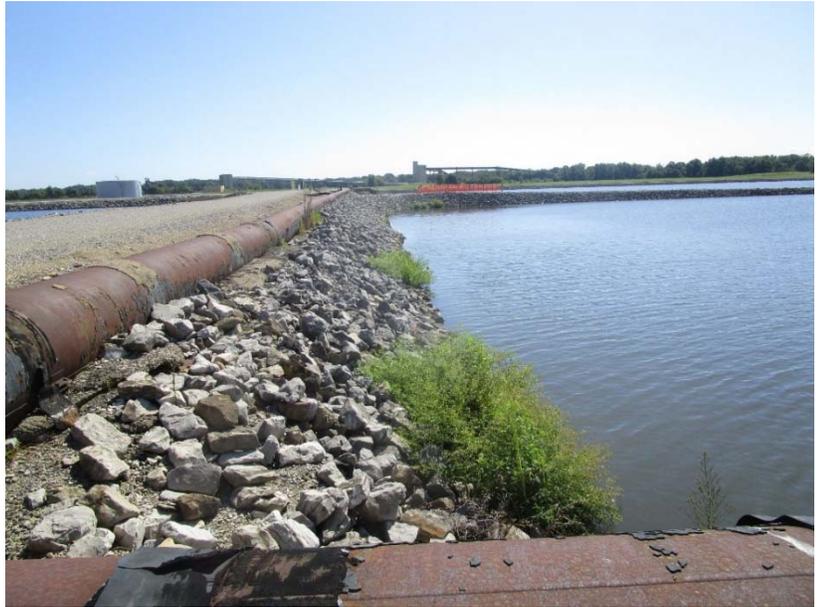
Photo #2WW– interior north slope of West WW pond

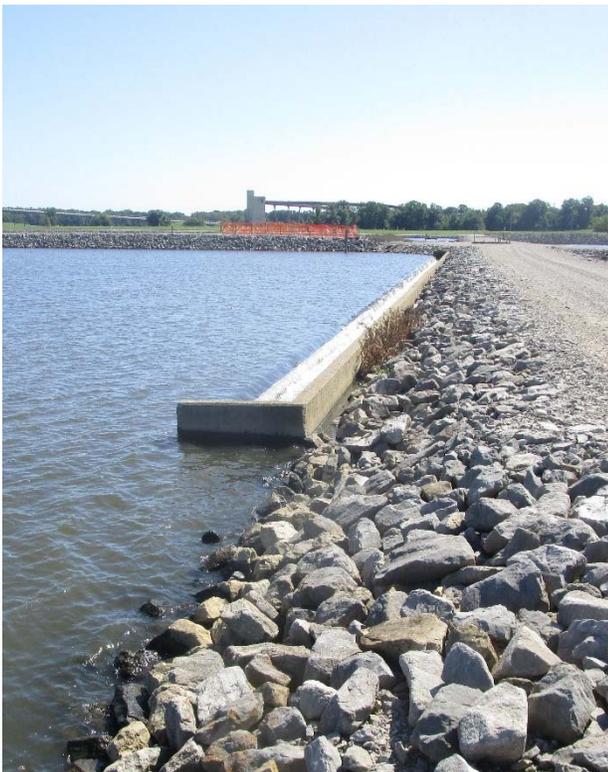
3. The spillway structures in the EWWP and the WWWP were in good condition. There were no obstructions at either structures and they appear to be functioning properly. Flow over the weir in the EWWP and WWWP was smooth. The water discharged into the distribution structure where the flow was directed to the Reclaim Pond.

Photo #3WW – operating discharge structure in West WW pond

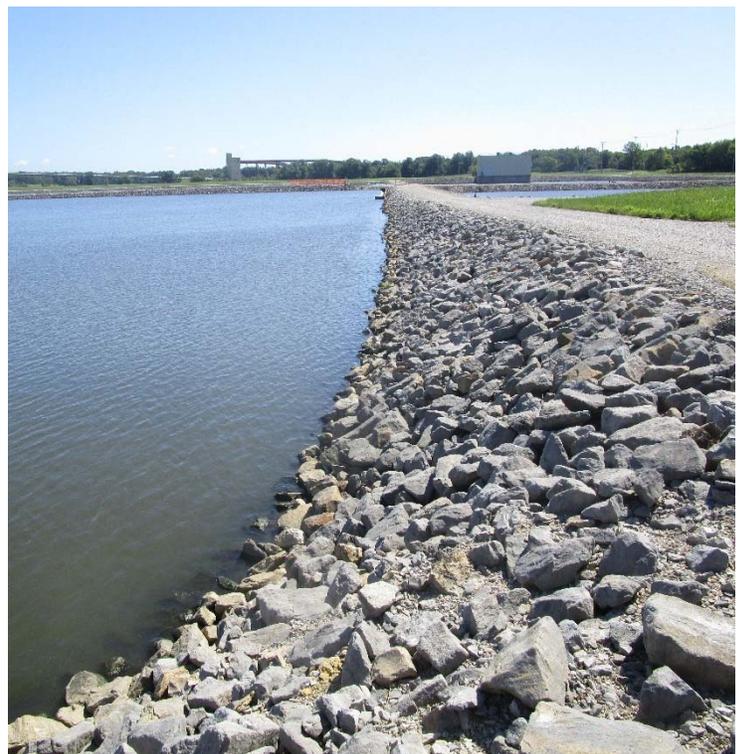
Photo #4WW – interior south slope Of West WW pond

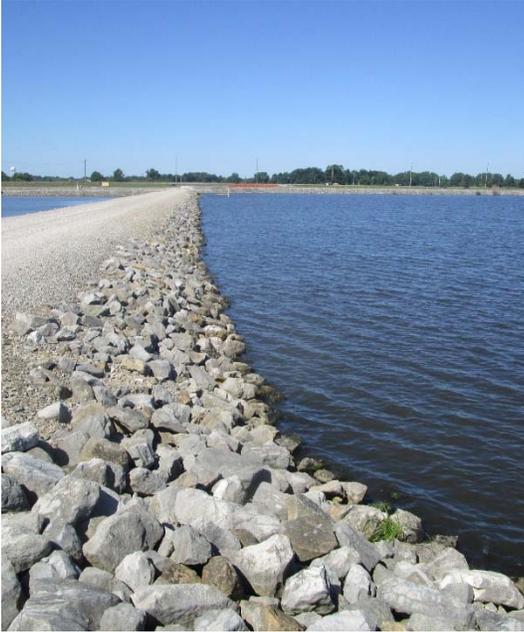
Photo #5WW – interior north slope of East WW pond

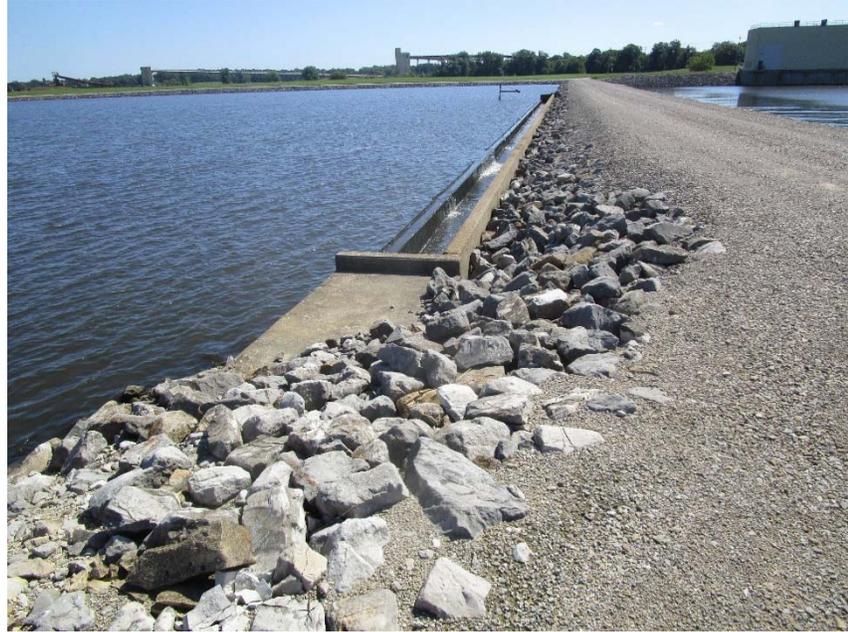
Photo #6WW– discharge weir structure at East WW pond

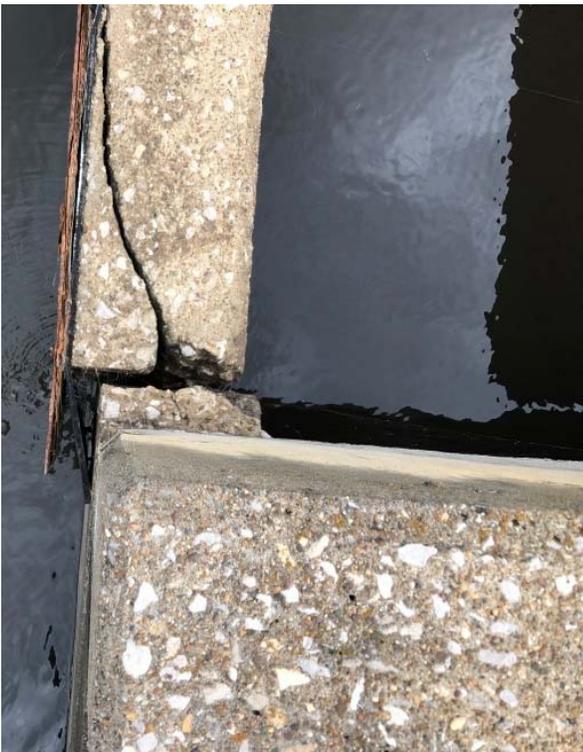
4. The separation of the rectangular concrete weir channels in both ponds does not appear to be any different than the conditions noted in previous inspection reports.

Photo #7WW – old displacement of concrete weir – rebar is still engaged.

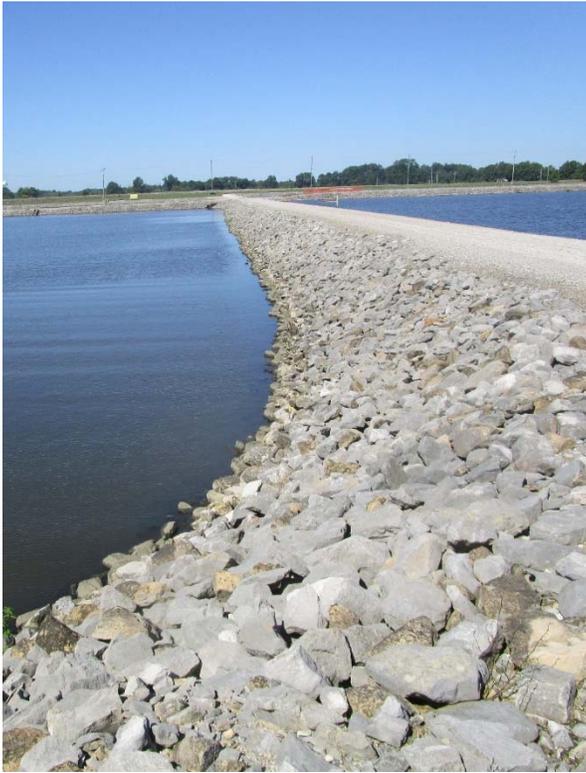
Photo #1 – interior slope of north Clearwater pond

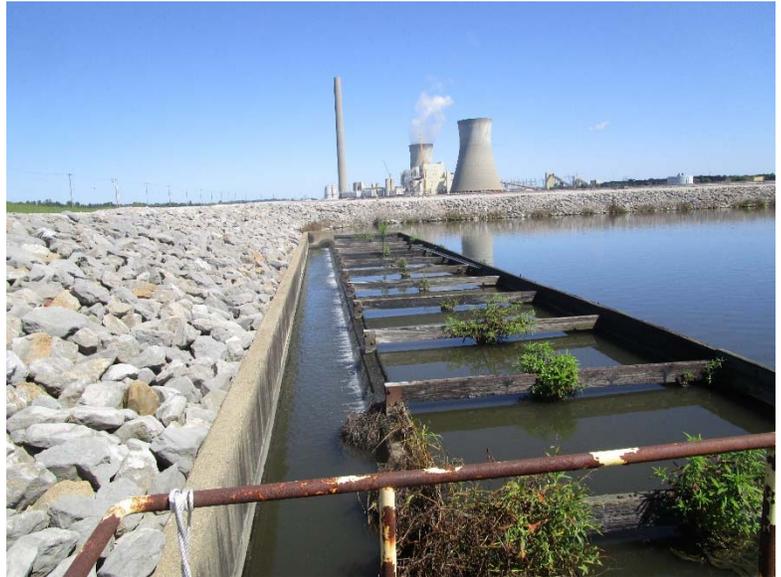
4. The reclaim pump structure was in good condition and appeared to be pumping properly.
5. The outlet structure between the Reclaim Pond and Clear Water Pond appeared in good condition with no obstruction.
6. The outlet structure of the Clear Water Pond was in fair condition with no obstructions. The skimmer board and weir structure was in fair condition, however, two of the steel brackets were broken and few of the wood logs rotten. Some vegetation was growing at the entrance to the weir structure.

Photo #2– discharge structure at Clearwater pond

- 1) Eliminate vegetation growth within rip rap areas using herbicide.
- 2) Replace rotten wood logs and weld steel brackets at the clear water outlet structure.
- 3) Eliminate/ remove vegetation growth from within Clearwater pond discharge structure.

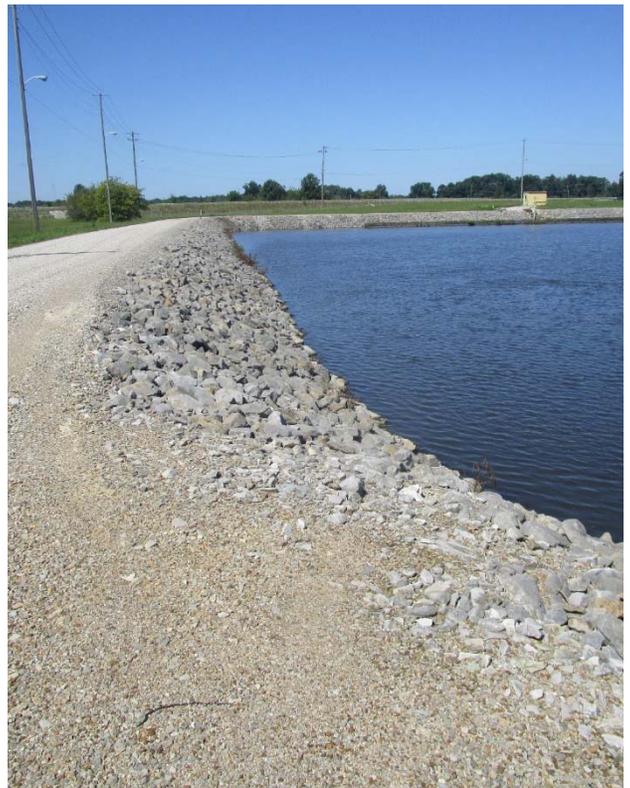
Photo #3 – interior south slope of Clearwater pond

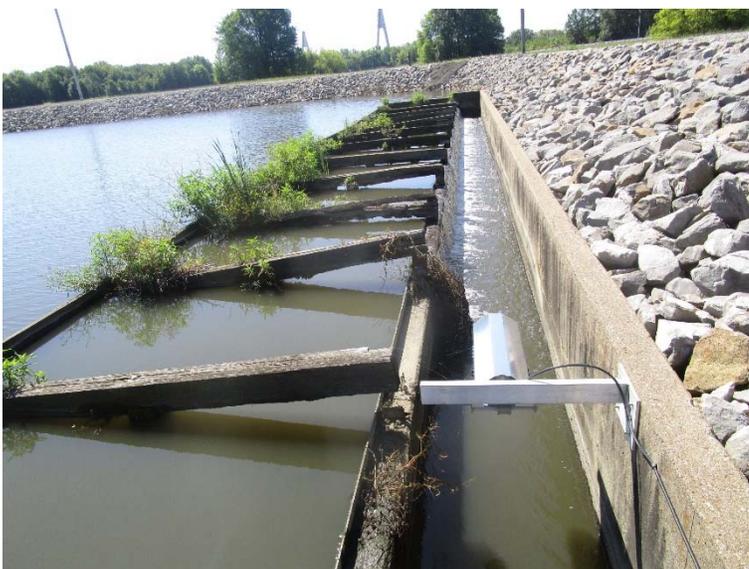
Photo #4 – discharge structure at Clearwater pond
