2020 Annual Dam and Dike Inspection Report

Bottom Ash Pond Complex

**John E. Amos Plant
Appalachian Power Co.
Putnam County, West Virginia**

August 13, 2020

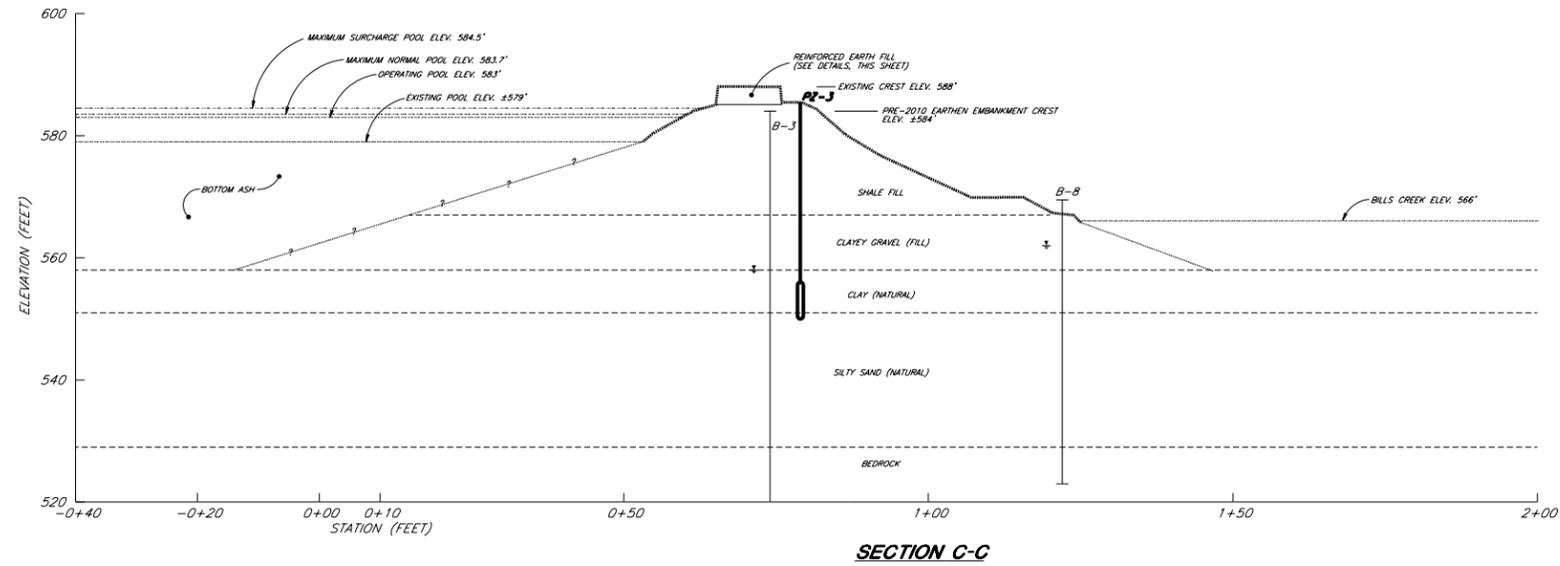
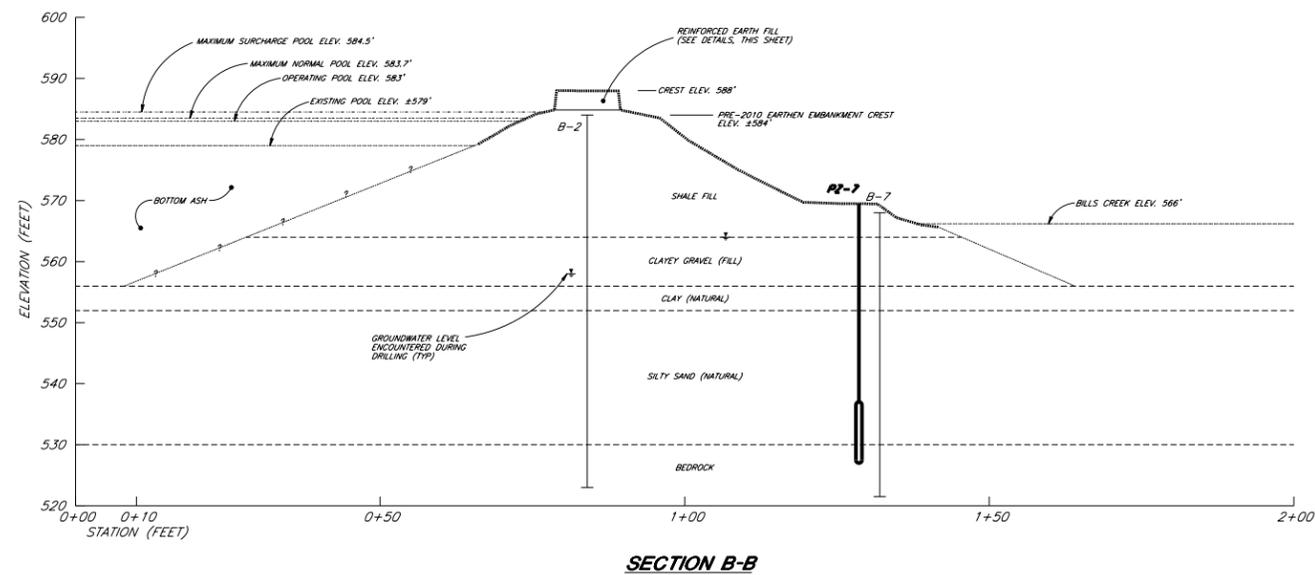
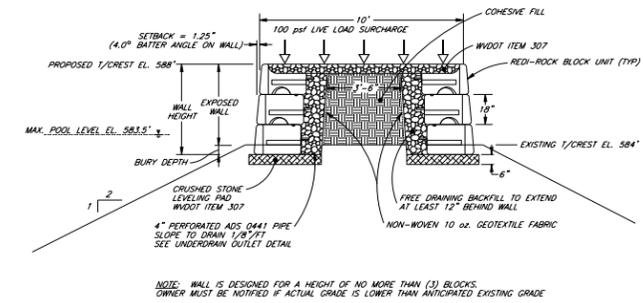
DRN BY: <i>Amanda Graphics</i>	APPALACHIAN POWER COMPANY			AEP SERVICE CORP. 1 RIVERSIDE PLAZA COLUMBUS, OH 43215
DATE: 07/12/2016	SCARY	AMOS PLANT WEST VIRGINIA		
SCALE: N. T. S	EMBANKMENT SECTIONS & DETAILS		FIGURE 3

The north dike of the Reclaim Water Pond and Treatment Pond is approximately 800 feet long. The height of the dam is about 29 feet and the design crest width is 10 feet using concrete block face filled with compacted cohesive soil. The top of the dike is at elevation 588.0 feet with the natural ground surface beneath the dikes is at about elevation 559 feet. Field measurements indicate that dam side slopes are 2.5:H to 1:V (Figure 3).

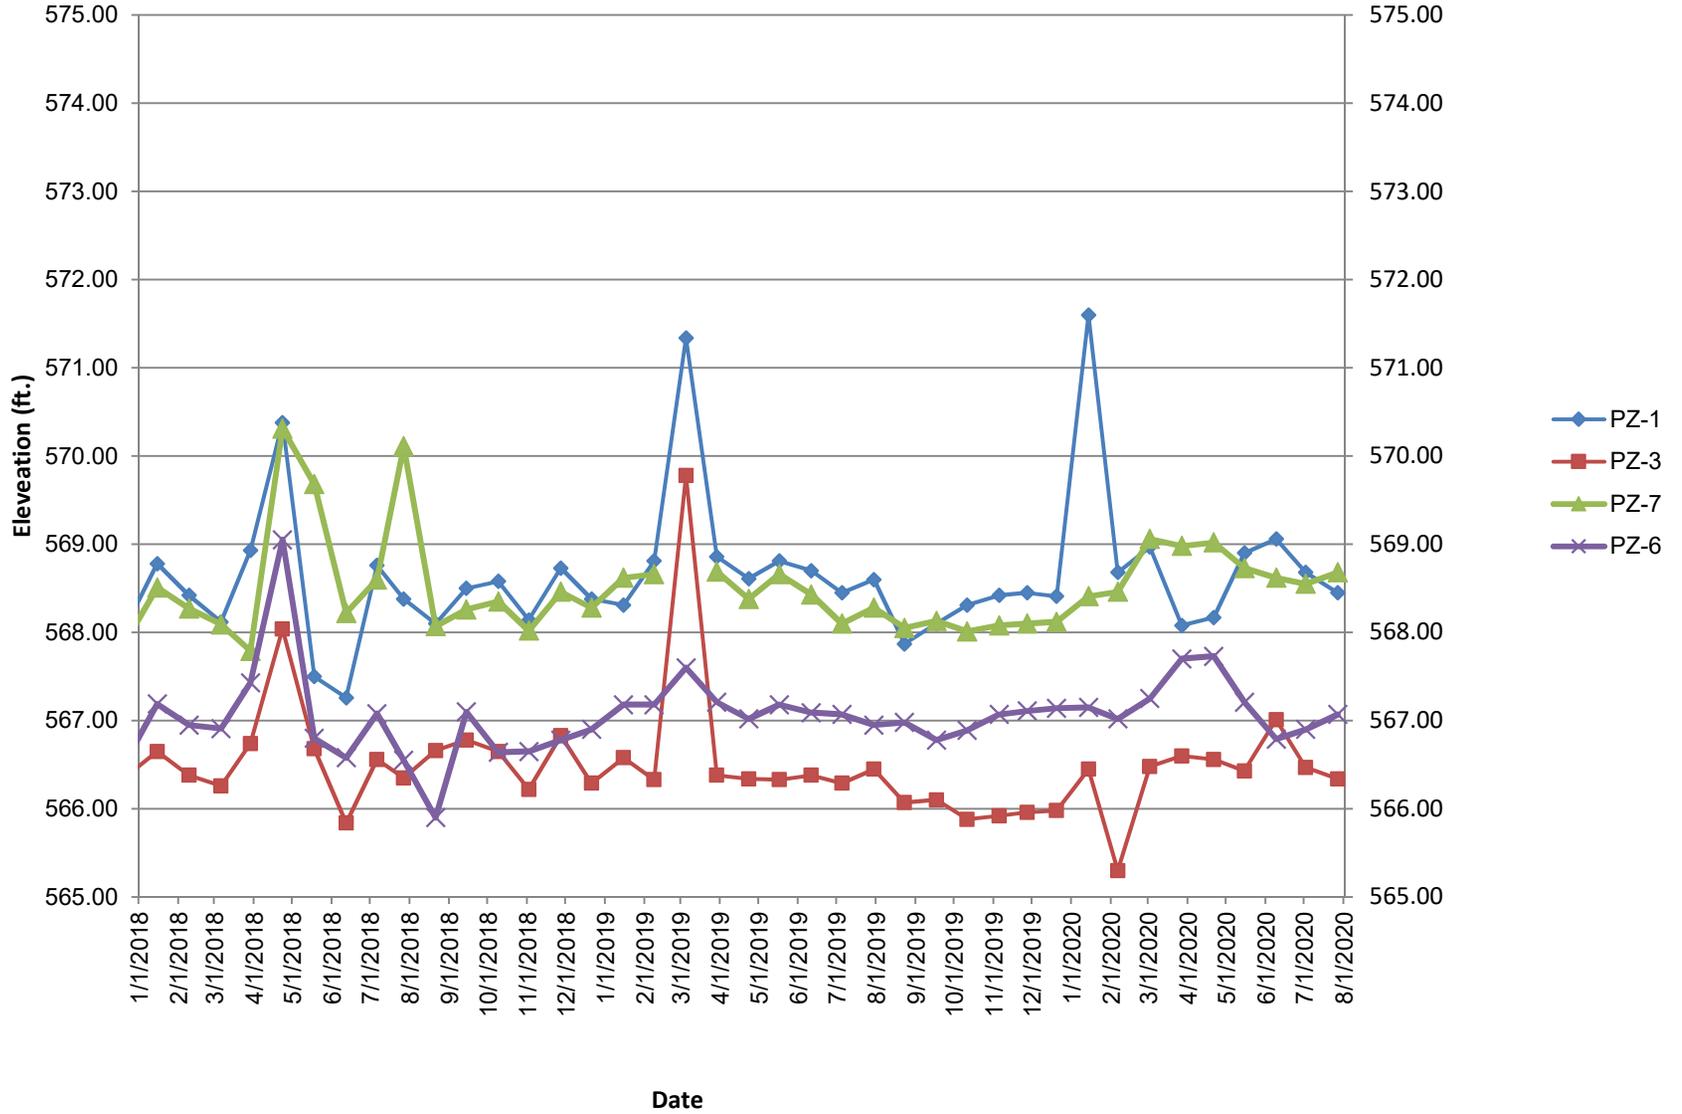
John E Amos Plant Piezometer Readings Bottom Ash Pond

The elevations of pond water levels and respective piezometer water levels have remained fairly constant with no adverse trends observed that would impair the structural stability of the perimeter dike. Piezometer hydrographs are contained in Attachment C.

1. Static water levels should continue to be measured on its current frequency for piezometers PZ-1, PZ-3, PZ-6 and PZ-7.
2. The pond pool stages should continue to be recorded on a periodic basis.
