2020 Annual Dam and Dike Inspection Report

Fly Ash Pond and Bottom Ash Pond Complex

**Big Sandy Plant
Kentucky Power
Lawrence County, KY**

November 19, 2020

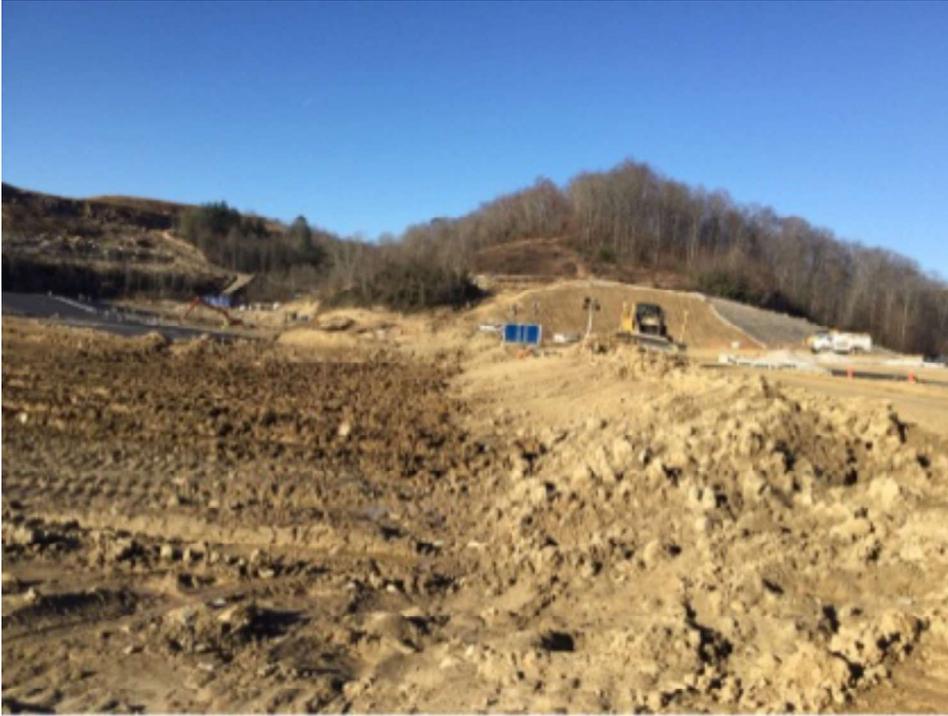
- 3) The condition of the upstream slope has been impacted by construction. The open water pool has been removed and the upstream slope area needs final regrading and seeding as part of closure activities

General condition of upstream slope looking east. Construction of final cover soils along area in progress.

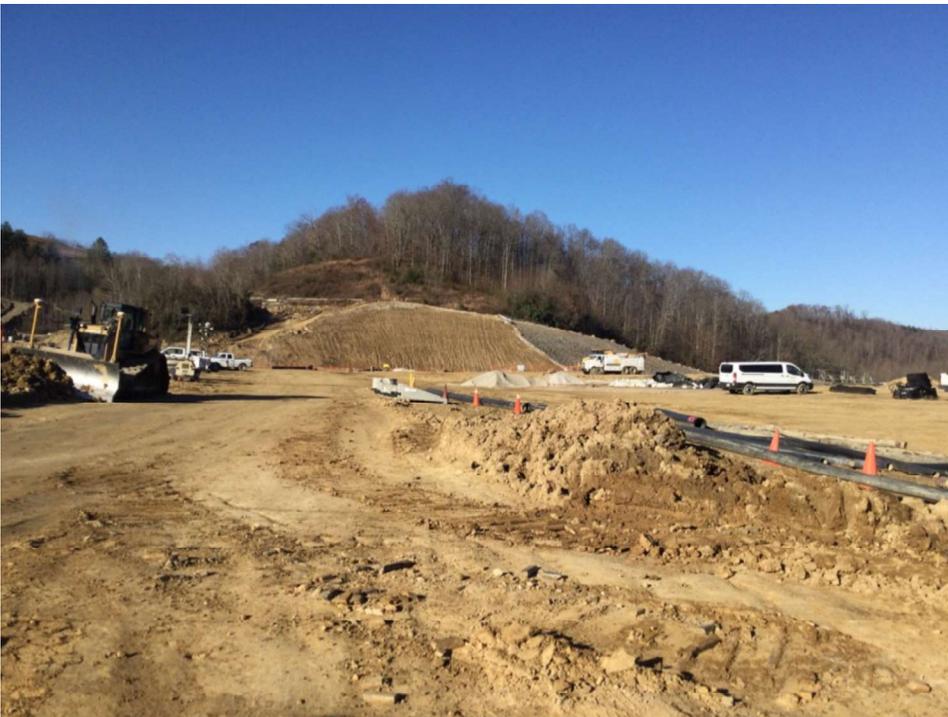
- 5) The crest of the dam changed with lowering of the dam but no signs of instability, misalignment, cracking, or large displacement were observed. Final grading and seeding of the crest remains to be completed as part of the construction activities

General condition of lowered crest. Area needs final grading and stabilization.

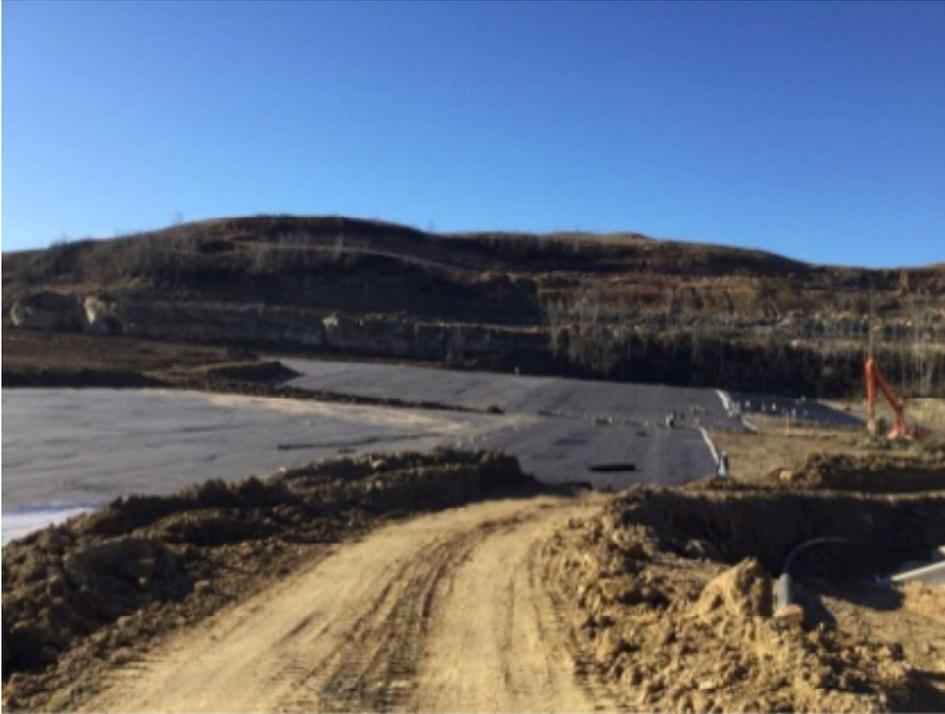
Installation of final cover system system. Soil/ash subgrade on, the right, geosynthetics in the middle, and soil protective cover on the left

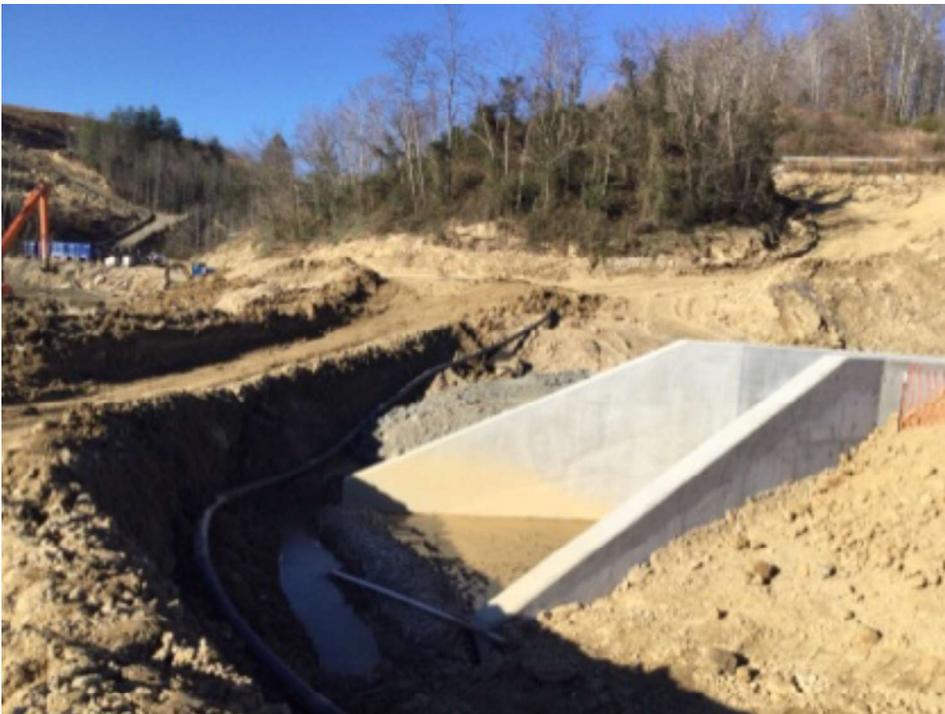
Entrance of new concrete spillway. Temporary berm in front to prevent discharge of untreated contact water.

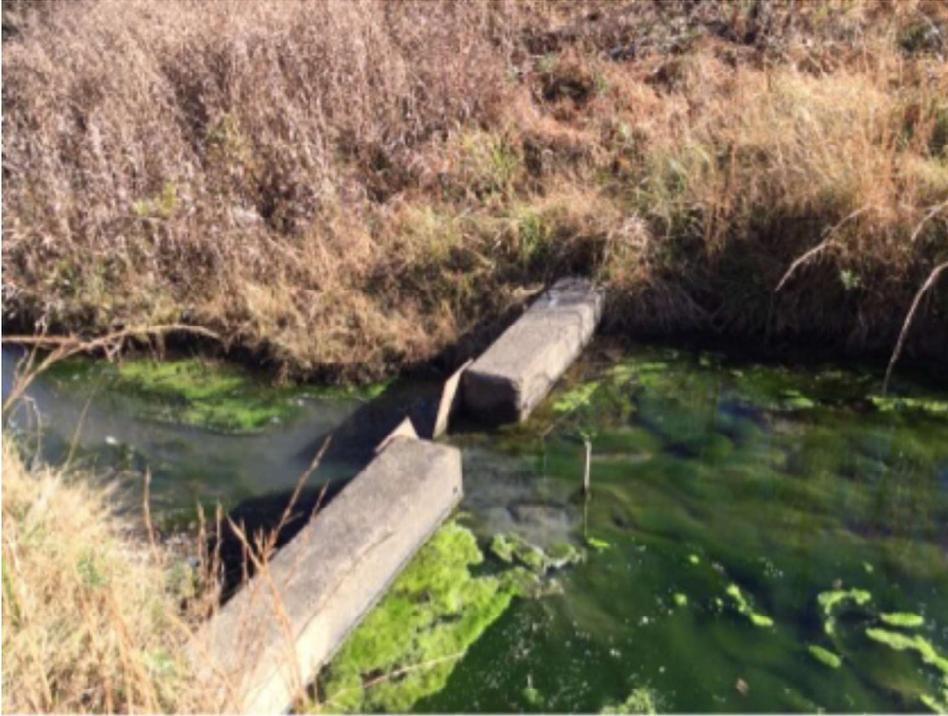
Photo #: 13

- 14) The v-notched weir (Outfall 018) and channel on the right downstream side of the dam was functional and good condition.
- 15) The abandoned outfall pipe located near the middle of the stone buttress did not show any signs of seepage around or through the grouted pipe.

Notes: General condition of 018 outfall

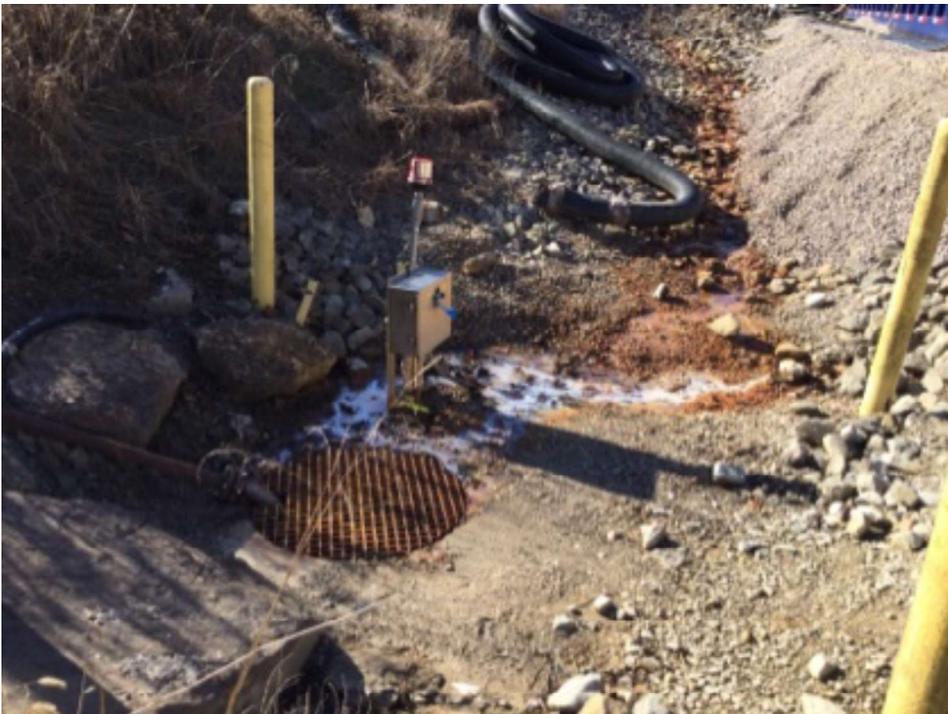
Photo #: 14

- 16) The seep collection system at the right downstream groin and the 590 berm appeared to be in good condition. This seep has historically had a red coloring and was pumped back to the main pool for discharge. A temporary treatment system is currently in-place and the discharge directed to flow to Outfall 018, a permanent treatment system will be installed.

Notes: General condition of red water sump. Settling tank in place as final treatment system is installed.

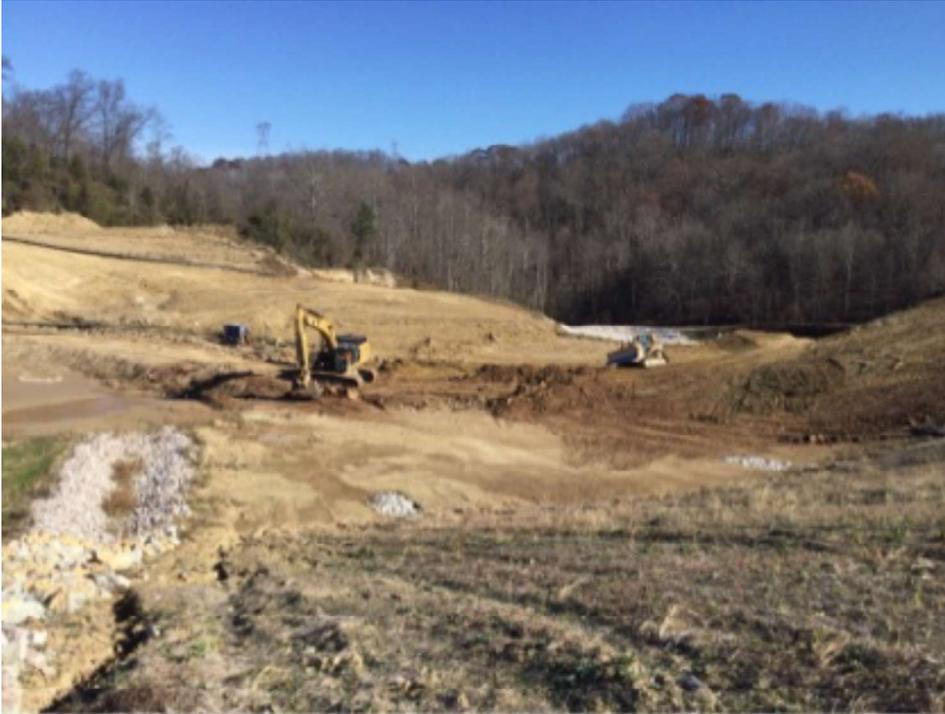
Photo #: 19

Construction to remove last portion of saddle dam.

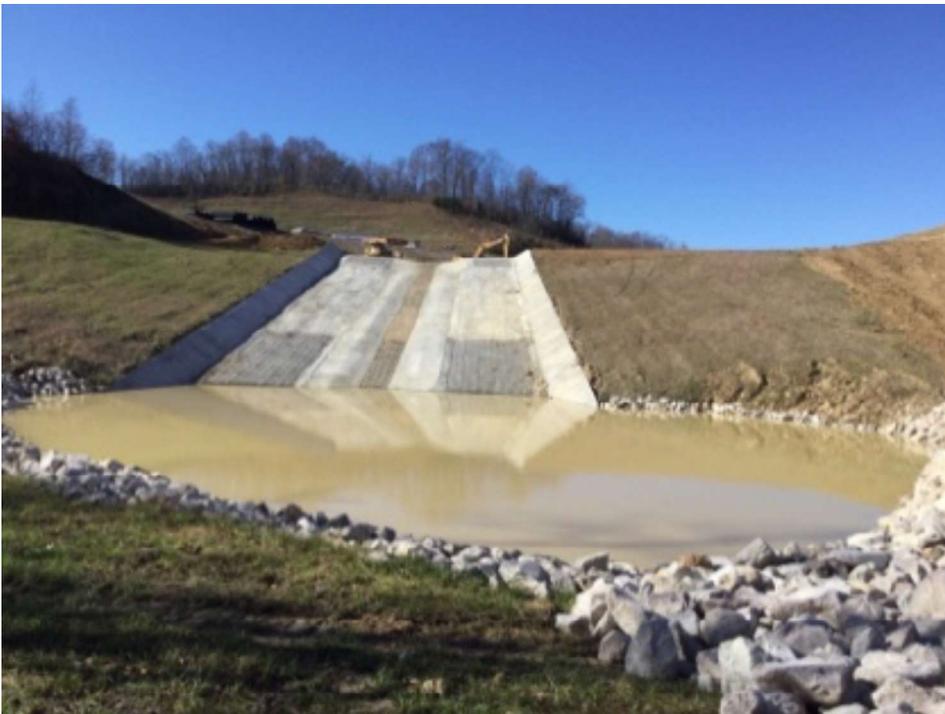
Photo #: 20

- 1) The remaining clay core of the Saddle Dam was removed and the new articulated concrete block mat spillway (Auxiliary Spillway) is complete and operational below the dam.

New articulated concrete block mat spillway and plunge pool located in the area of former saddle dam.
