# 2020 Annual Landfill CCR Inspection Report

Class 3N Landfill

Flint Creek Plant

Document Number: GEVR-20-021

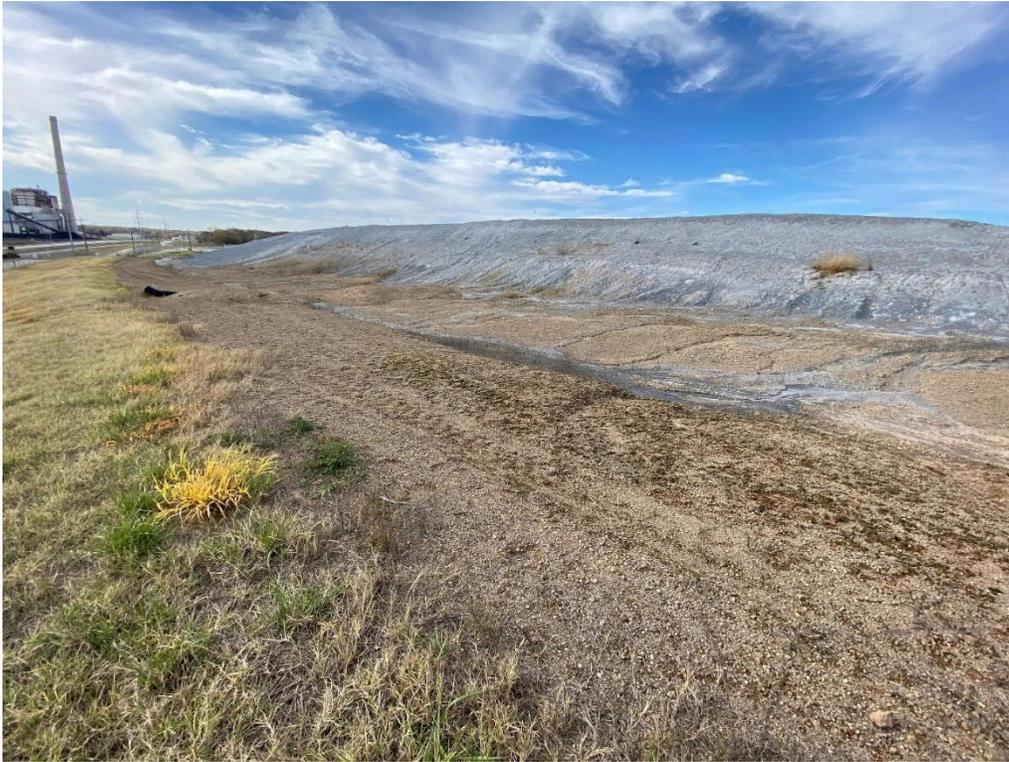
1. No ponding of water was observed on the surface (**Photo 1 & 2**). The material in the Cell is separated from the inactive areas by a low splitter berm (**Photo 3**). Disposal activities were taking place at the time of the inspection.
2. There was no erosion of the CCR material in the active area.

1. The southwest corner of the active area looking from the east.

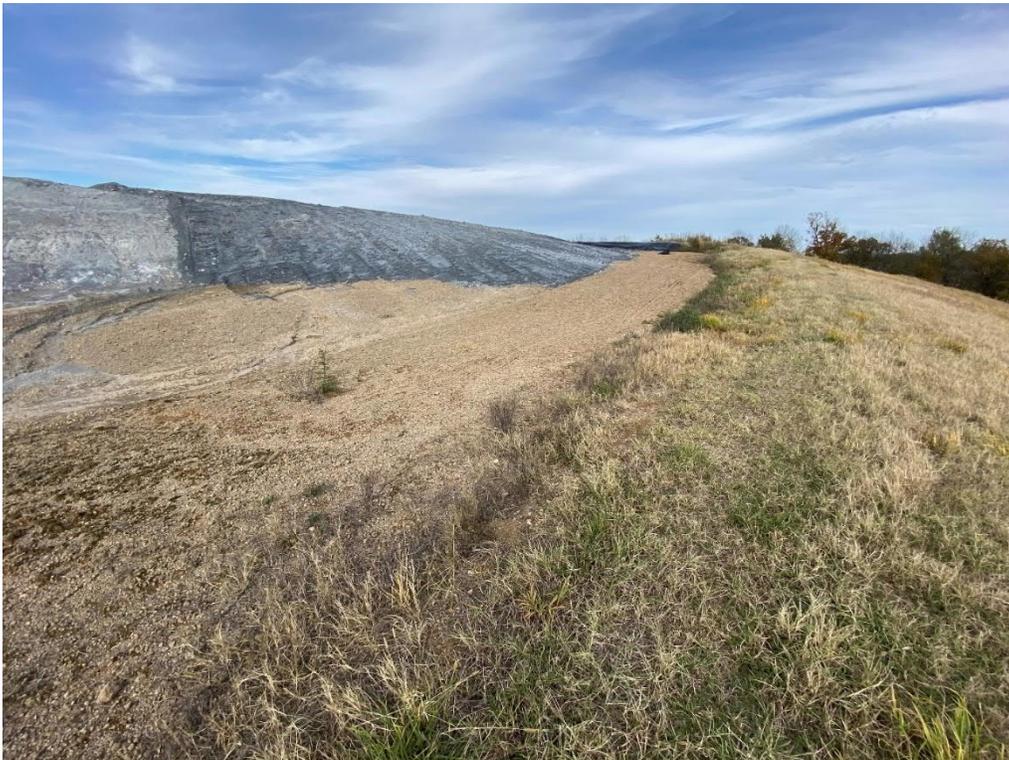
2. The southeast corner of the active area looking from the west.

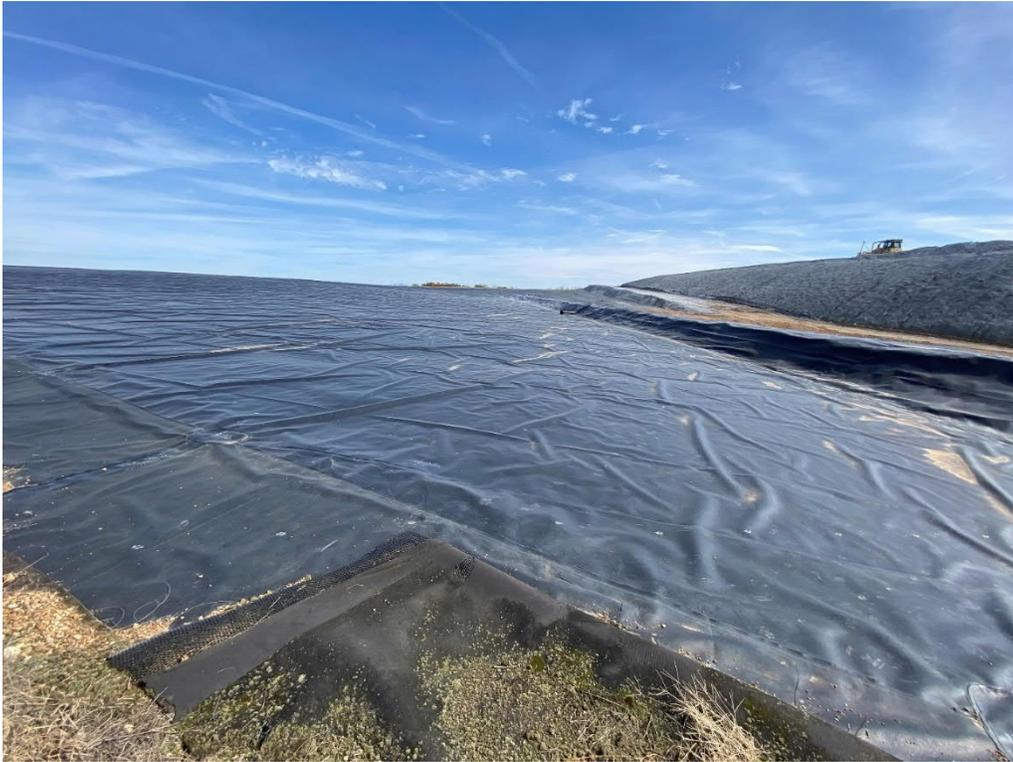
3. The northeast corner from the active landfill looking from the west side of the inactive area.

5. The exposed geomembrane was observed only from the perimeter of the cells. There was no apparent significant damage to the exposed geomembrane based on the observation from the perimeter. A complete walk down of the area is recommended prior to placing CCR to ensure the integrity of the liner (**Photos 3, 5, & 6**).
6. There was minor ponding of water on the surface of the inactive areas by the southwest letdown (**Photo 5**). The areas drain to the perimeter stormwater letdowns (**Photo 7**) and channels.

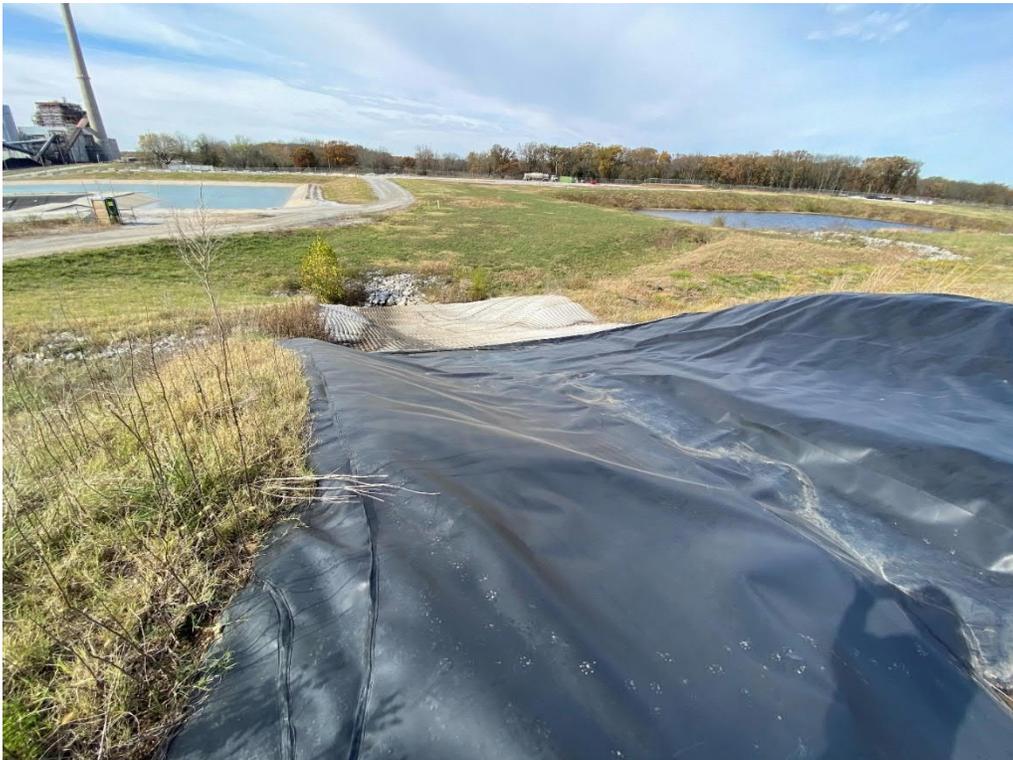
12. The perimeter ditches were in good condition. The ditches are grassed lined and no scour or erosion was observed during the inspection (**Photos 14 & 16**).
13. There are three stormwater letdown channels on the slopes of the landfill (**Photos 4, 7, & 15**). These are fabriform-lined and there were no observed issues with the channel. The channels discharge into a riprap-lined channel to dissipate energy before entering the receiving drainage features. There was some minor erosion under the letdown at the southwest corner of the landfill.
14. The stormwater culverts around the landfill appeared in good condition (**Photo 17**).

4. Inactive area letdown on the southwest corner of the inactive area.

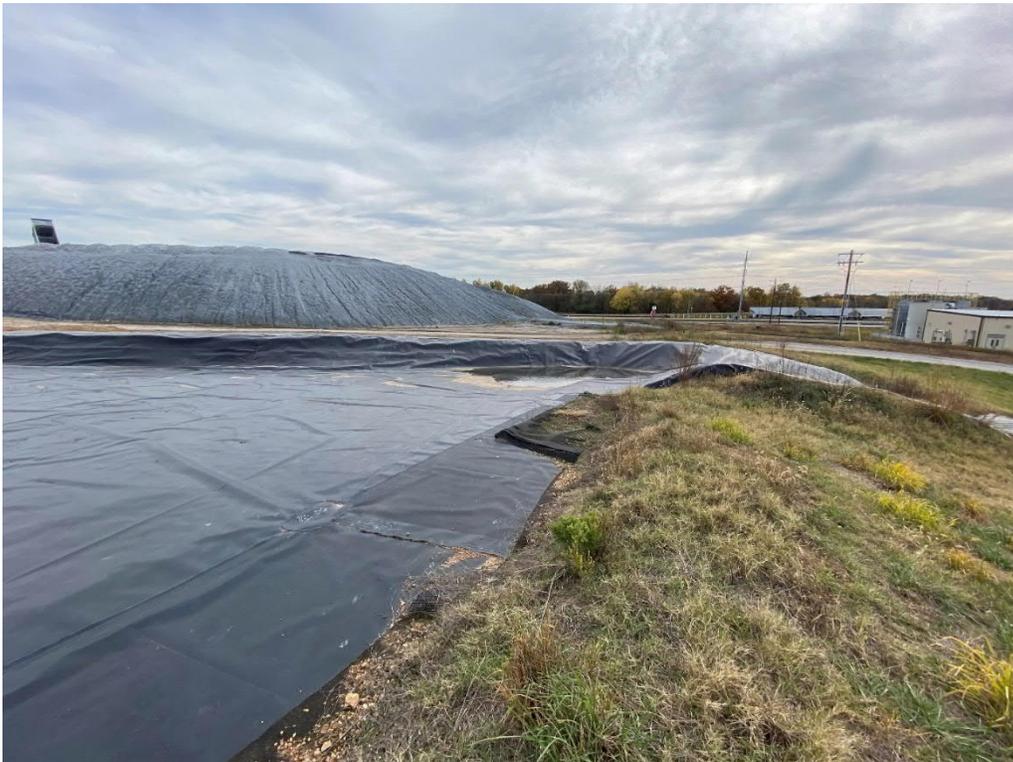
5. Minor ponding at the top of the southwest letdown of the inactive area.

Continue to monitor the riprap and scour at the toe of the west letdown.

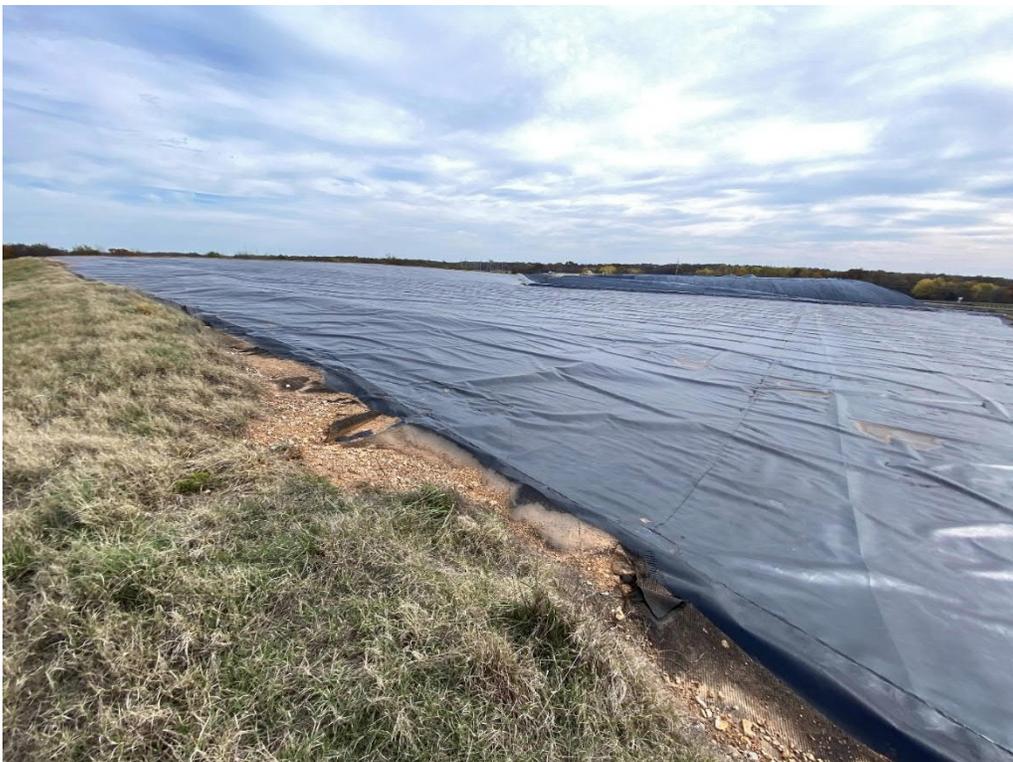
6. Exposed geomembrane of the inactive area looking southeast from the northwest corner.

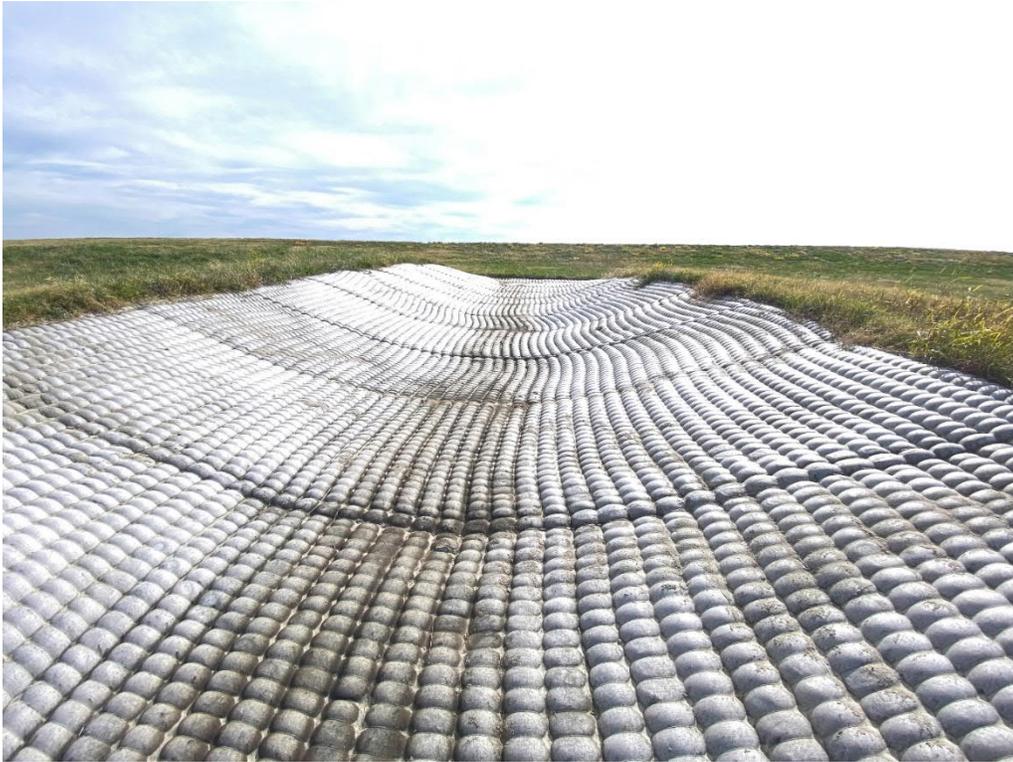
7. Fabriform letdown on the north closed area of the landfill.

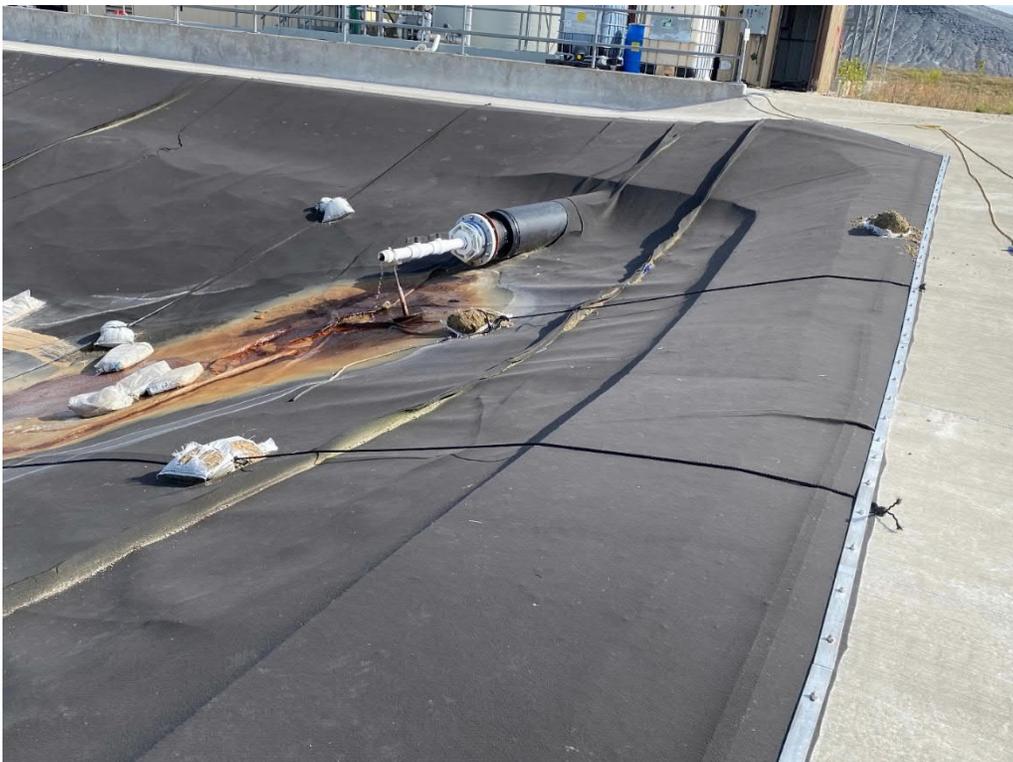
7. There is one active leachate collection pipe that flows into the pond (**Photo 8**). The pipe was visible and only a small volume of leachate (~1 gpm) was flowing out of the pipes. The leachate effluent appeared clear.

8. Leachate inlet pipe at the southeast corner of the leachate collection pond.

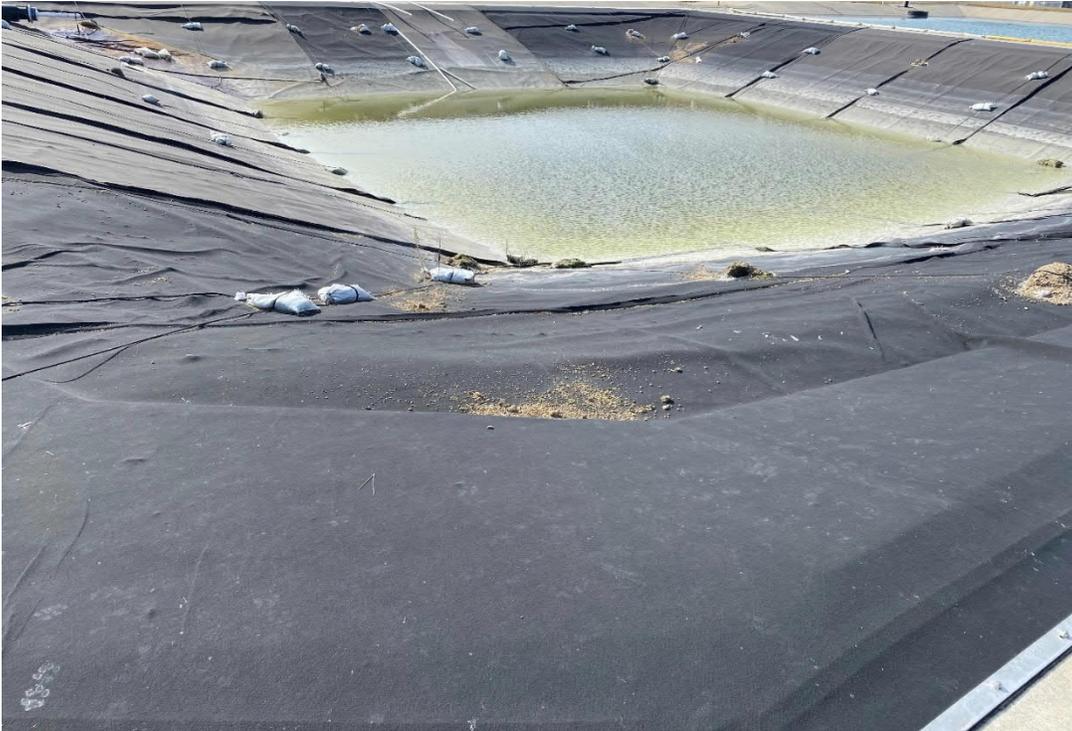
8. The pond was containing a very low volume of water at the time of this inspection. The protective cover of the interior slopes appeared to be in good condition (**Photo 9**).

9. Leachate Collection Pond.

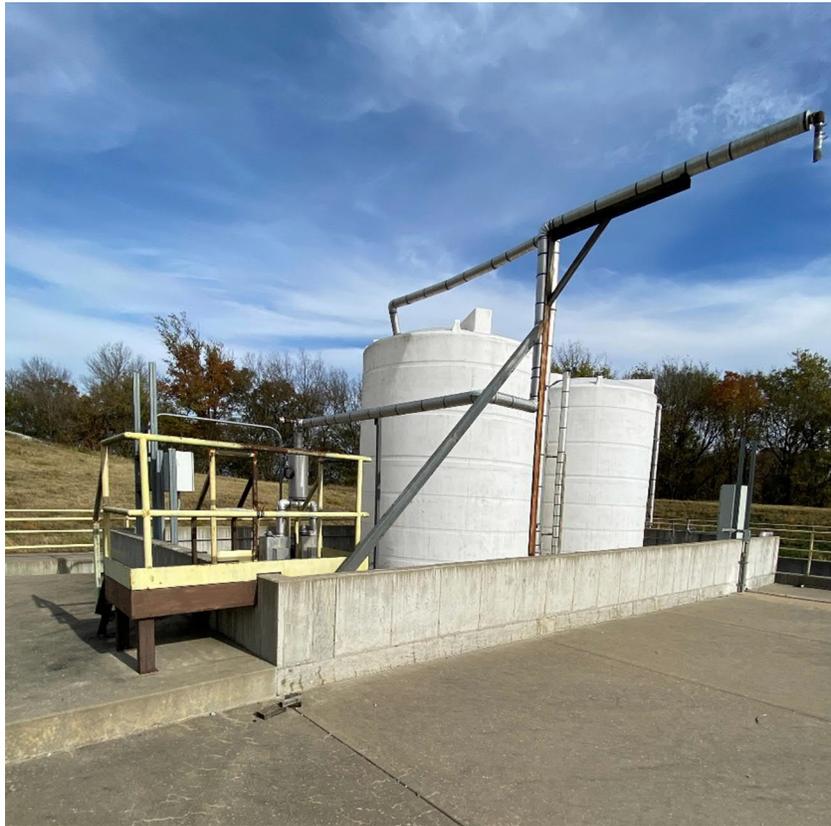
9. The leachate pond sump is on the southwest corner of the landfill (**Photo 10**). The leachate sump level indicator is in the building on the east side of the leachate collection pond (**Photo 11**).

10. Inactive leachate sump on the southeast corner of the landfill.

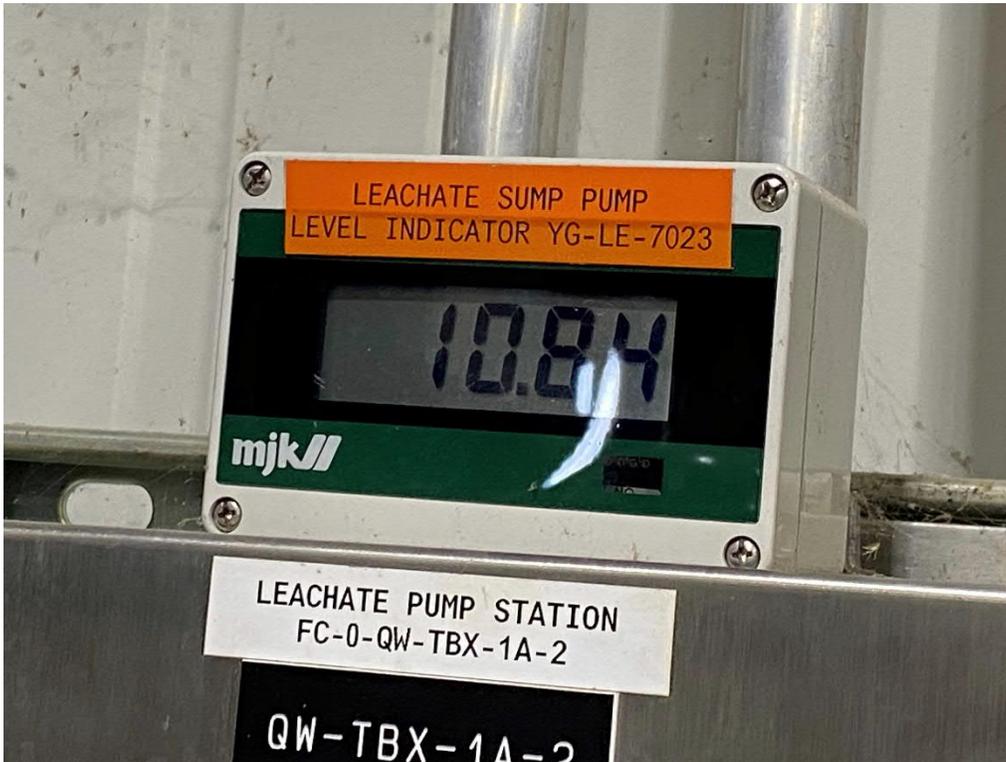
11. Leachate pond sump level indicator.

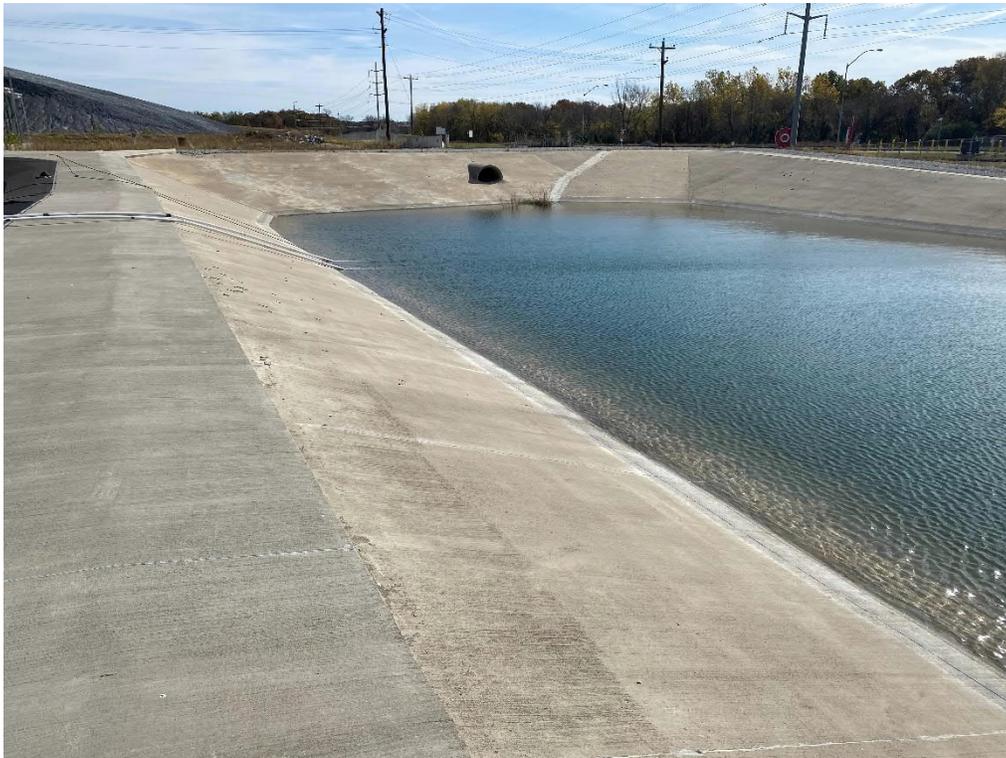
10. The contact water portion of the pond complex was full but not at the level to discharge.
11. The concrete protective cover of the interior slopes of the contact water portion was in good condition (**Photos 12 & 13**). There was no misalignment of the concrete joints. The condition of the caulking material at the joints was good.

12. East side of contact water pond.

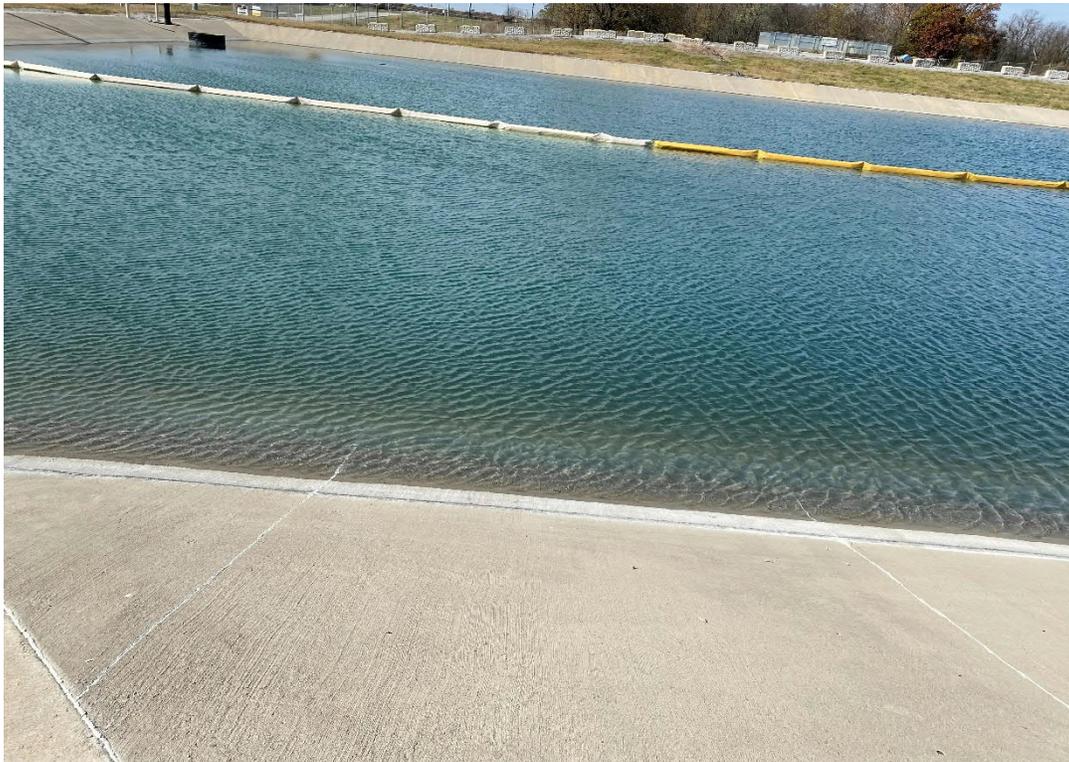
13. West side of contact water pond.

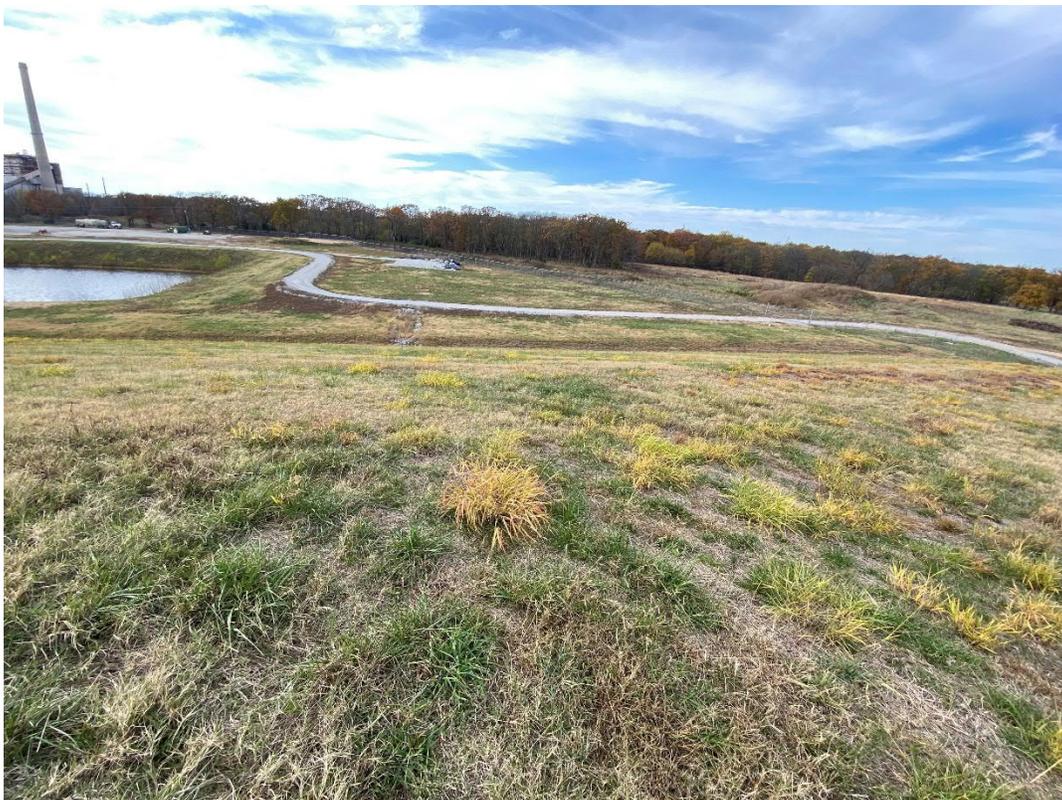
14. Stormwater ditch on the west side of the landfill.

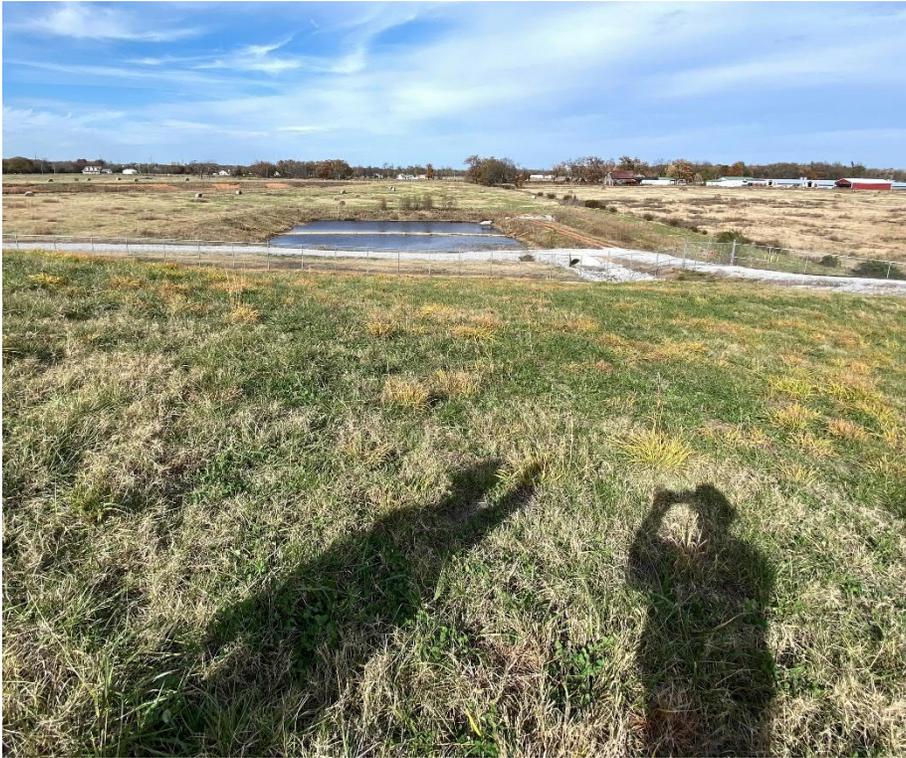
15. Fabriform letdown at the northeast corner of the landfill that flows into the north sediment basin.

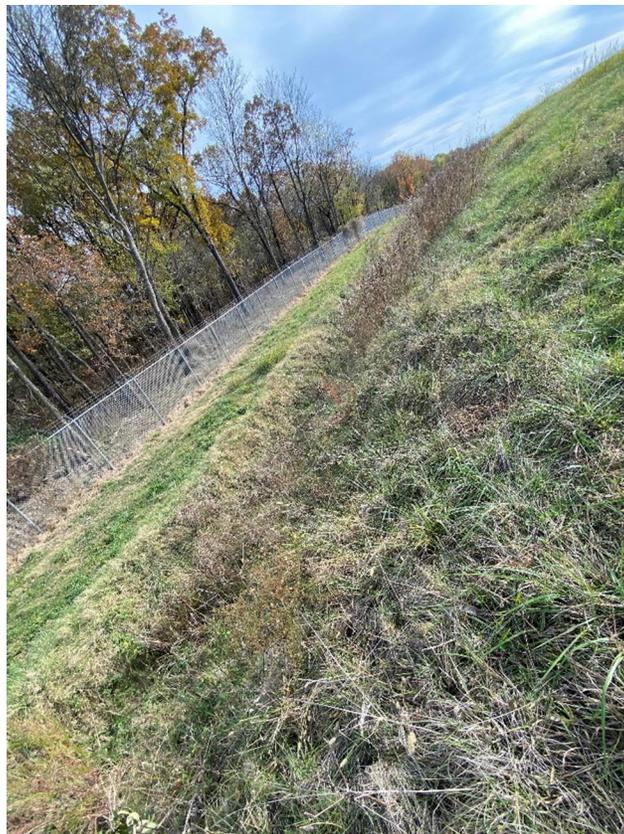
16. Stormwater ditch on the east side of the landfill.

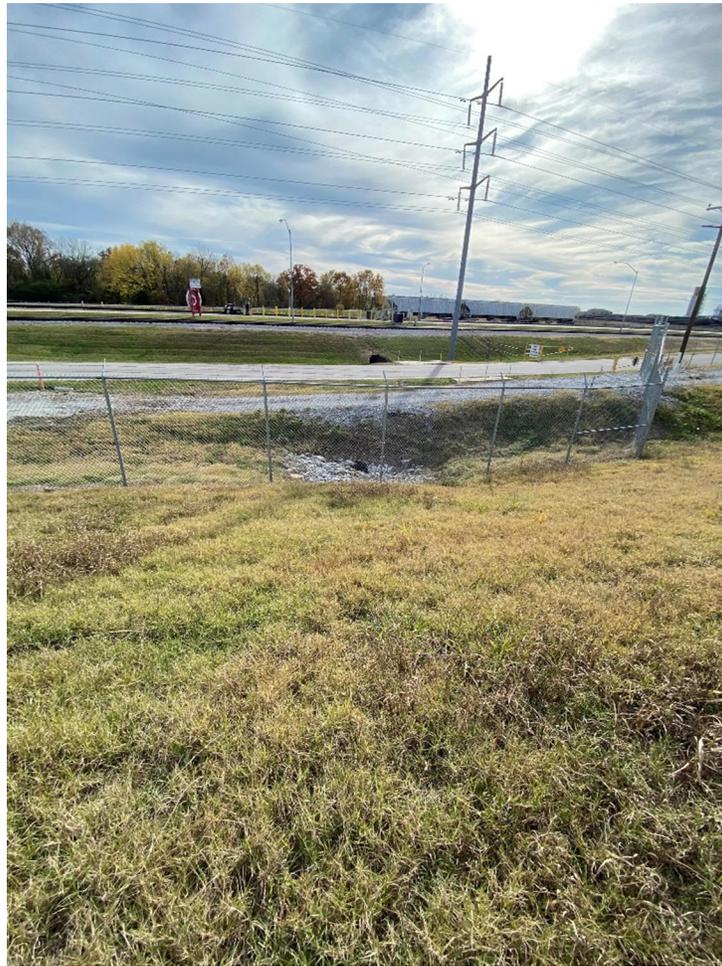
17. Stormwater culvert on the south side of the landfill.

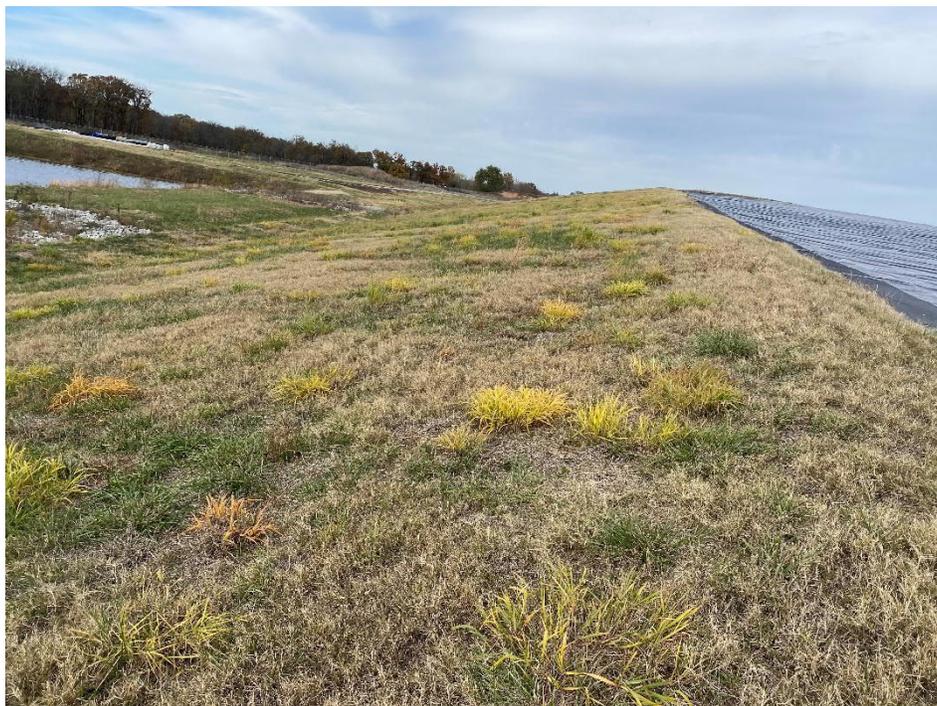
18. Portions of the landfill slopes have received final cover and certified as closed. The condition of these slopes was good (**Photos 18-20**). There were no observed erosion gullies, sloughs, or other signs of movement of these areas. All areas had adequate vegetative cover. The vegetation is well established.

18. West side final cover slope looking north.

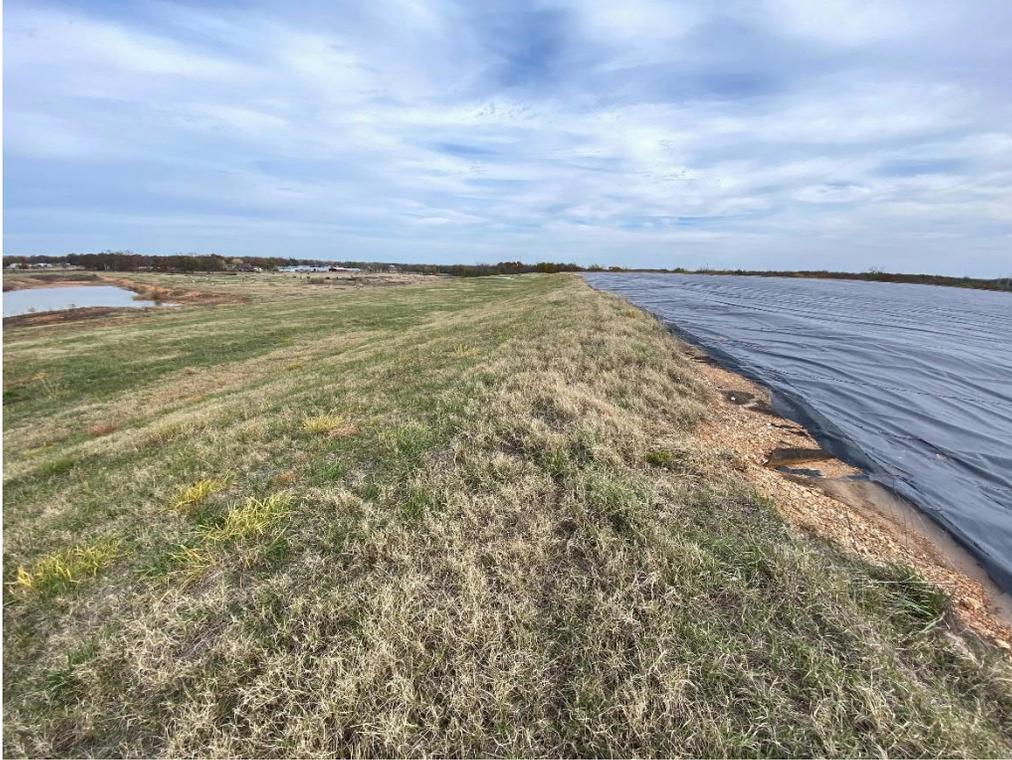
19. North side final cover looking east.

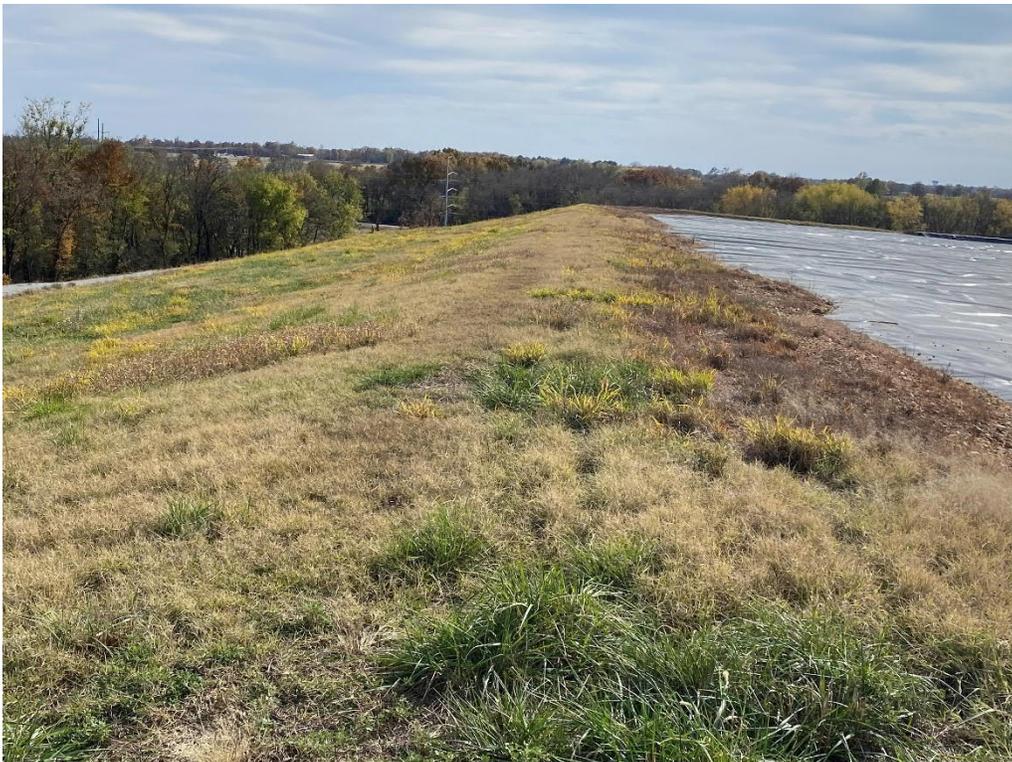
20. East side final cover looking south.
