# 2020 Annual Landfill Inspection Report

**Mitchell Plant**

**Kentucky Power Company and Wheeling Power Company  
Moundsville, West Virginia**

**Document ID: GERS-20-032**

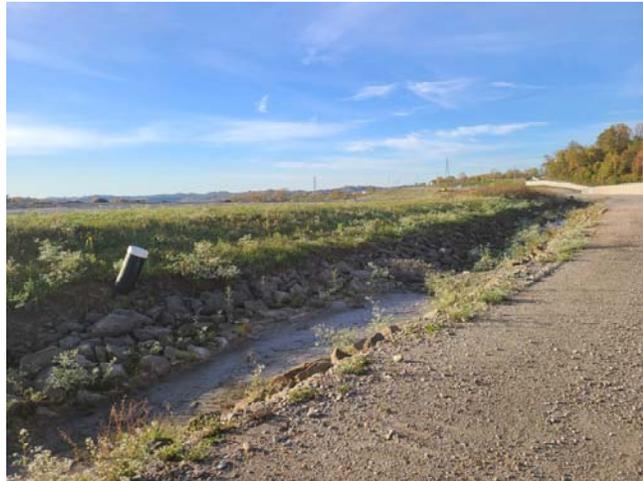
**Photo No. 1**

1. The Phase 1 Area is actively receiving CCR material for disposal. CCR material is dumped, spread out with a dozer and compacted with a smooth drummed roller. Chimney drains consisting of bottom ash piles were observed to be scattered around the Phase 1 area. There was no evidence of standing water, erosion, slope instabilities or uncontrolled seepage. Minor sediments collected in outer ditch north of phase 1 and 2 (Photograph 1).

Observation 1: Sediment Accumulation

Location: Outer Ditch Phase 1 and 2

Recommendations: Clean ditch.

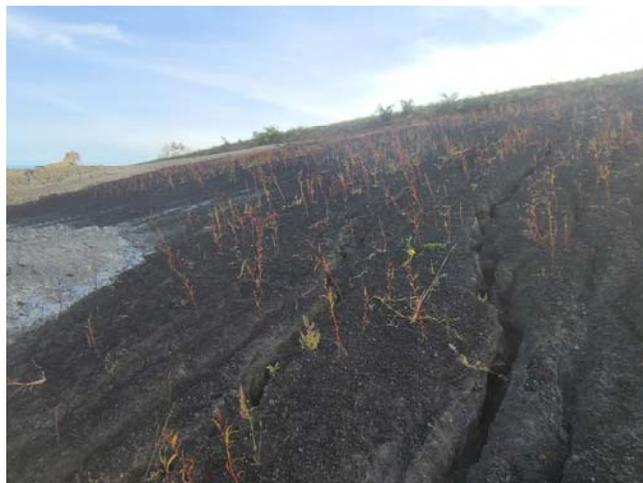
**Photo No. 2**

1. During the inspection, parts of Phase 2 area was actively receiving CCR materials. CCR material is dumped, spread out with a dozer and compacted with a smooth drummed roller.
2. Less than 6-inch deep erosion rills were noted along the northern slope of the temporary cover in the Phase 2 area (Photograph 2). Plant personnel indicated that erosion of this temporary cover is an on-going maintenance issue and usually addressed after rain events. There was no evidence of standing water, slope instabilities or uncontrolled seepage.

Observation 2: Minor Erosion

Location: East inboard slope of Phase 2

- 1) Continue to repair the erosion rills in the temporary ash cover on the north slope of Phase 2 and 3 areas and outside the landfill footprint after rain events.
- 2) Periodically remove the vegetation growing in the riprap-lined areas on the upstream slope and downstream toe area of the south pond dam.
- 3) Continue to perform routine maintenance on the leachate pump system components and remove any debris accumulation (leaf litter, sticks, etc.) as necessary for proper operation of the pumping system.

Recommendations: Repair erosion by placement of Bottom ash.

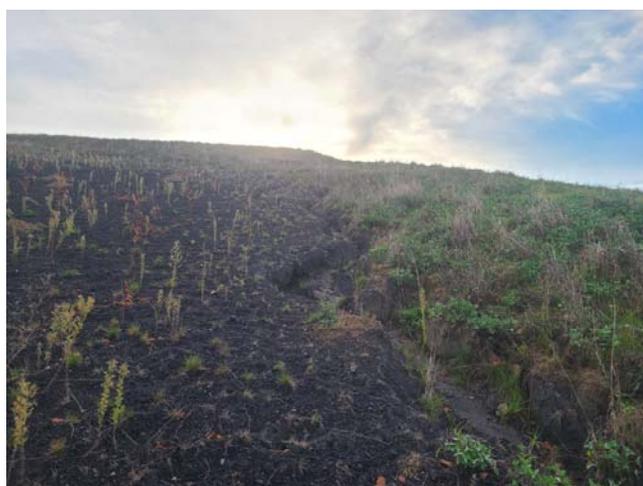
**Photo No. 3**

1. During the inspection, Phase 3 area was actively receiving CCR material for disposal. CCR material is dumped, spread out with a dozer and compacted with a smooth drummed roller. Greater than 6-inch deep erosion rills were noted along the northern slope of the temporary cover in the Phase 3 area (Photographs 3 through 8).

Observation 3: Minor Erosion

Location: left edge of East inboard slope of Phase 3.

Recommendations: Repair erosion by placement of bottom ash.

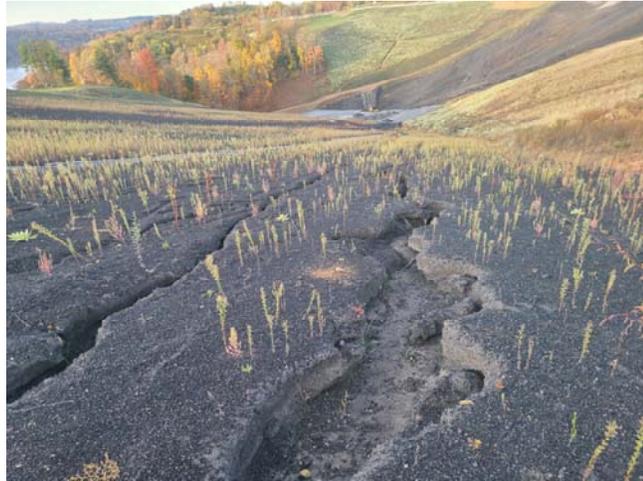
**Photo No. 4**

Observation 3: Minor Erosion

Location: Right edge of East inboard slope of Phase 3

Recommendations: Repair erosion by placement of bottom ash.

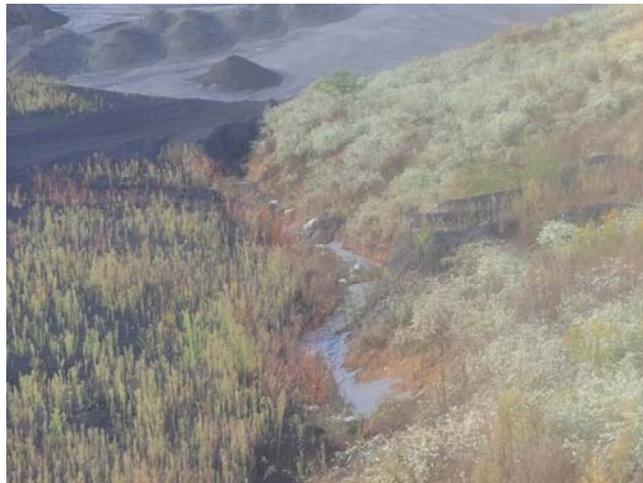
**Photo No. 5**

Observation 4: Minor Erosion

Location: Right edge of East inboard slope of Phase 3.

Recommendations: Repair erosion by placement of bottom ash.

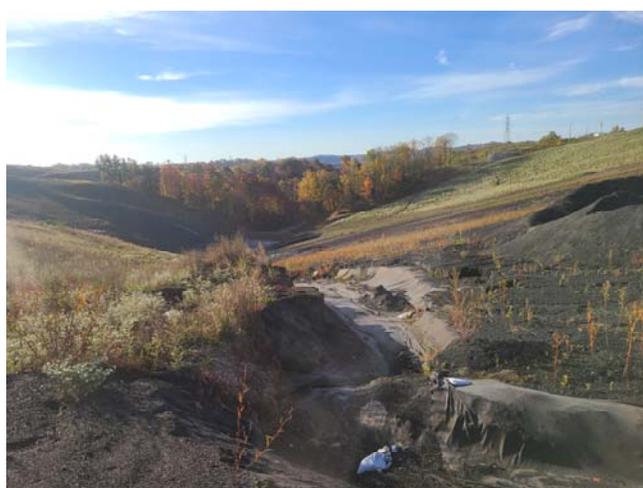
**Photo No. 6**

Observation 4: Poor Erosion

Location: left edge of West inboard slope of Phase 3.

Recommendations: Repair erosion by placement of bottom ash.

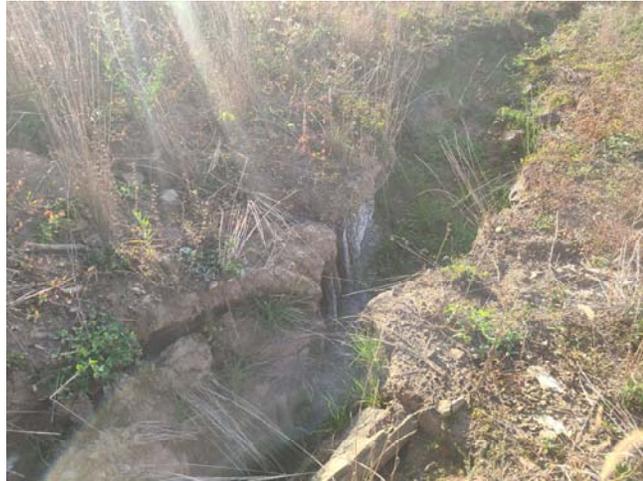
**Photo No. 7**

Observation 4: Poor Erosion

Location: left edge of West inboard slope of Phase 3.

Recommendations: Repair erosion by placement of Bottom ash/soil.

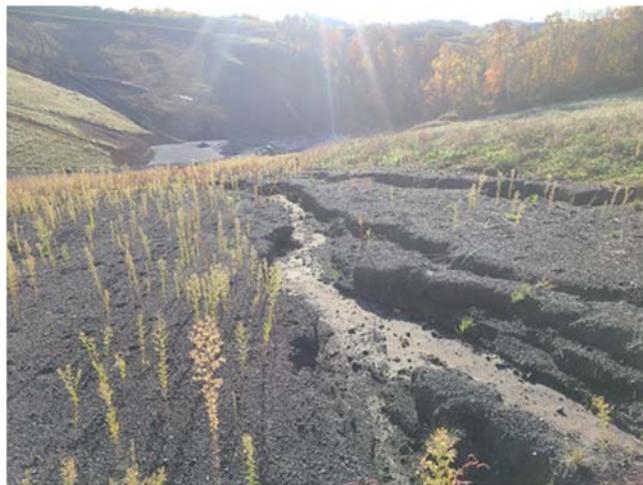
**Photo No. 8**

Observation 4: Minor Erosion

Location: East inboard slope of Clear

Recommendations: Repair erosion by placement of soil.

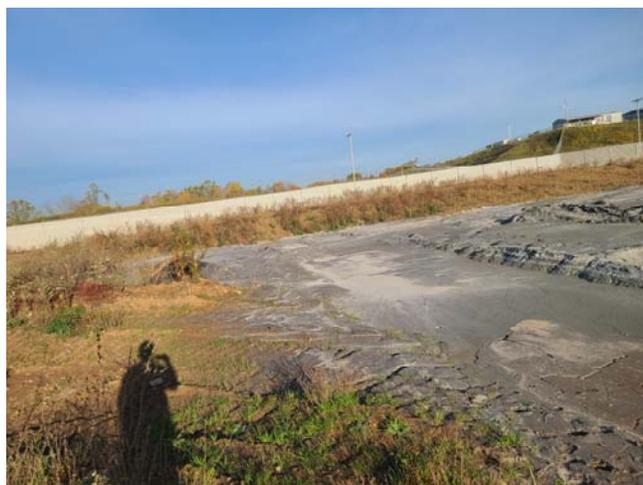
**Photo No. 9**

1. At the time of inspection, the clay berm south of phases 1 and 2 was recently mowed with good established grass cover. At some areas, the clay was harvested to be used in constructing the phase 3 Berm. At the right edge of the clay berm, there was a location of low freeboard that may cause some of the water in phase 1 to flow towards phase 3 and cause erosion in phase 3 area (photograph 9).
2. There was no evidence of uncontrolled leachate, slope instability or ponding water on the clay berm area.

Observation 5: Low Freeboard

Location: Right side of phase 1/3 clay berm

Recommendations: Repair by raising soil barrier.

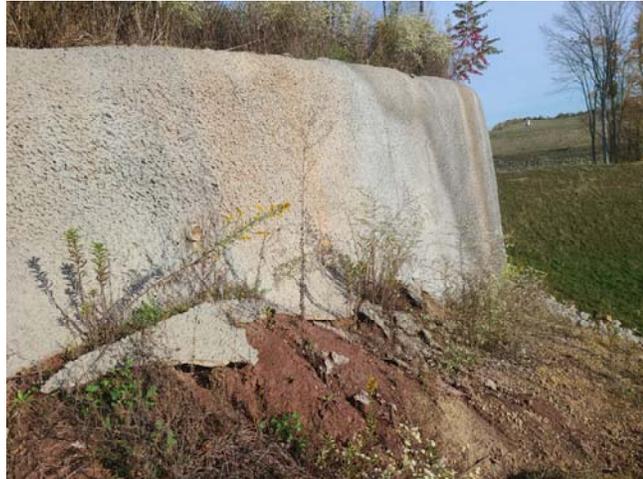
**Photo No. 10**

4. South edge of Soil nail wall facing downslope of the pond appear to become undermined (Photograph 10).
5. Minor Erosion rill was observed downslope of the pond to the north east (Photograph 11).

Observation 6 : Soil Nail Facing undermined

Location: East inboard slope of Clear

- 1) Continue to monitor the sediment accumulation in the storm water sedimentation ponds (including the south pond forebay) and plan to periodically remove the sediments as necessary to retain the design storage capacity of the ponds.
- 2) Communicate with Soil Contractor to evaluate the soil nail wall facing conditions and investigate the need for fix to the undermining issue.

Recommendations: Check on construction warranty.

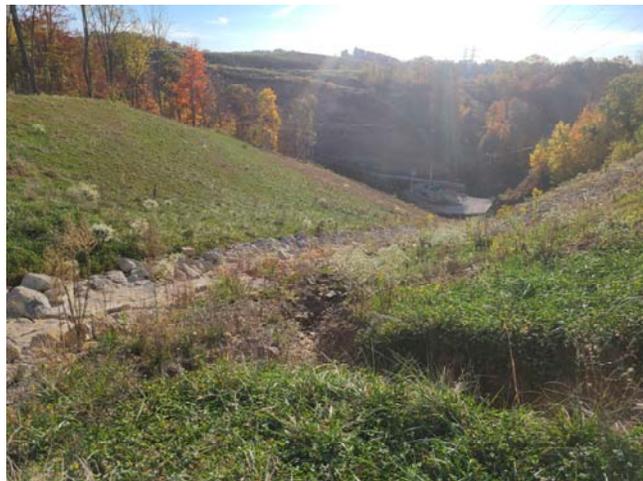
**Photo No. 11**

Observation 7: Minor Erosion

Location: right of the right ditch outside west side of future Phase 4.

Recommendations: Repair erosion by placement of soil.

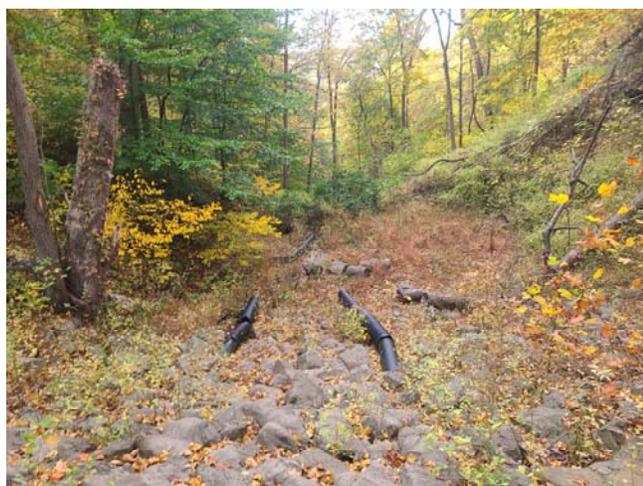
**Photo No. 12**

7. Falling tree log on the two pipes referenced above were removed by cutting it and setting it aside (Photograph 12).

Observation 8: Falling log removed off pipes

Location: downslope of west sediment pond.

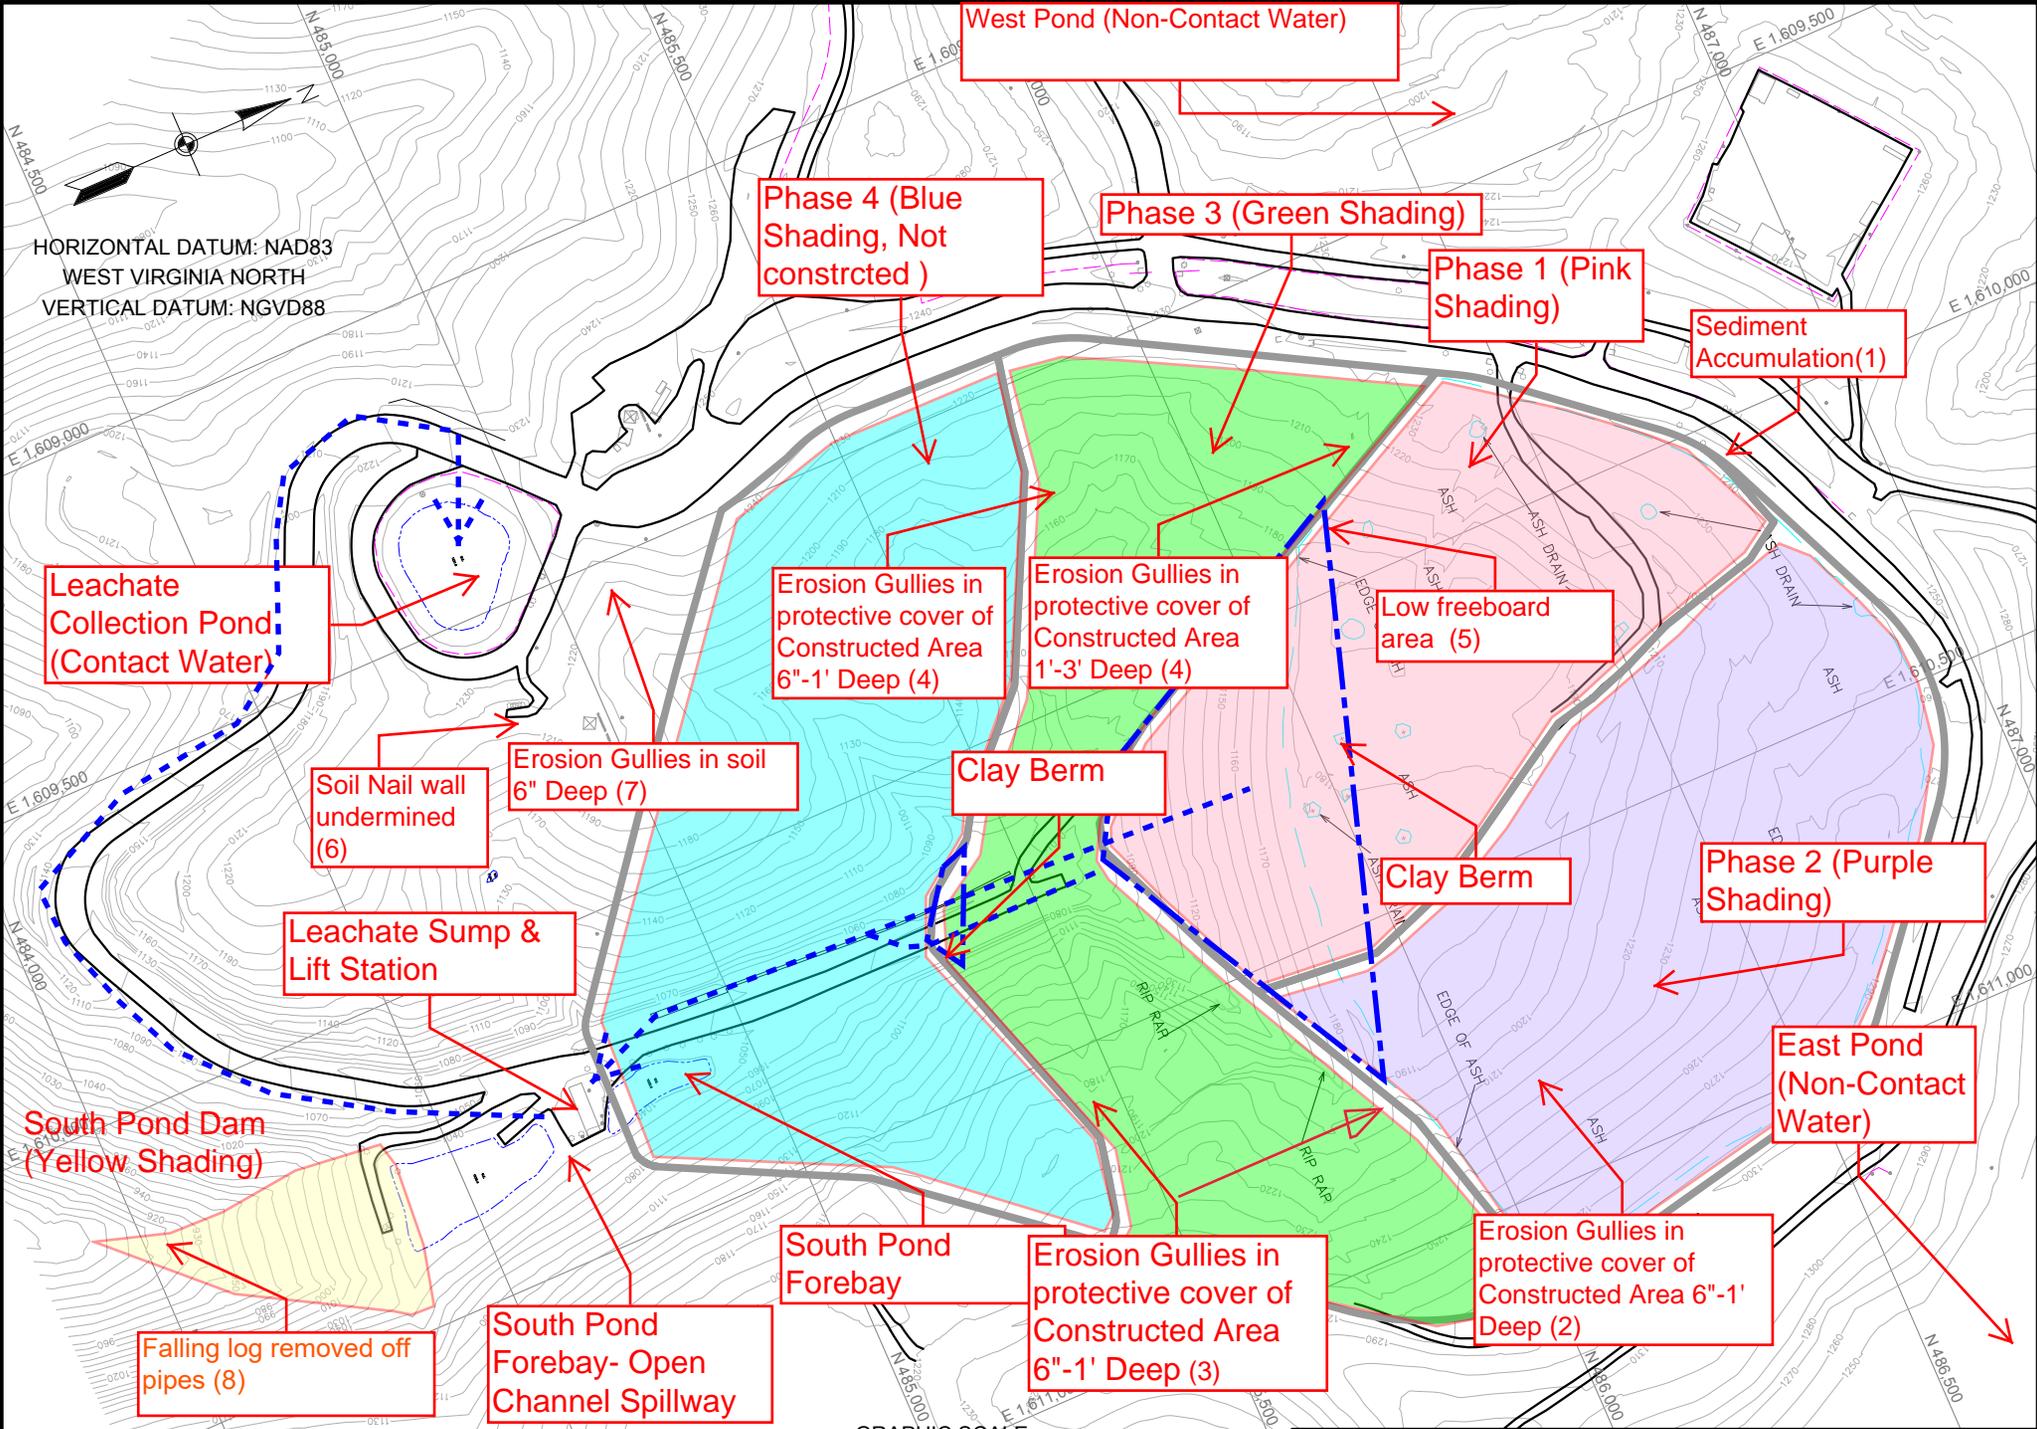
DRN BY: .	GEOTECHNICAL		
DATE: .	OHIO POWER COMPANY MITCHELL PLANT		
SCALE: 1"=300'	WEST VIRGINIA	LANDFILL	
FIGURE 1			AEP SERVICE CORP. 1 RIVERSIDE PLAZA COLUMBUS, OH 43215

Sediment Accumulation(1)

Erosion Gullies in protective cover of Constructed Area 6'-1' Deep (4)

Erosion Gullies in protective cover of Constructed Area 1'-3' Deep (4)

Low freeboard area (5)

Soil Nail wall undermined (6)

Erosion Gullies in soil 6" Deep (7)

Falling log removed off pipes (8)

Erosion Gullies in protective cover of Constructed Area 6'-1' Deep (3)

Erosion Gullies in protective cover of Constructed Area 6'-1' Deep (2)
