2020 DAM AND DIKE INSPECTION REPORT GEVR-20-008

BOTTOM ASH POND NORTHEASTERN 3&4 PLANT PUBLIC SERVICE COMPANY OF OKLAHOMA

2020 Annual Dam and Dike Inspection Report

Document Number: GEVR-20-008

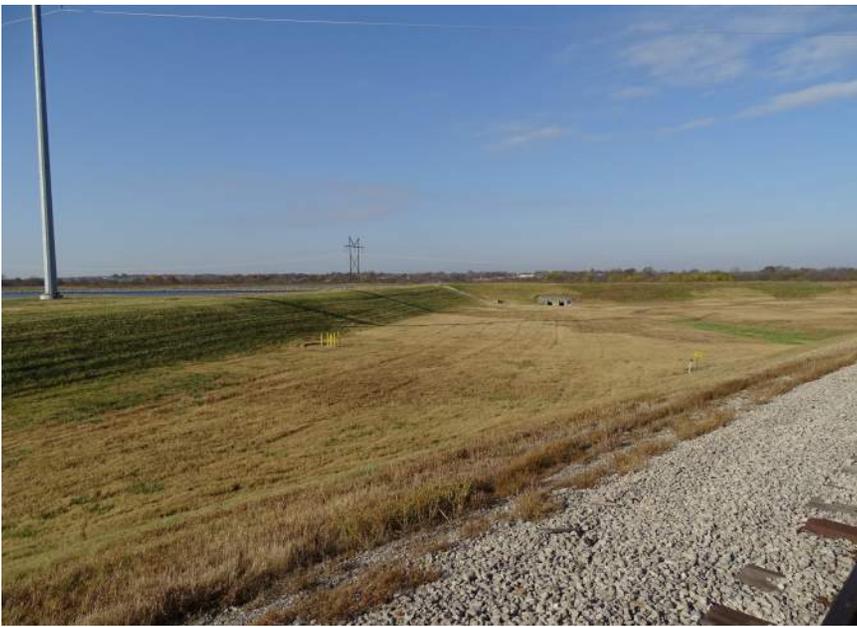
Photo #1 - Exterior slope north dike, looking west

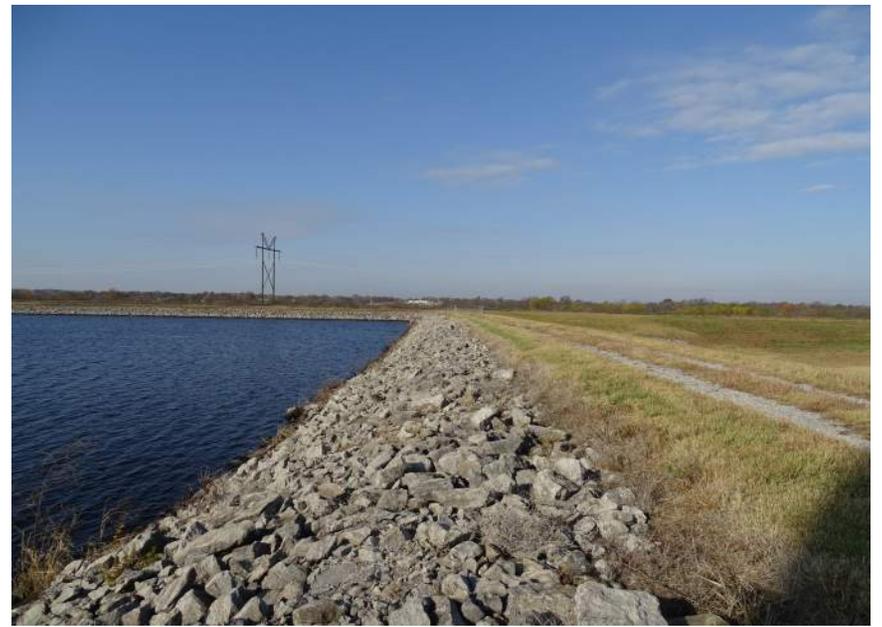
Photo #2 - Upstream slope of north dike, looking west

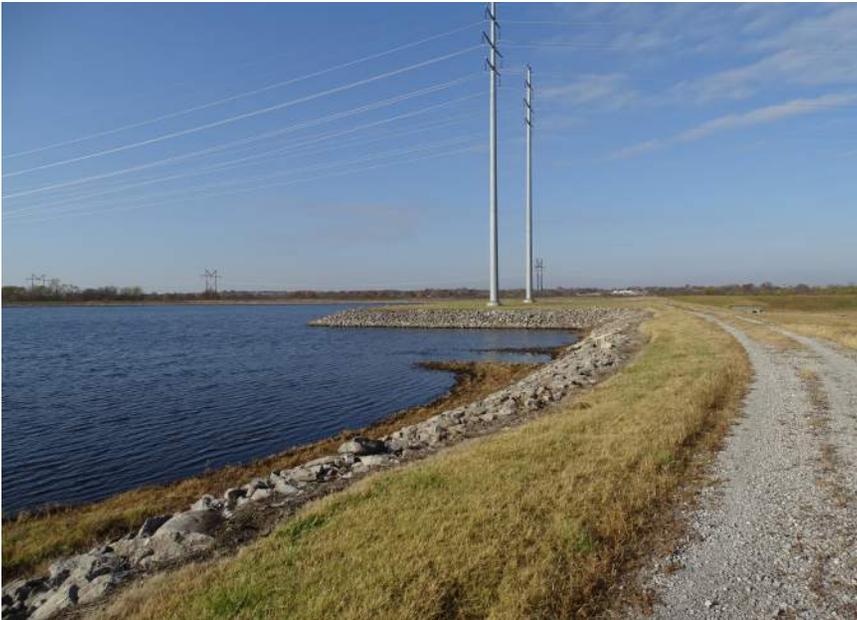
Photo #3 - Upstream slope of north dike, looking west

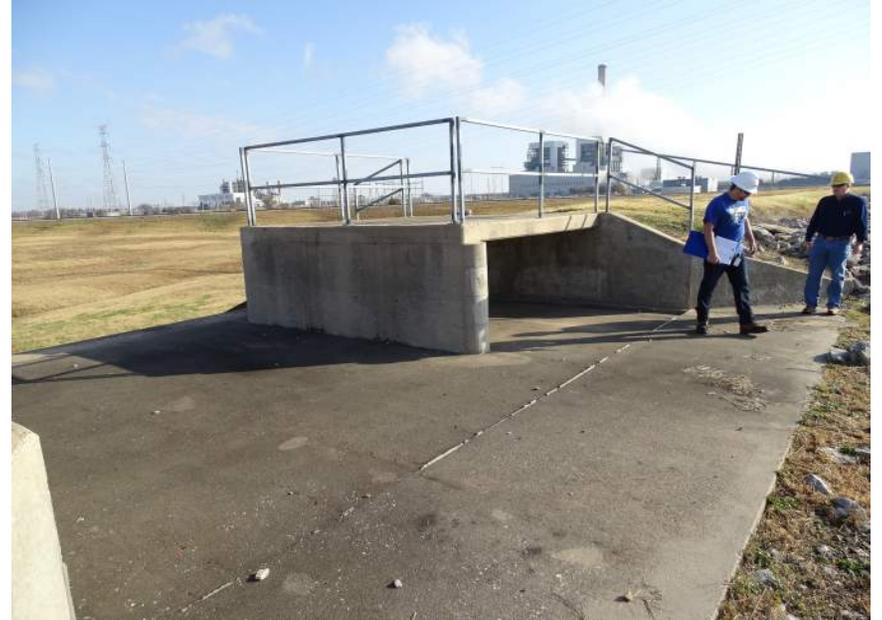
1. The concrete control section and discharge chute were in good condition and clear of any heavy vegetation or debris that would restrict flow. (photo 4 and 5)
2. There were no signs of movement or misalignment along any of the construction joints except for the joint at the top of the chute. This occurred some time ago and the condition has remained stable based on past inspections. There was no seepage along the contacts between the concrete training walls and downstream slope of the embankment, nor at the end of the concrete chute.
3. The energy dissipater baffles at the toe of the spillway were clear of sediment and were in good condition. (photo 5)
4. The caulking at the concrete joints was in good condition.

Photo #4 - Auxiliary spillway

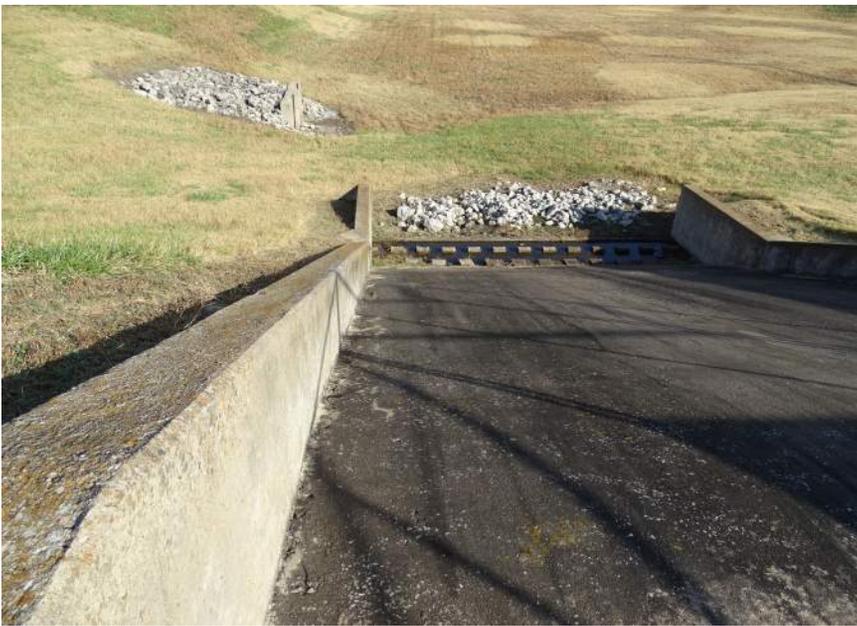
Photo #5 - Spillway chute looking north

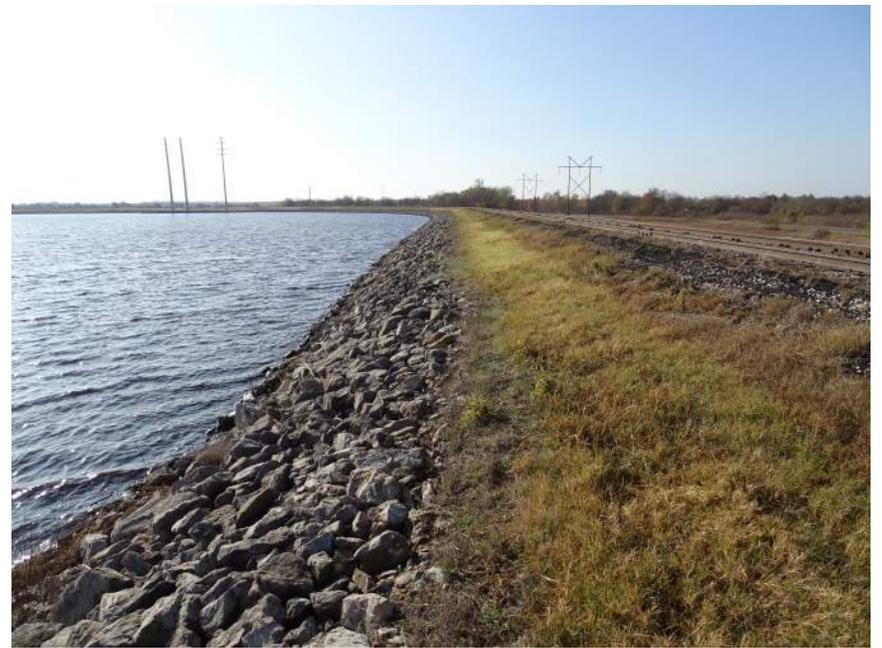
1. The upstream slope of this embankment was in good condition. The riprap was free of any vegetation. (photo 6)
2. The area beyond the toe of the embankment has been well maintained to prevent heavy and/or woody vegetation within the regulatory 30-foot setback. The downstream slope is well vegetated and maintained (photo 7). There was no seepage noted along the toe of the West embankment.
3. The crest and railroad tracks do not show any signs of settlement or misalignment. The tracks are inspected monthly by an independent company to ensure no misalignment or settlement.
4. Two rodent holes were observed just above the riprap on the downstream slope. (photo 8) (see Location Map).

Photo #6 - Upstream slope of west embankment, looking south

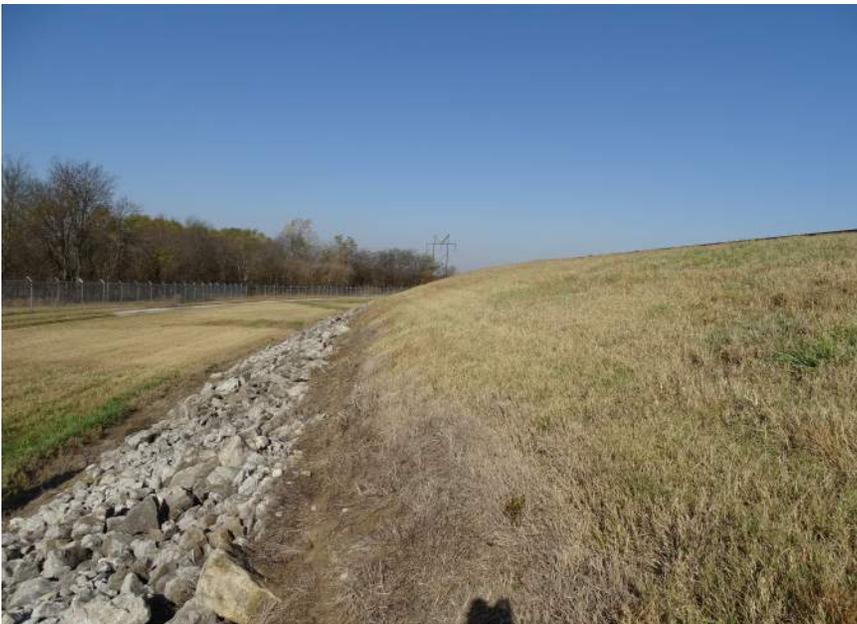
Photo #7 - Downstream slope of west dike, looking northeast

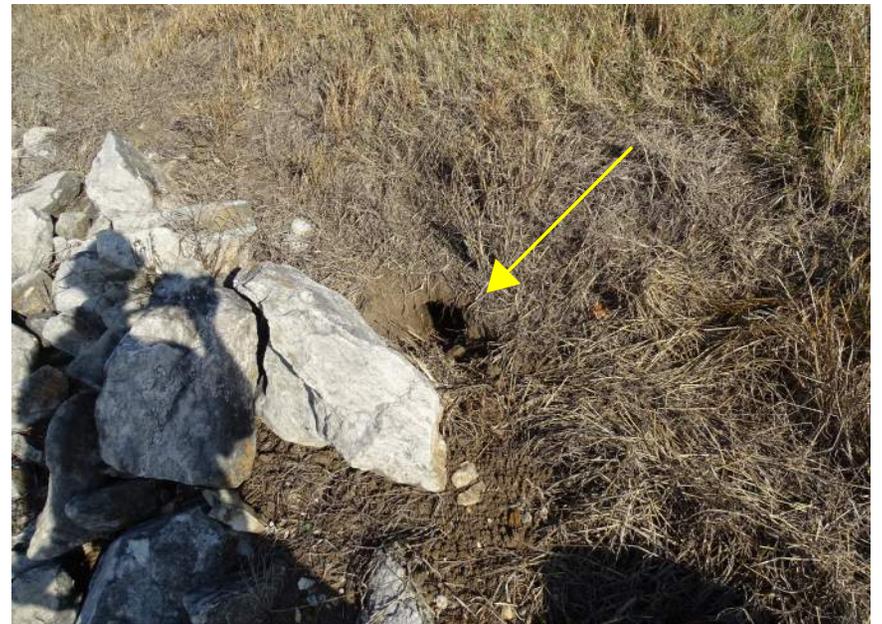
Photo #8 - Rodent hole, less than 1 foot deep

- 1) Repair the three observed rodent holes. Mitigate holes by filling with compatible material and compaction.
- 2) Continue to clear vegetation growing in the riprap.

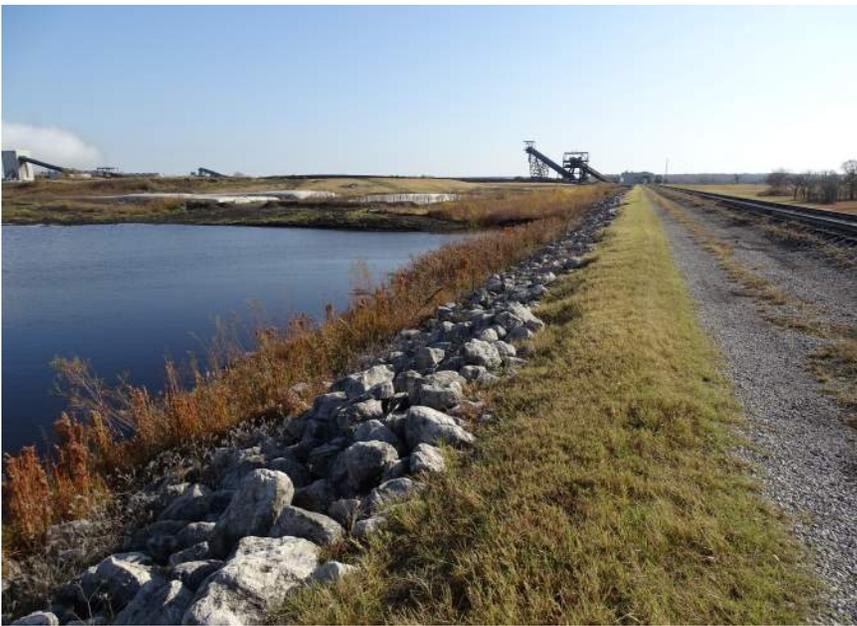
5. The upstream slope of the South Dike embankment was in good condition. There were no signs of bulges, cracks, sloughing or other deficiencies. There is vegetation growing in the riprap on the southeast upstream embankment. The crest and railroad tracks do not show any signs of settlement or misalignment. As noted above, the tracks are inspected monthly by an outside company to ensure no misalignment or settlement. (photo 9)

Photo #9 - Vegetation growing in the riprap on the south embankment

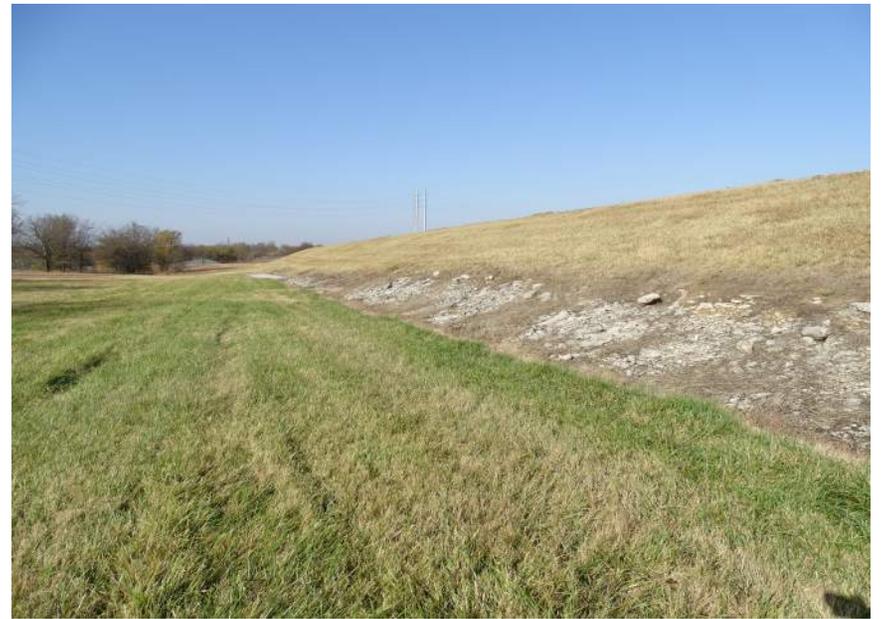
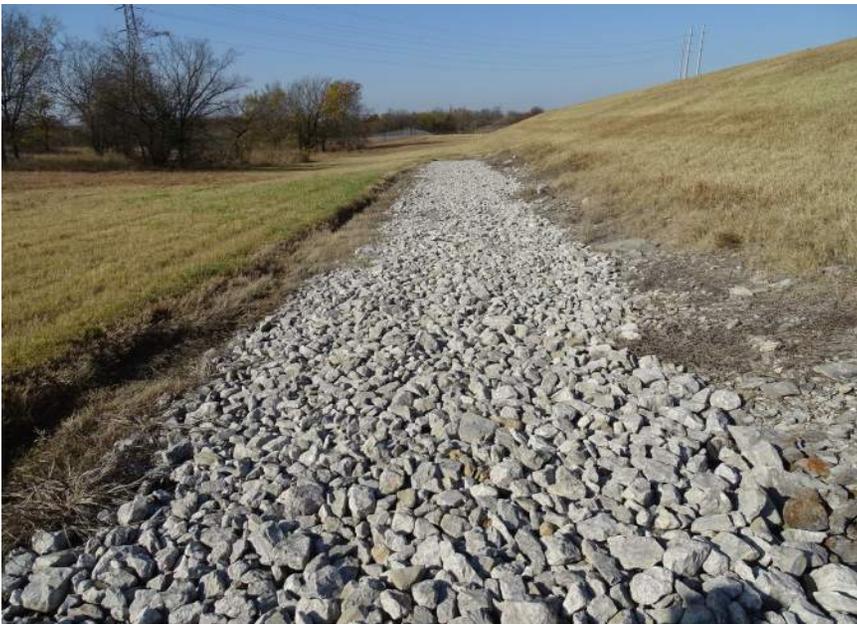
6. The downstream slope is well vegetated and maintained. There was no observed seepage, wet or damp areas along the slope. (photos 10 and 11)
7. One rodent hole was observed on the downstream slope just above the riprap.

Photo #10 - South downstream embankment looking west

Photo #11 - South downstream embankment looking west

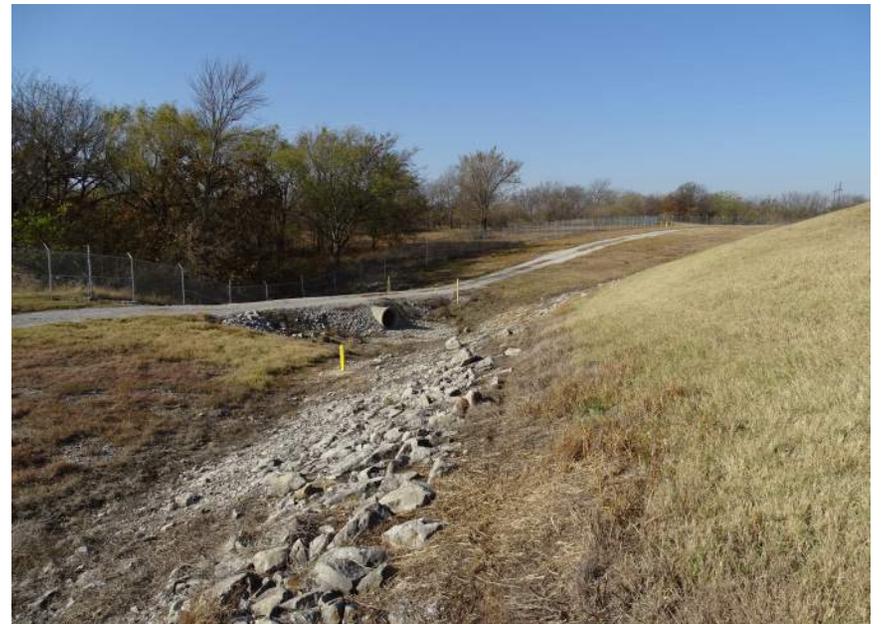
8. The seepage collection blanket appears to be functioning as designed. Seepage is directed to the low area below the embankment and is typically discharged through a pipe below an access drive. No seepage or moisture was observed at the outlet of the pipe during the inspection (photo 12).

Photo #12 - Drainage culvert at the bend between south and west embankment
