2020 DAM AND DIKE INSPECTION REPORT GEVR-20-017

H.W. PIRKEY POWER PLANT BOTTOM ASH PONDS

Marshall, Texas

INSPECTION DATE October 27, 2020

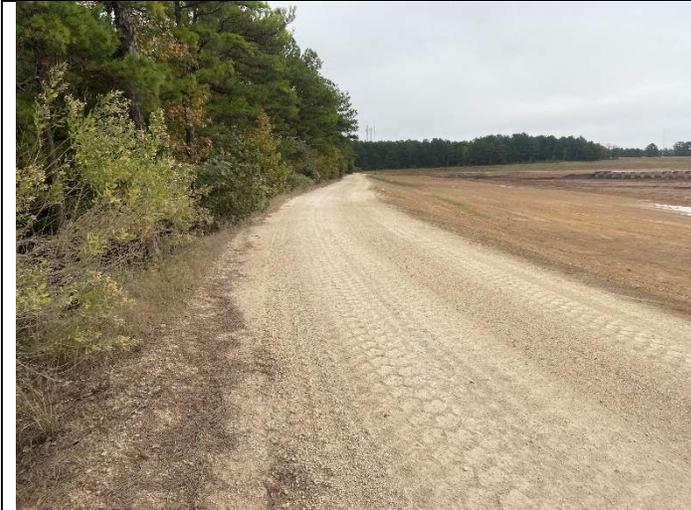
Photograph 1: East Bottom Ash Pond

1. (Photograph 1) The north side crest area appeared to be in satisfactory condition with no signs of rutting, settlement, or misalignment. The bottom of the pond had been excavated of ash material (Photograph 7). Dense tree vegetation was noted on the downstream slope and toe area. This issue was discussed in the field, and AEP staff explained that beyond the toe there is a roadway embankment which effectively forms a secondary containment along the north side.

View along crest of north embankment, looking east. Note pond was drained for ash material excavation. Note dense tree vegetation along downstream side of crest (left side of photo).

- Areas with dense stands of tree and brush vegetation near the downstream toe should be maintained at least 25 feet from the toe of the embankment.
- The erosion gully at the downstream toe of the West BAP west embankment should be repaired and stabilized.
- Hog dam and animal burrows should be repaired.
- Given its proximity to the downstream toe of the south east corner of the West BAP, the low area which ponds water should be drained and vegetation maintained similar to the surrounding areas. The culvert beneath the access ramp may need to be cleaned out.
- In the West BAP piezometer reading spreadsheet, labels for the “Depth to Water” and “Water Level Elevation” columns should be flipped.

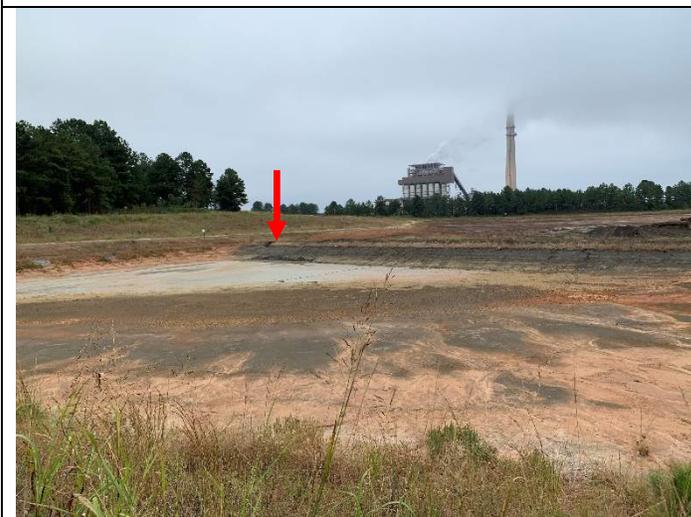
Photograph 2: East Bottom Ash Pond

2. (Photograph 2) A partial breach section was observed in the interior ash berm which forms a small containment pond in the northeast corner. The section of the East BAP is incised into native ground.

View of northwest corner overflow pond, looking south. Arrow points to location of partial breach in the interior ash berm.

- The partial breach of the interior ash berm at the northwest corner of the East BAP should be repaired prior to the pond being put back into service.
- The drainage ditch around the east and south sides of the East BAP should be maintained so that vegetation does become so thick that it obstructs flow.

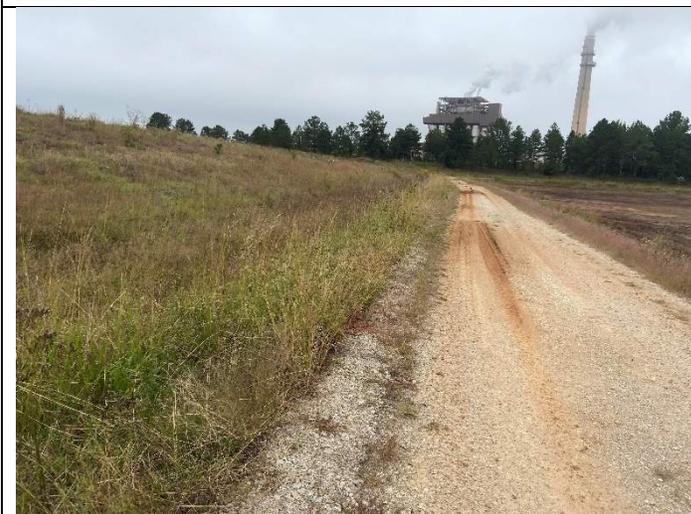
Photograph 3: East Bottom Ash Pond

3. (Photographs 3-5) The east and south sides of the pond were in satisfactory condition, with no signs of rutting, settlement, or misalignment. The upper portion of the interior slope was vegetated and needed to be mowed. The bottom of the pond had been excavated of ash material. The perimeter drainage ditch that runs along the east and south sides of the pond was heavily vegetated, which prevented complete inspection of the ditch (Photograph 5). Water was standing in the ditch as a result of recent rainfall.

View of east side of pond, looking south. Perimeter drainage ditch runs along left side of crest.

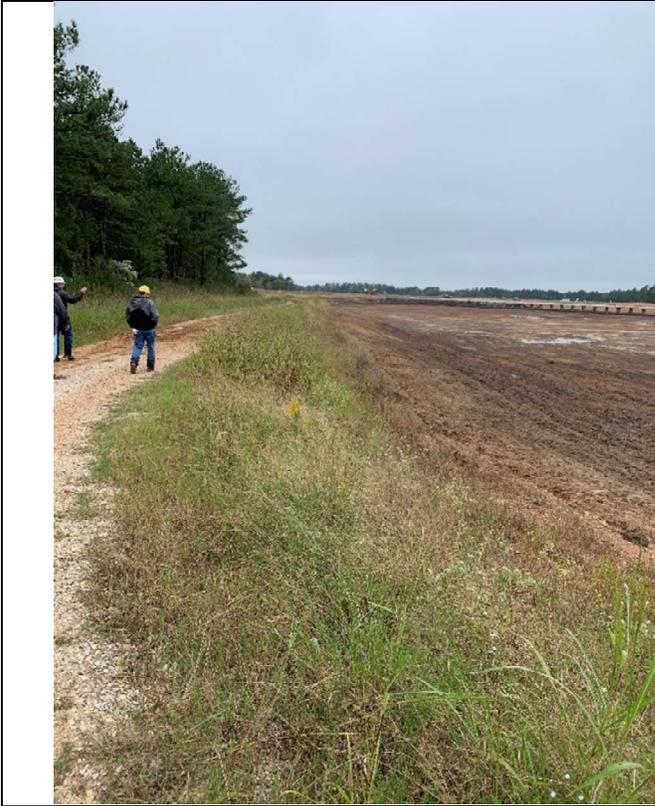
Photograph 4: East Bottom Ash Pond

View along crest and upstream slope along south side of pond, looking west. Vegetation coverage in upper section of slope is good, but needed to be mowed.

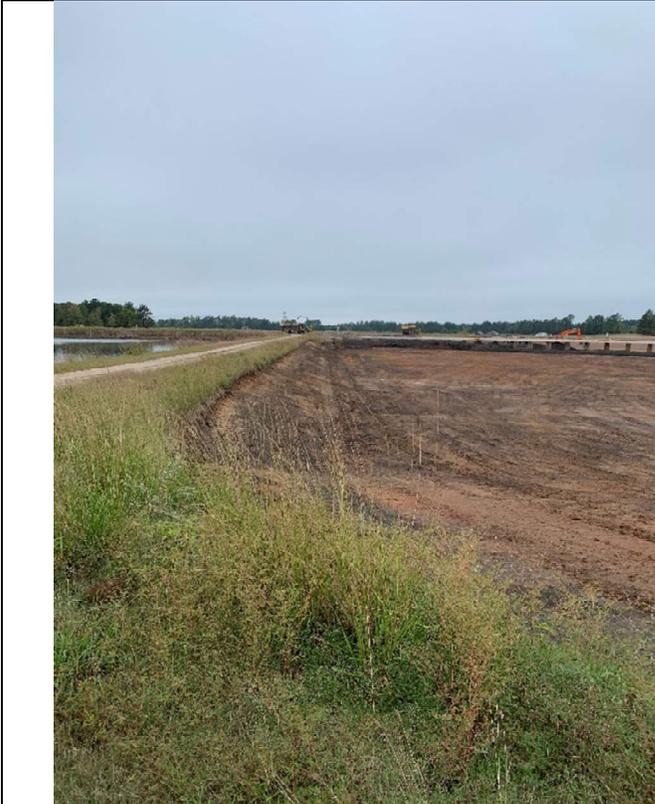
Photograph 5: East Bottom Ash Pond

4. (Photograph 5) The south embankment was in satisfactory condition with no signs of rutting, settlement, or misalignment. The upstream slope had been excavated of ash material, and the exposed slope appeared in good condition. This embankment section is a shared embankment with the Secondary Bottom Ash Pond.

View along upstream slope of shared embankment with Secondary Bottom Ash Pond (at left of photo). Ash material has been excavated from the upstream slope and bottom of pond.

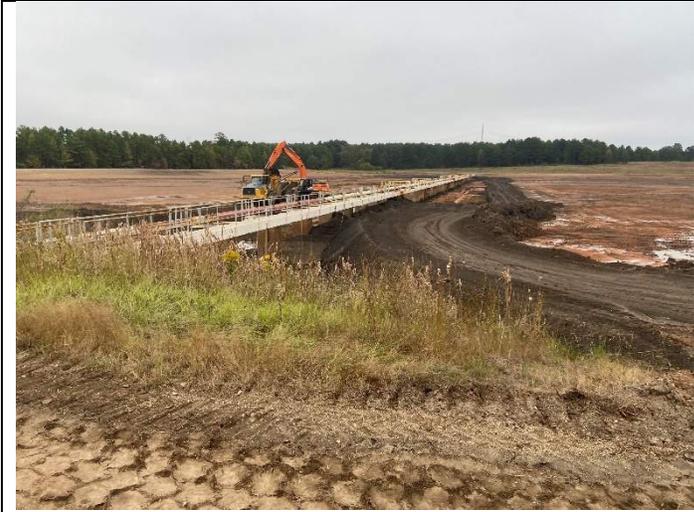
Photograph 6: East Bottom Ash Pond

Ash material excavation activities near discharge structure.

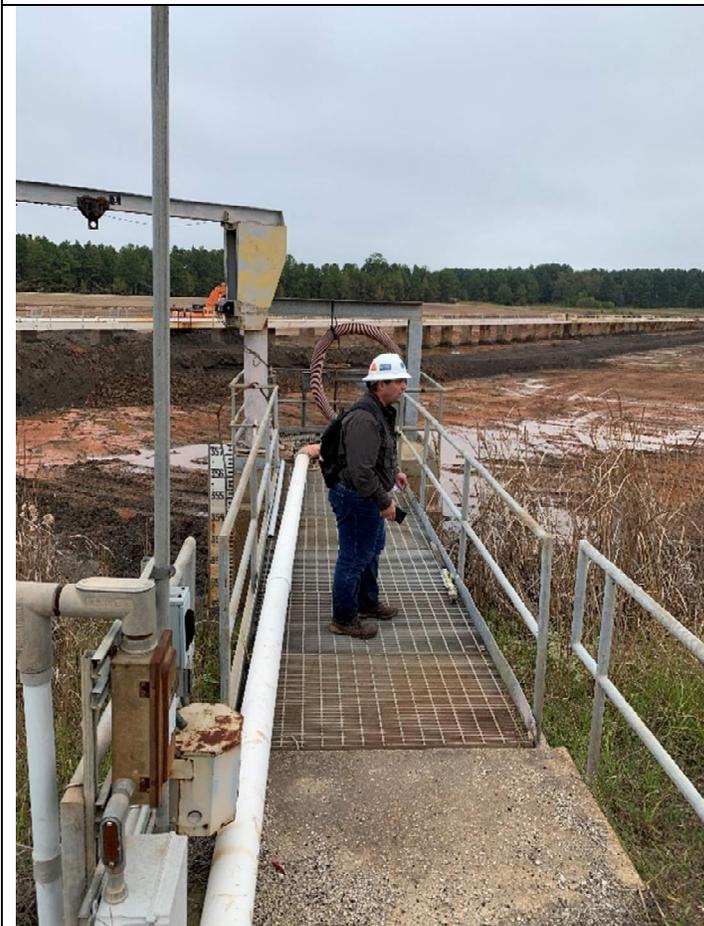
Photograph 7: East Bottom Ash Pond

5. (Photograph 7) The overflow discharge structure walkway, railings, metal decking, and visible concrete appeared in satisfactory condition. Significant corrosion was observed on the outlet slide gate, frame, and stem. Given the pond was dry, the functionality of the overflow structure could not be judged.

View of discharge structure.

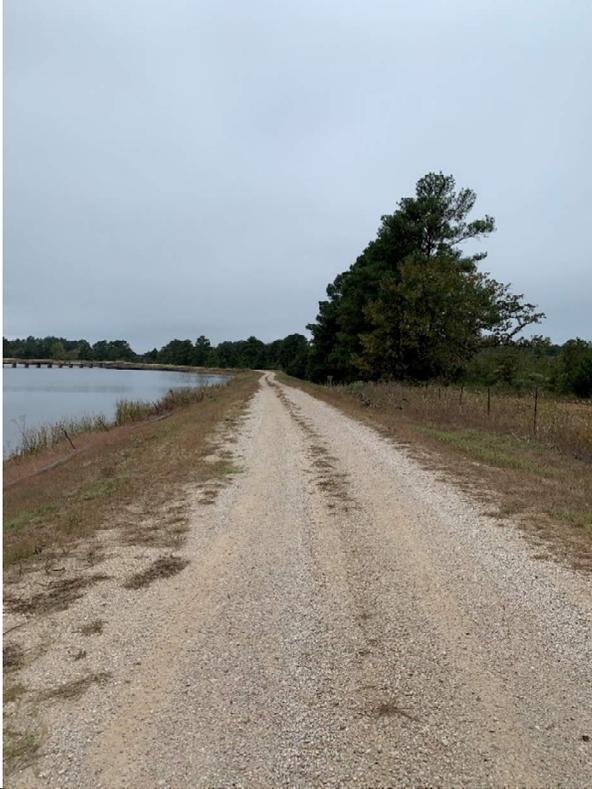
Photograph 8: West Bottom Ash Pond

1. (Photographs 8-9) The north embankment was in satisfactory condition. The interior slope was in fair overall condition. Minor wave erosion was noted on the slope, and vegetation along the upper portion of the slope was slightly overgrown. The exterior slope was in good overall condition, and there were no signs of sloughing, seepage, or signs of instability. The slope was well vegetated and had recently been mowed.

View along crest, looking west, of north side of pond. Crest was in good condition.

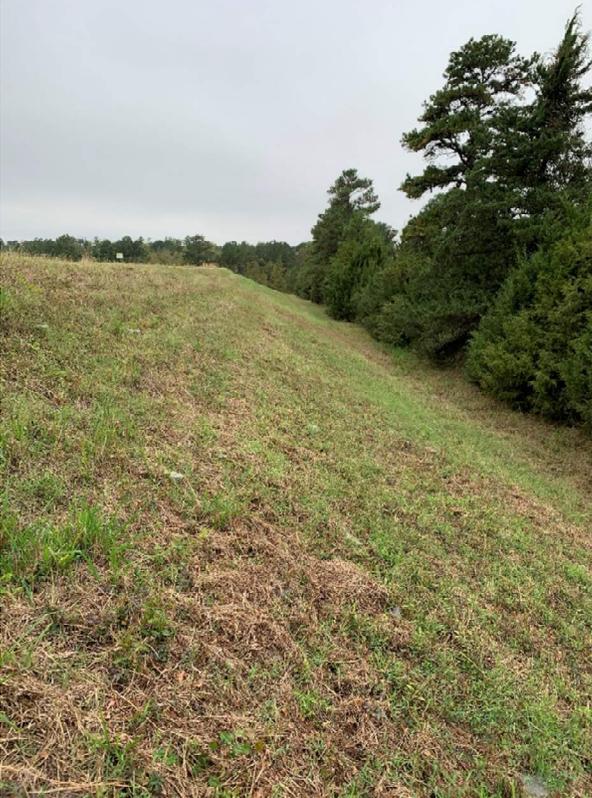
Photograph 9: West Bottom Ash Pond

View along exterior slope of north embankment, looking west. Note tree line along downstream toe.

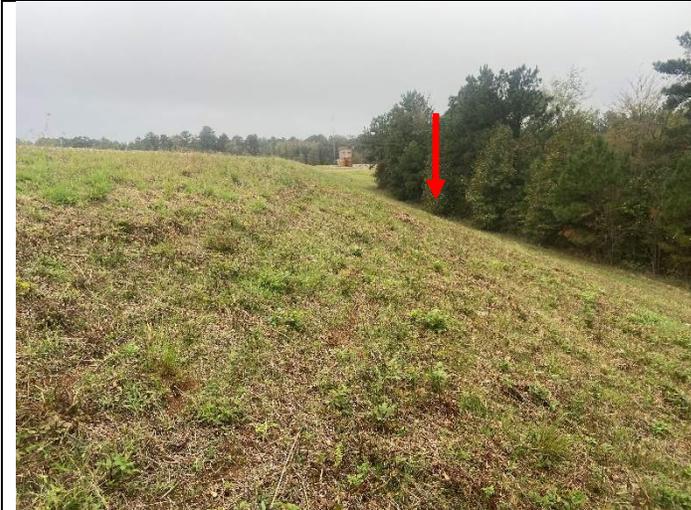
Photograph 10: West Bottom Ash Pond

2. (Photographs 10-12) The west embankment was in satisfactory condition. The interior slope was in fair overall condition; minor wave erosion was noted on the slope similar to rest of the pond (Photograph 11). The exterior slope was in fair overall condition, and there were no signs of sloughing, seepage, or signs of instability. Significant hog damage had occurred throughout the slope, primarily towards the southern end (Photograph 12). Mature trees are established along the downstream toe on the northern half of the embankment. An erosion gully has formed just inside the tree line, but is largely obscured from underbrush (Photograph 10). The erosion gully appears to be the result of surface runoff from the area to the south.

Typical view of exterior slope, looking south, along west side of pond. Slope had recently been mowed. Note tree line along downstream toe. Arrow points to location of erosion gully located just inside the tree line.

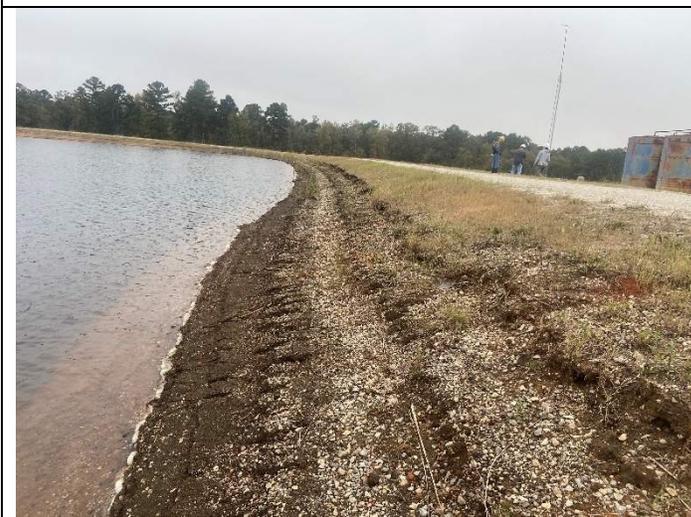
Photograph 11: West Bottom Ash Pond

Example of minor wave bite on interior slope, west side of pond.

- Wave erosion on the interior slopes should be routinely monitored. If the erosion progresses to the point where more substantial scarps develop that could threaten the integrity of the crest, then corrective measures will be needed.

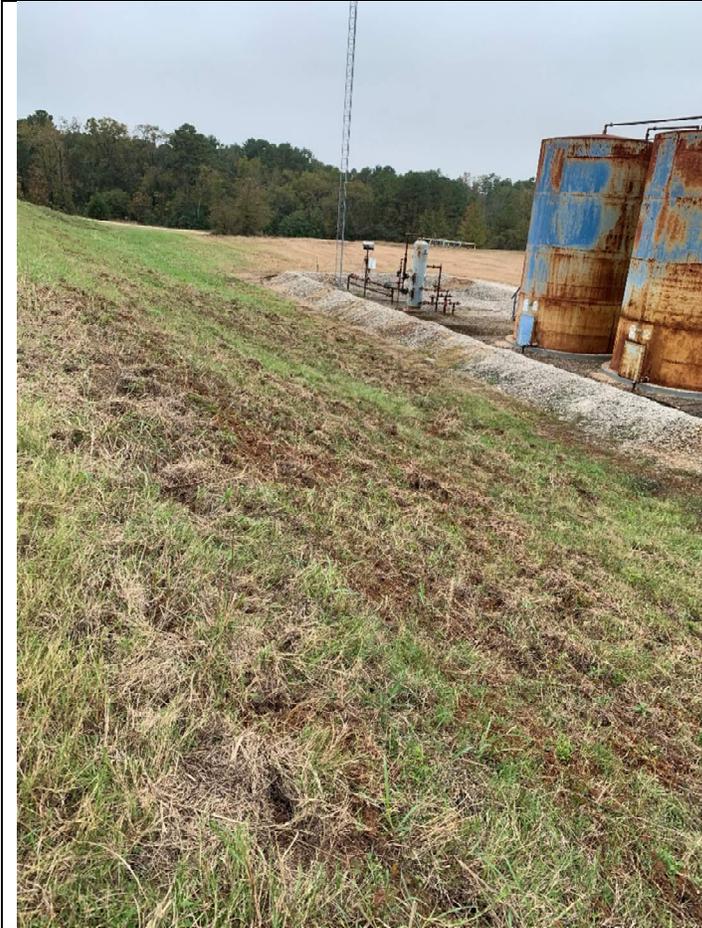
Photograph 12: West Bottom Ash Pond

Area of significant hog damage on exterior slope of west embankment. Total extent of damage was approximately 150 yards long.

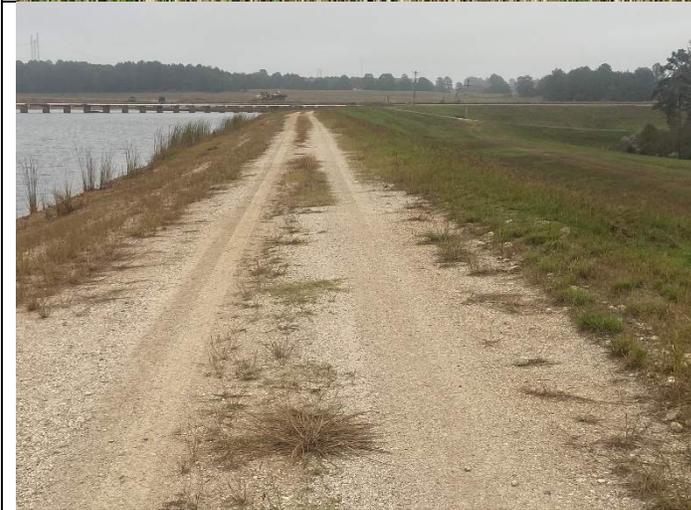
Photograph 13: West Bottom Ash Pond

3. (Photographs No. 13-17) The south embankment was in satisfactory condition. The interior slope was in fair overall condition; minor wave erosion was noted on the slope similar to rest of the pond (Photograph 14). The exterior slope was in good overall condition, and there were no signs of sloughing, seepage, or signs of instability. Vegetation quality on the south exterior slope is noticeably better the west and north embankments (Photograph 15). Minor hog damage was noted in several locations on the exterior slope, typically near the crest (Photograph 16). Downstream of the toe in the southeast corner of the pond, a low area ponds water (Photograph 17). The ponded water appeared to be associated with a partially blocked culvert which drains the local runoff beneath an access embankment; this area did not appear to be the result of embankment seepage.

View of crest of south embankment, looking east. Crest was in good overall condition.

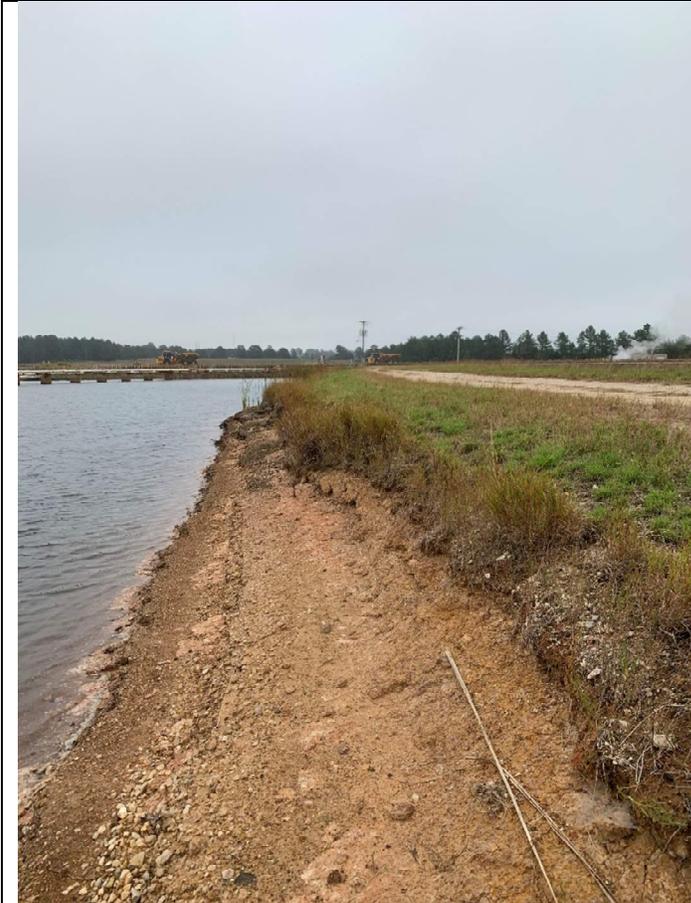
Photograph 14: West Bottom Ash Pond

Example of minor wave erosion on interior slope of south embankment, looking east.

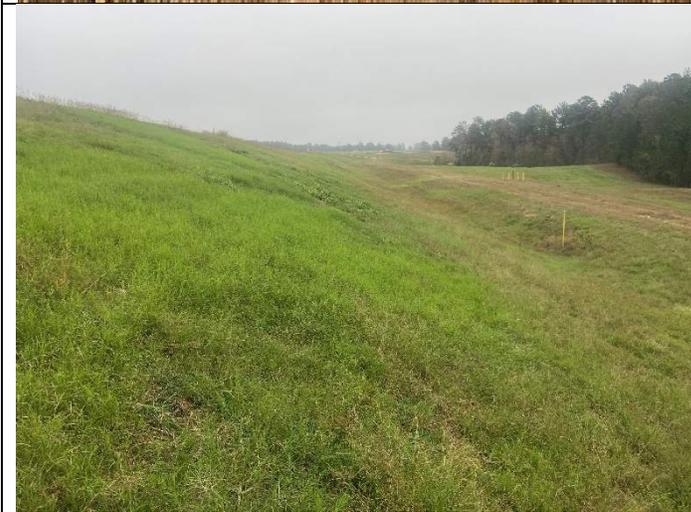
Photograph 15: West Bottom Ash Pond

View of exterior slope of south embankment, looking east. Note vegetation quality was better on south embankment compared to the other areas of the pond.

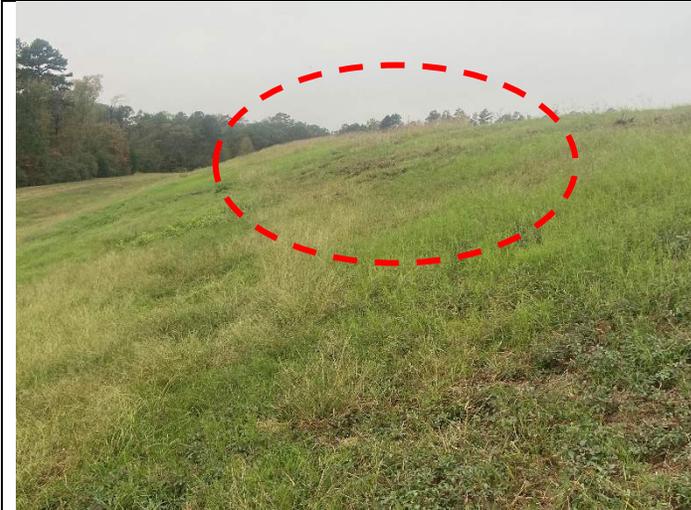
Photograph 16: West Bottom Ash Pond

Typical view of exterior slope of south embankment, looking west. Circled area indicates minor hog damage near the crest.

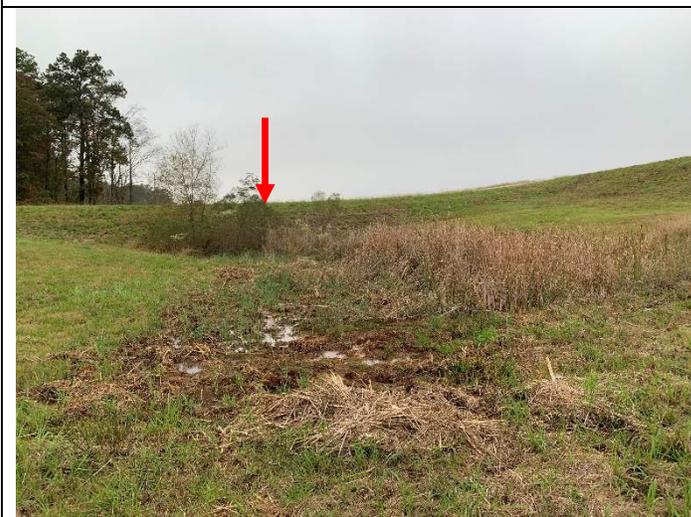
Photograph 17: West Bottom Ash Pond

Low area with ponded water at exterior toe of south embankment, southeast corner of pond. Arrow points to access embankment in the background.

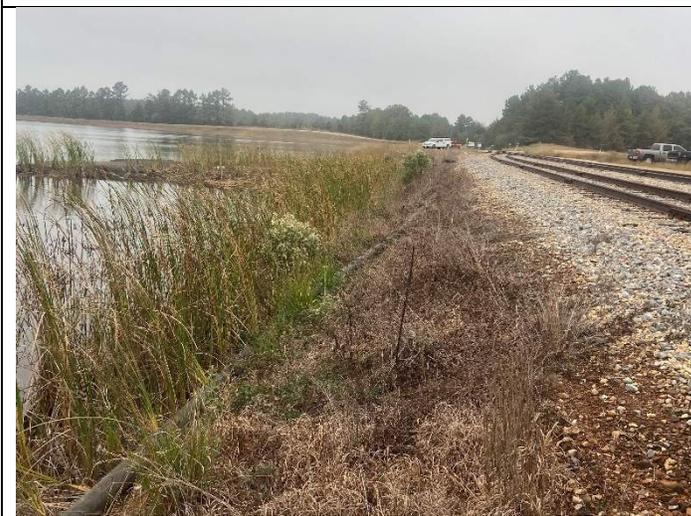
Photograph 18: West Bottom Ash Pond

View of interior slope along east side of pond, looking north.
