2020 Annual Landfill Inspection Report

Landfill

**Rockport Plant
Indiana Michigan Power Company
Rockport, Indiana**

Document ID: GERS-20-025

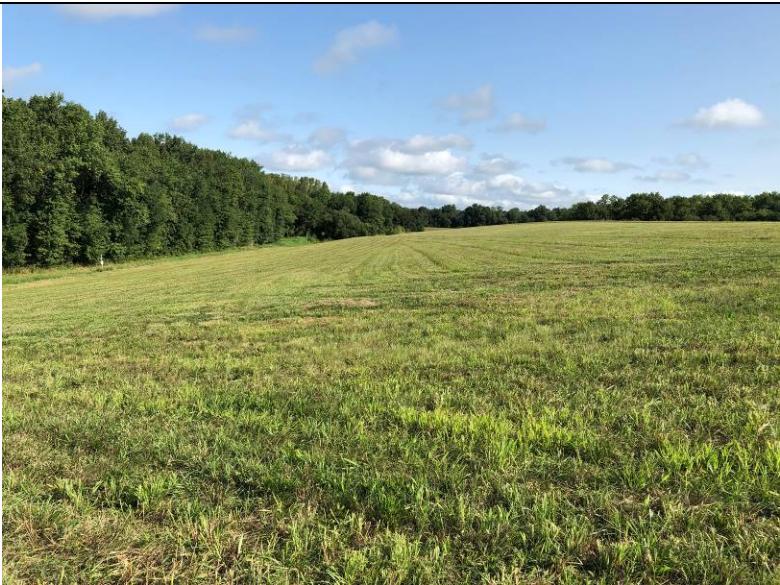
Photograph 1:

1. The closed landfill area was observed to have a thick grass cover over the entire capped area that had recently been mowed. There were no signs of settlement, signs of movement or distress of the landfill area. The closed landfill area was in good condition and well maintained. The closed landfill area had been mowed the day before the inspection.
2. There was an area of erosion occurring on the northern edge of a riprap channel adjacent to the landfill access road. The erosion rill was about 2 feet deep.
3. There was an erosion rill noticed where the bench ties into the riprap channel on the southeastern side of the closed landfill area. The erosion rill was about 1.5 to 2 feet deep and was observed on both sides of the riprap channel.

Typical view of the vegetated cap on the closed section of the landfill.

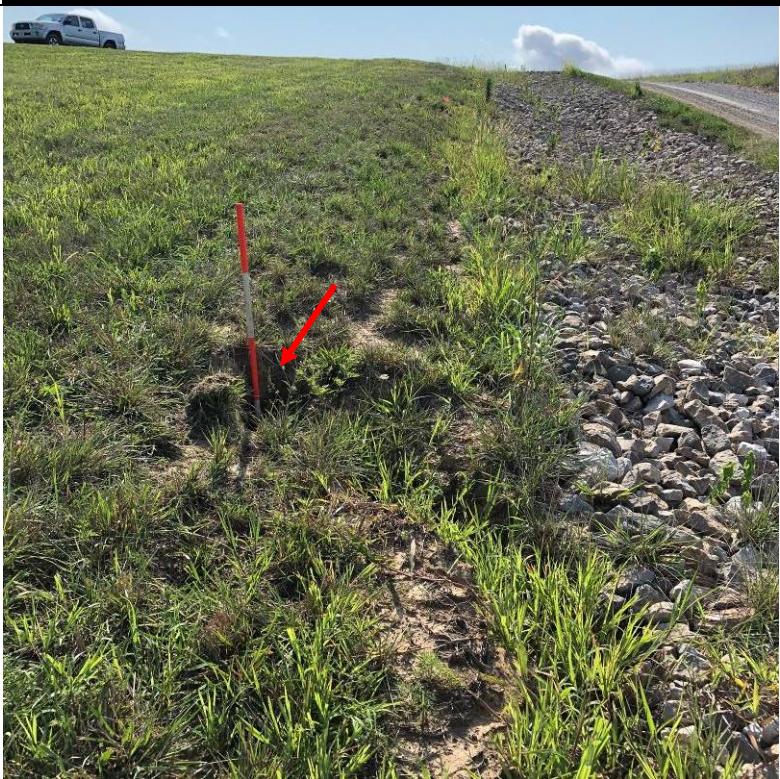
Photograph 2:

View of an erosion rill noted along the edge of a riprap let down channel on the north side of the landfill.

- 1) Repair the small holes in the liner systems for the leachate ponds. These were noted in a few locations the North Pond, West Pond and 002 pond.
- 2) Repair the small erosion rills noted adjacent to the riprap downslope channels located to the north and southeastern sides of the closed landfill section.
- 3) Install flexible sealant in the crack in the concrete lined section of the west pond, located above the leachate discharge pipe.
- 4) Improve the surface drainage to prevent ponding water at the location where the bench meets the riprap let down channel on the southwestern side of the closed landfill.
- 5) Repair the damaged boundary marker near the ditch to the east of the north pond.

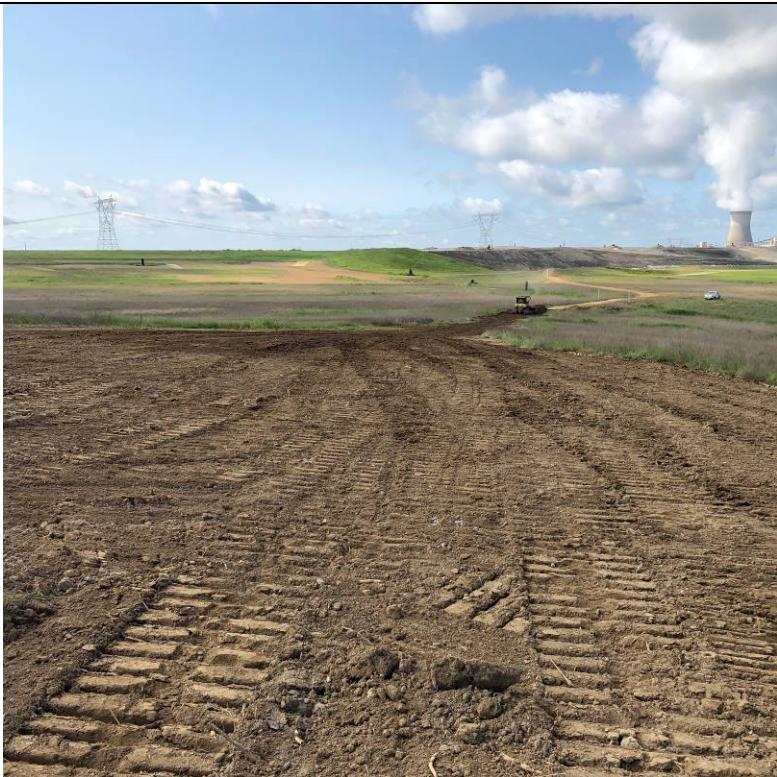
Photograph 3:

1. Maintenance was being performed to improve the vegetation in an area on the northern section of Cell 5 during this inspection. The repairs consisted of removing 1 foot of soil that has been difficult for grass to grow on. The removed soil was placed in the active landfill area as waste. New soil was imported, placed and tracked in with a dozer to match the existing grades. This area is estimated to be roughly 1.5 acres.
2. The surface of Cell 4A and 5 has a soil and vegetative layer which was placed as protective cover in 2017.

View of the maintenance efforts (resoiling) on the north side of cell 5.

- 6) Monitor the small depression adjacent to the access road on the northeast side of the landfill. Ensure that this area does not enlarge and reduce the width of the access road.
- 7) Monitor the recently placed soil at Cells 1A and Cell 5 for erosion after heavy rain events until the grass cover has become established.

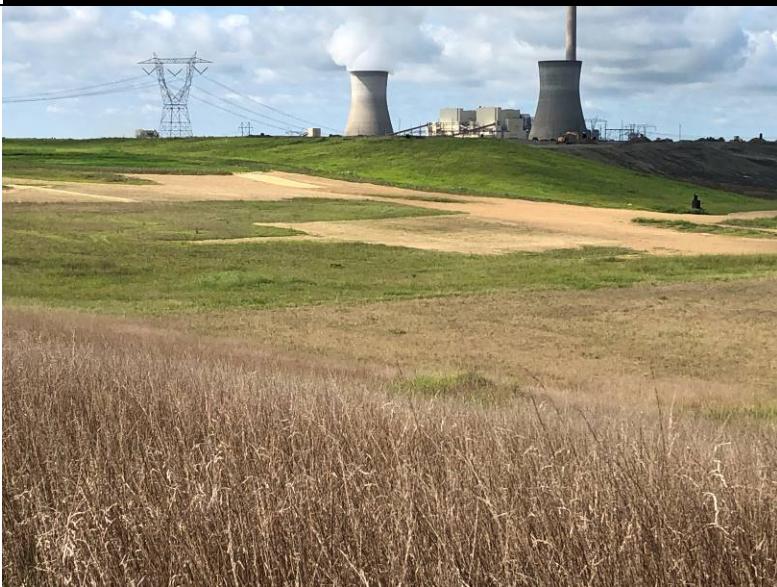
Photograph 4:

1. Recent maintenance efforts to improve the temporary vegetation cover have been completed in Cell 1A. The repairs occurred between June 22 and July 10, 2020. Additional details of the repair are described in a separate report (GERS-20-020). The repair efforts stripped about 1 foot of soil that was difficult for grass to grow. It is believed that the SBC ash leaches upwards through the temporary soil cover and kills the vegetation. In general, the repairs consisted of:
 - Stripping 1 foot of soil and placing in the active section of the landfill as waste.
 - Fresh, new soil was imported and placed, (AKA resoil) and tracked in with a dozer to match the existing grade.
 - Erosion rills were repaired by placing new soil, coconut fiber matting and placement of riprap check dams.
 - All disturbed areas were seeded.

The fresh soil had been seeded and some grass was beginning to emerge. There were no signs of erosion noted on the areas where the grass has not started emerging. This area is estimated to be roughly 3 acres.

View of the completed maintenance efforts (resoiling) on Cell 1A and Cell 1B.

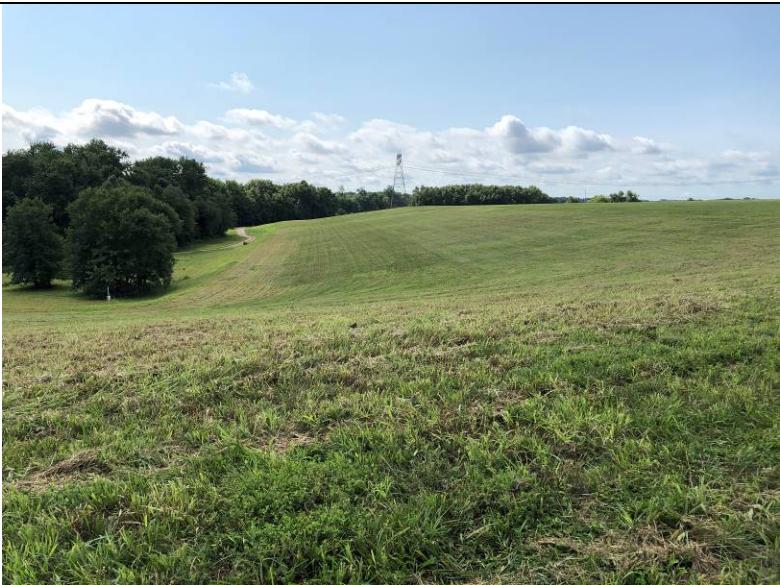
Photograph 5:

Another view of the closed section of the landfill.

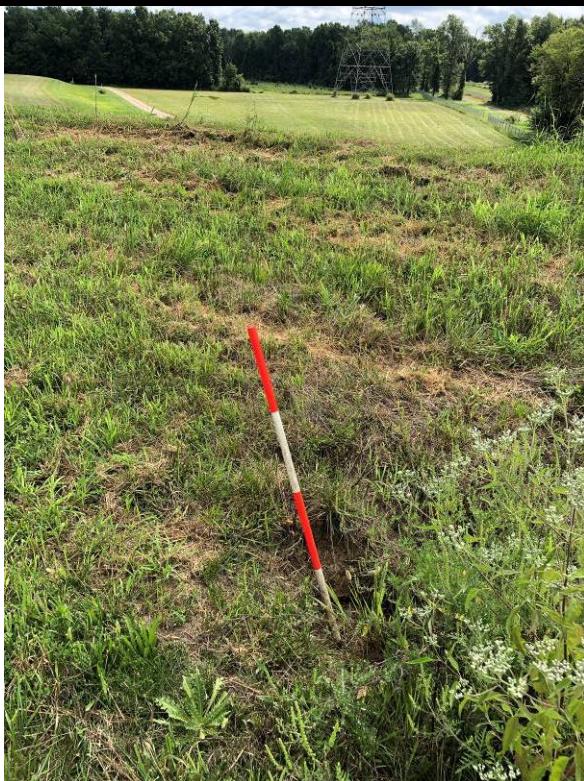
Photograph 6:

View of the erosion rill occurring at the bench/riprap at the southeast corner of the landfill.

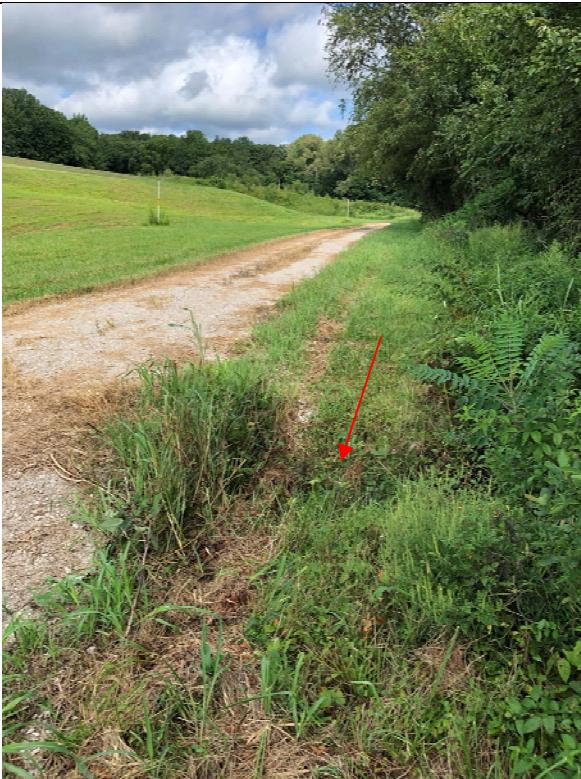
Photograph 7:

4. There was an area of poorly drained soils located where the bench meets the riprap channel on the southwestern corner of the closed landfill area. This was observed on both sides of the riprap channel.
5. There was a small depression associated with a culvert outlet pipe that is on the verge of beginning to cut into the access road width on the northeast perimeter of the landfill. Otherwise, access roads on top and adjacent to the landfill area were in good condition.

View of a culvert outlet under the access road on the northeastern side of the landfill. The depression was about 3 feet deep and was on the edge of cutting into the access road.

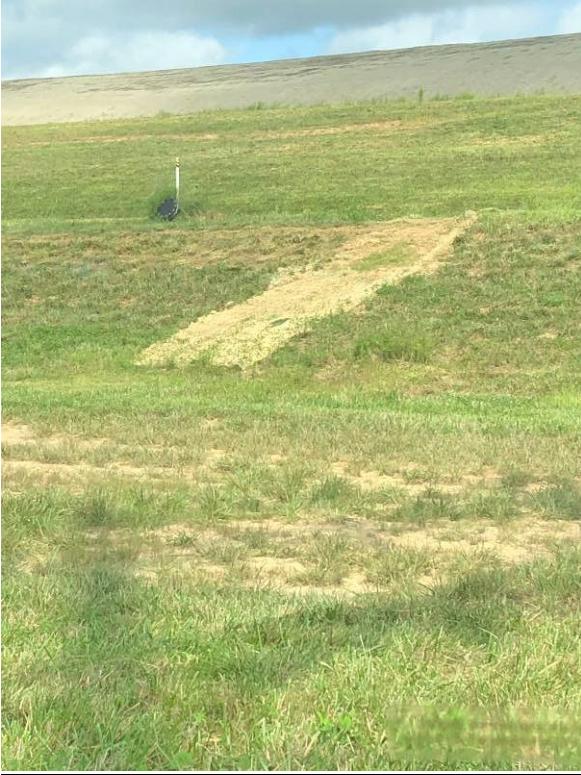
Photograph 8:

1. During the inspection, ash was being placed in the active disposal areas and the ash was being compacted as it was placed. The chimney drains were functioning as designed and there was no pooling of water around the drains.
2. There was a patch of grass cover on the perimeter berm to the south of Cell 2 & Cell 3 that had been repaired by seeding and installing straw matting.

View of a bare area that was reseeded and a straw matting applied. This area is on the perimeter berm on south side of the active landfill area.

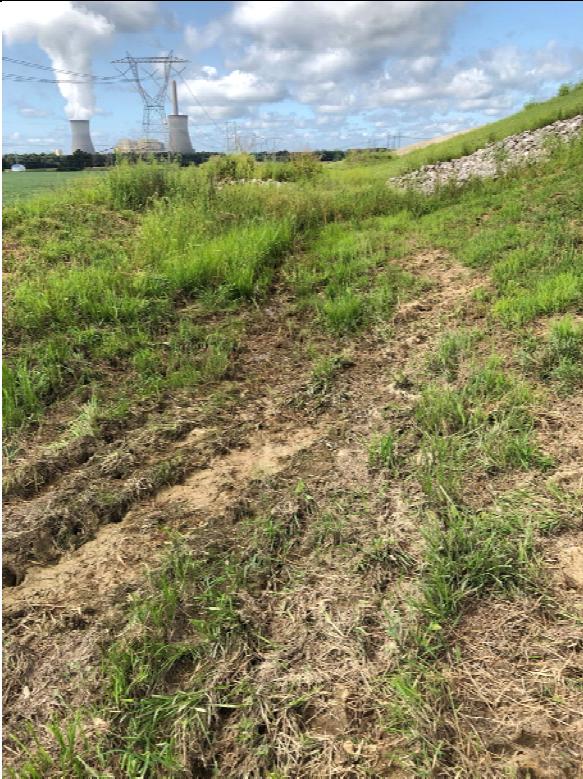
Photograph 9:

View of poor drainage area where the bench meets the riprap let down channel on the south side of Cell 1B.

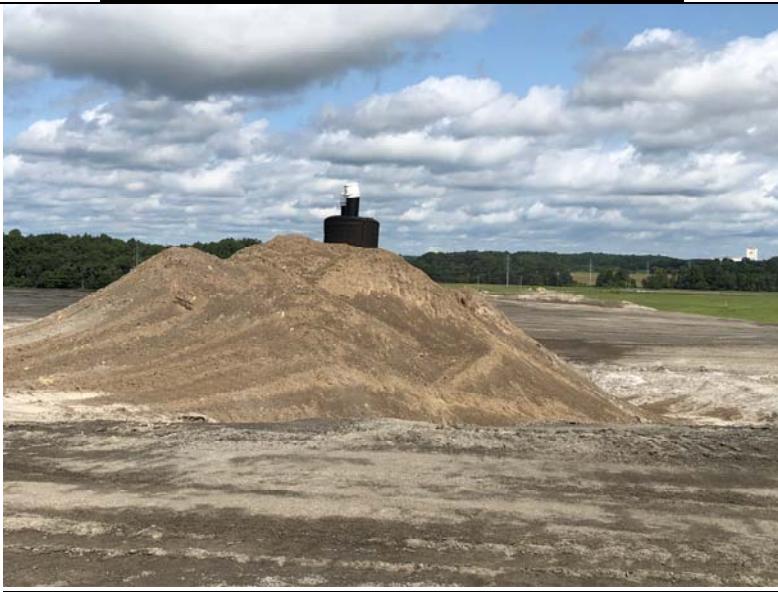
Photograph 10:

View of chimney drain construction in the active section of the landfill.

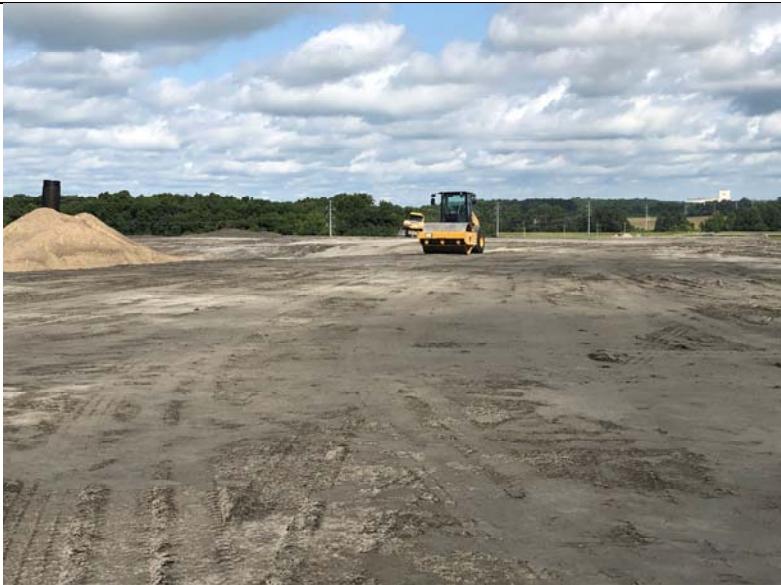
Photograph 11:

View of the active ash placement.

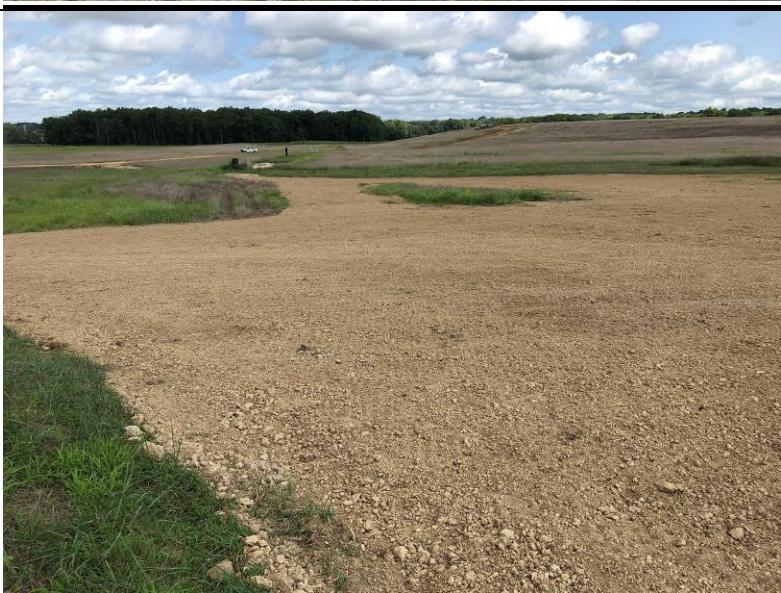
Photograph 12:

View of the completed maintenance efforts (resoilng) on Cells 1A/1B.

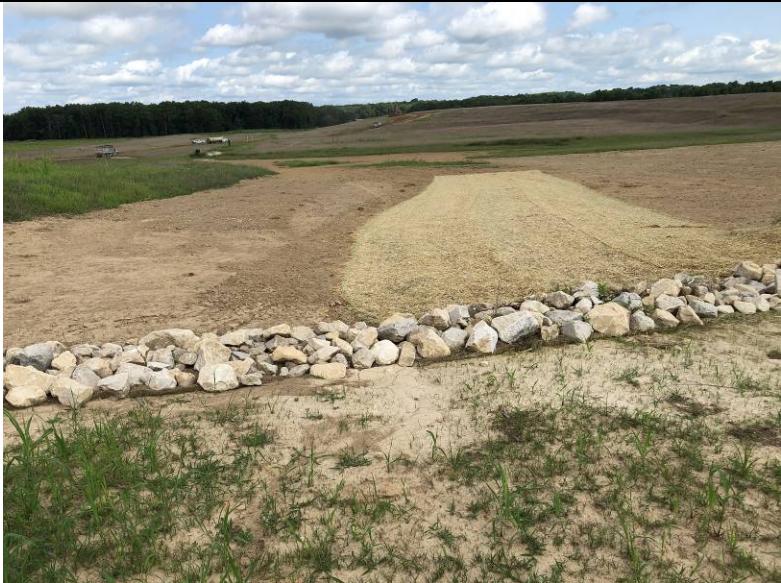
Photograph 13:

View of a check dam completed on Cells 1A/1B.

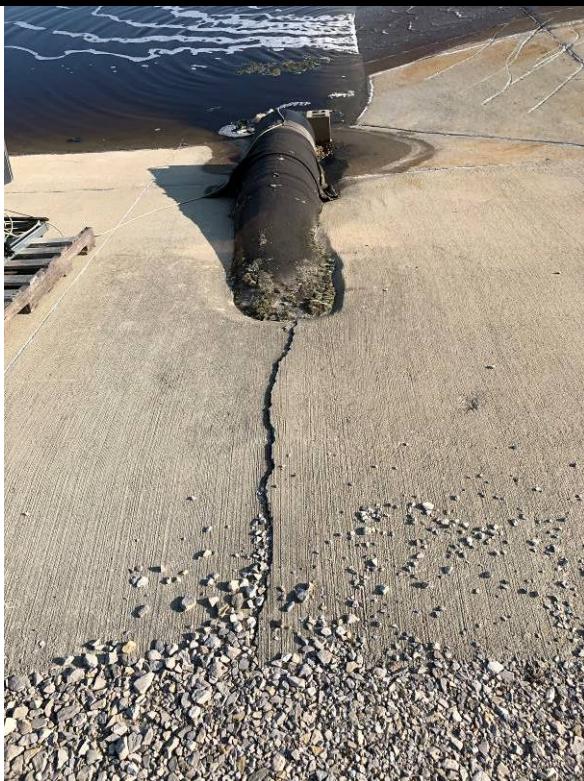
Photograph 14:

5. A small crack in the concrete liner of the West Pond was observed, and is located just above the leachate outlet pipes entering the pond from the south. There was about 3/8 inch vertical offset across this crack.

View of a small crack in the concrete lined section of the west pond, above the leachate discharge pipe.

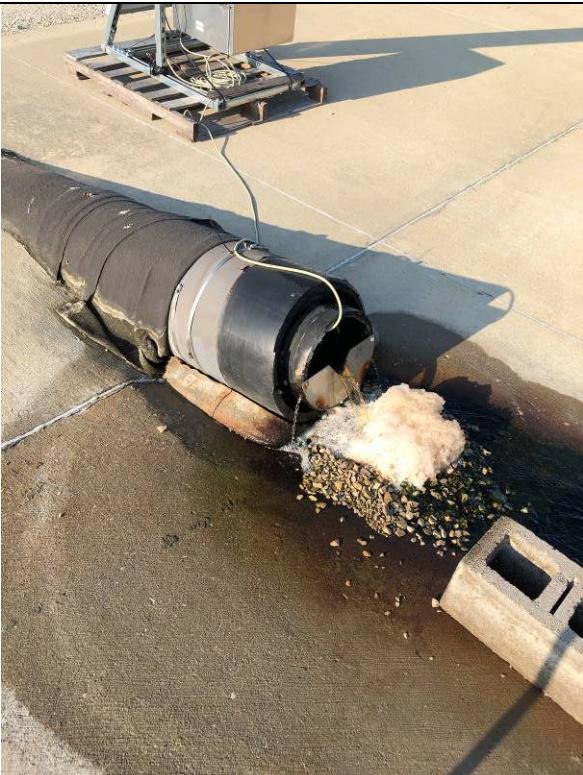
Photograph 15:

4. The West pond concrete lined portion was operating with about 4 feet of freeboard. The concrete lined section in general is in good condition with no signs of damage. A new flow measuring sensor has been placed at the leachate collection system discharge into the ponds from the south.

View of the flow measuring equipment installed on the leachate discharge pipe coming into the west pond.

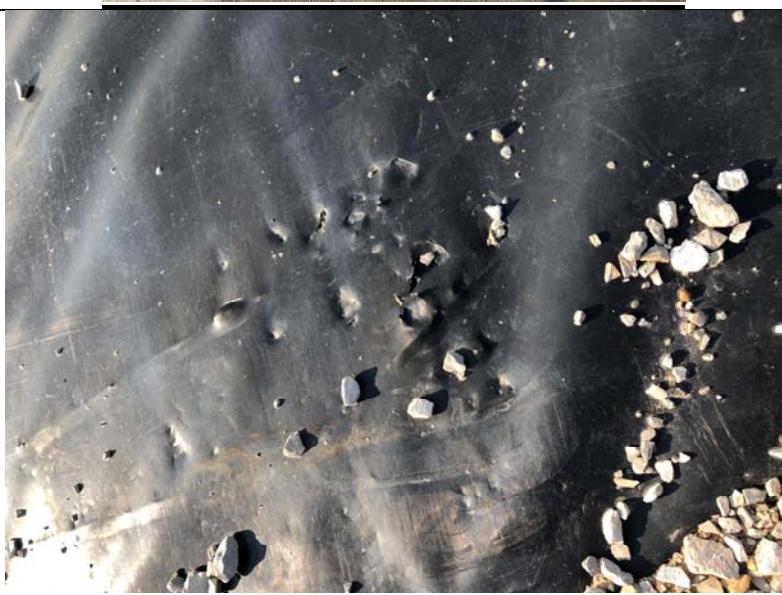
Photograph 16:

3. Several small holes in the exposed liner system were observed at both the North Pond, the West Pond and 002 Pond. With the exception of one area at the North Pond, these holes are well above the leachate water level, close to the edge of the gravel drive. In general, these holes were about an inch in diameter or less. There was one area at the North Pond, close to the leachate sump, where a circular liner patch appeared to be separating from the liner and was a few inches under the leachate pond level.

View of small holes in the exposed membrane section of the west pond.

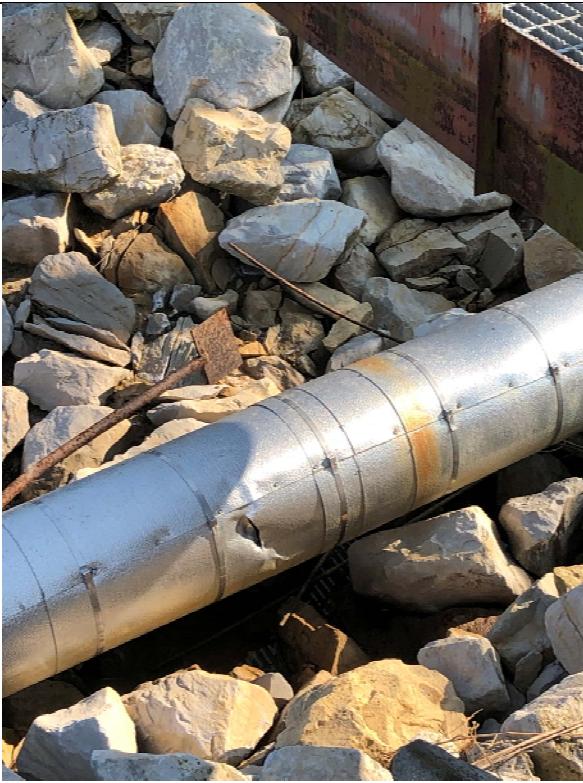
Photograph 17:

6. The 002 Pond was generally in good condition. A few holes or tears were visible on the exposed liner.
7. There was a small gash observed in the metal shielding wrapped around the leachate discharge pipe exiting 002 pond. This metal shielding is only to protect the pipe from the elements and does not impact the pipes ability to convey the pond discharge. Further, the leachate pond discharge pipe can function as designed.

View of a small gash in the metal shielding around the discharge pipe coming out of pond 002, heading towards outfall 002.

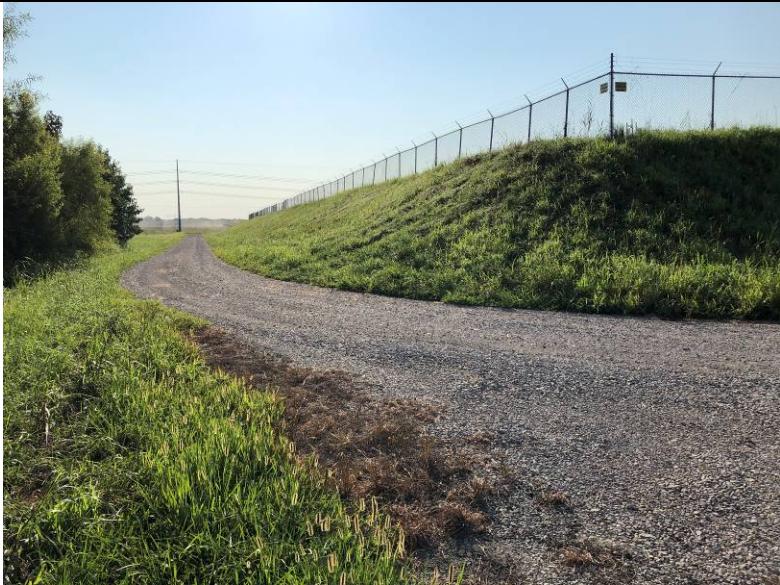
Photograph 18:

View of the exterior dike of pond 002.

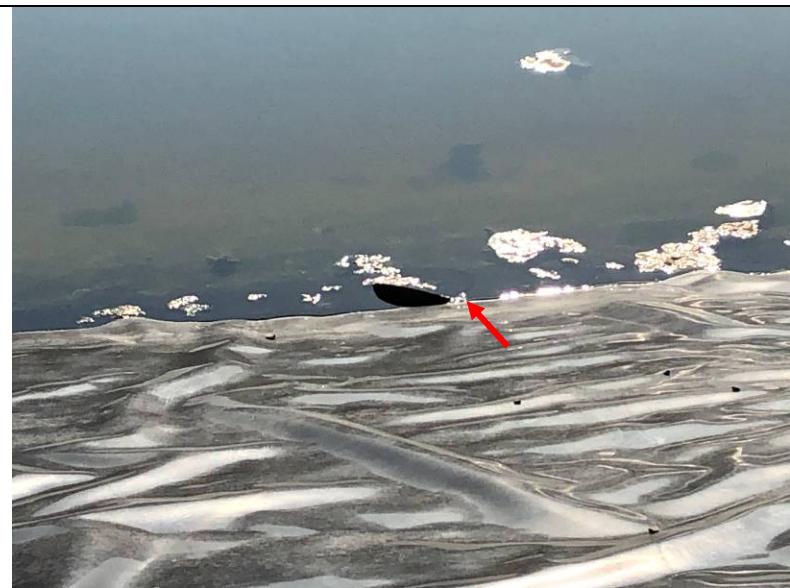
Photograph 19:

View of a circular patch coming off the liner at the north pond, near the leachate sump.

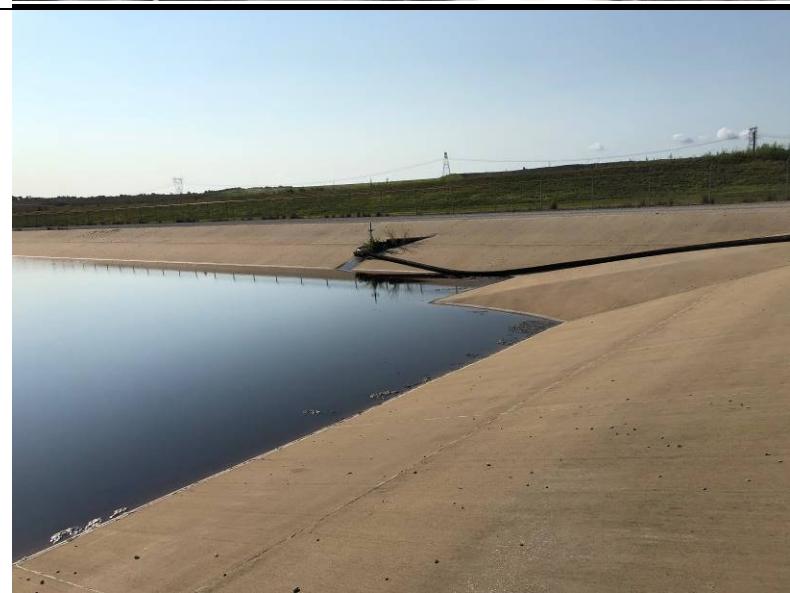
Photograph 20:

2. The concrete lined cell did not appear to have any signs of damage, cracks or spalling. There were no signs of blockage of the inlet and outlet piping. The fence surrounding the leachate pond was in good condition.

View of the concrete lined section of the north pond.
