2020 Annual Landfill CCR Inspection Report

Class 3N Landfill

Turk Power Plant

Document Number: GEVR – 20 – 022

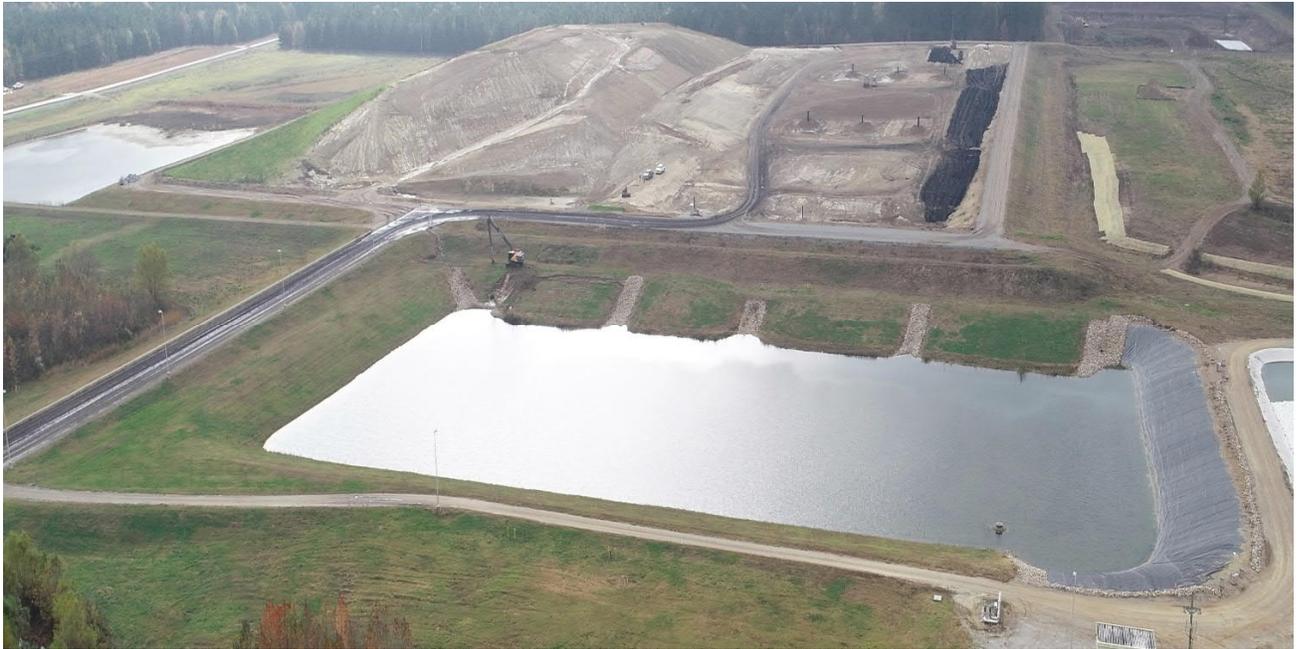
1. The overall layout of the leachate pond is shown in **Photograph 1**. The grassed slopes (the north, south, and east slopes) appeared in good and stable condition. Overall, the slopes were vegetated with Intermittent bare spots. Some of the bare spots on the sideslope are where hogs were rooting. There are three leachate drainpipes (southeast, center, and southwest) on the south slope of the leachate pond.

3. As part of the leachate pond improvements, three riprap lined letdown channels were previously installed at the interior slope to manage runoff. The letdown channels area located at the northwest corner, southwest corner, and south slope of the pond. **Photograph 1** illustrates typical letdown channel. All the letdown channels appeared to function as designed and appeared in good and stable condition.

1. Leachate Collection Pond looking from the north side.

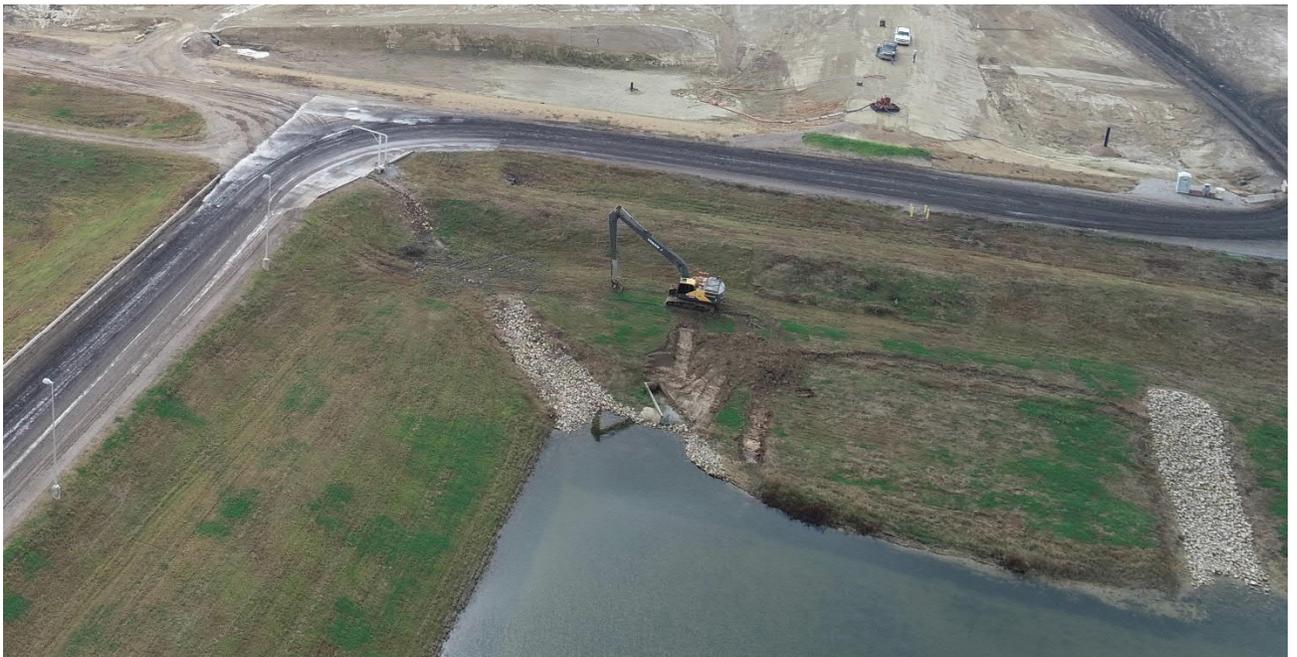
2. Leachate enters the pond from the Cell 1 leachate collection system through a pipe at the southeast corner of the pond. Sloughing in the protective cover on the southeast corner of the leachate collection pond was being repaired (**Photograph 2**). The sloughing on the southeastern slope is shown in **Photograph 3**.

1. Overall, the landfill and berms are in good condition. The protective cover in the southeast corner of the leachate collection pond is sloughing and is currently being repaired.
2. The Cell 1 east side intermediate cover had sparse vegetation.

2. The southeast corner of the leachate collection pond that is being repaired.

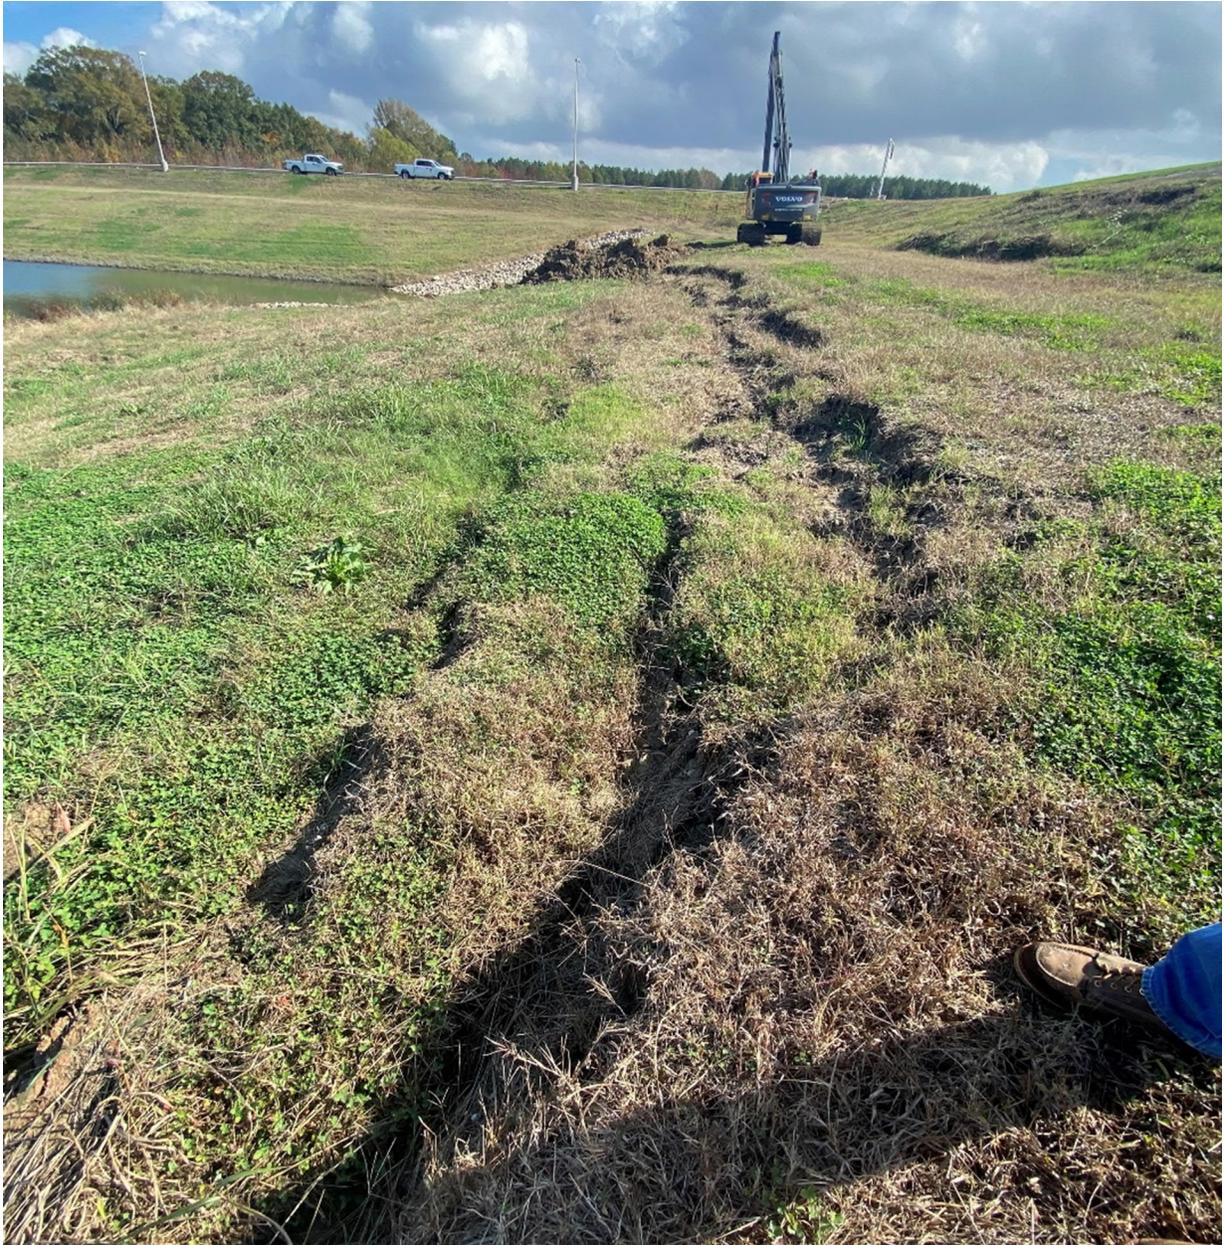
1. Erosion of the intermediate cover on the east side of Cell 1.
2. Sloughing in the leachate collection pond.

3. Sloughing on the southeast corner of the leachate collection pond looking towards the east.

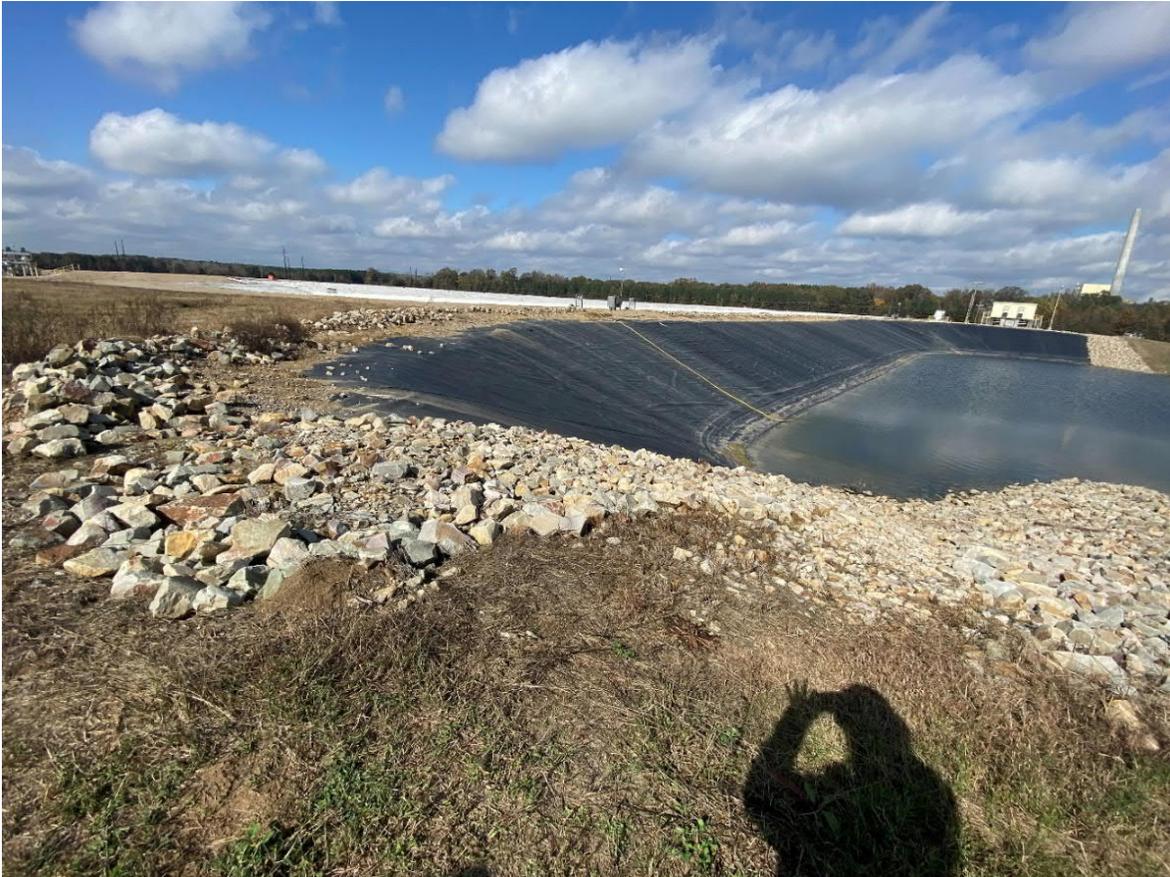
4. The west slope was previously repaired by replacing the vegetated soil cover with a HDPE liner. The slope and the liner appeared in good and stable condition and functioning as design (**Photograph 4**).

4. The west side of the leachate collection pond that has the geomembrane rub sheet.

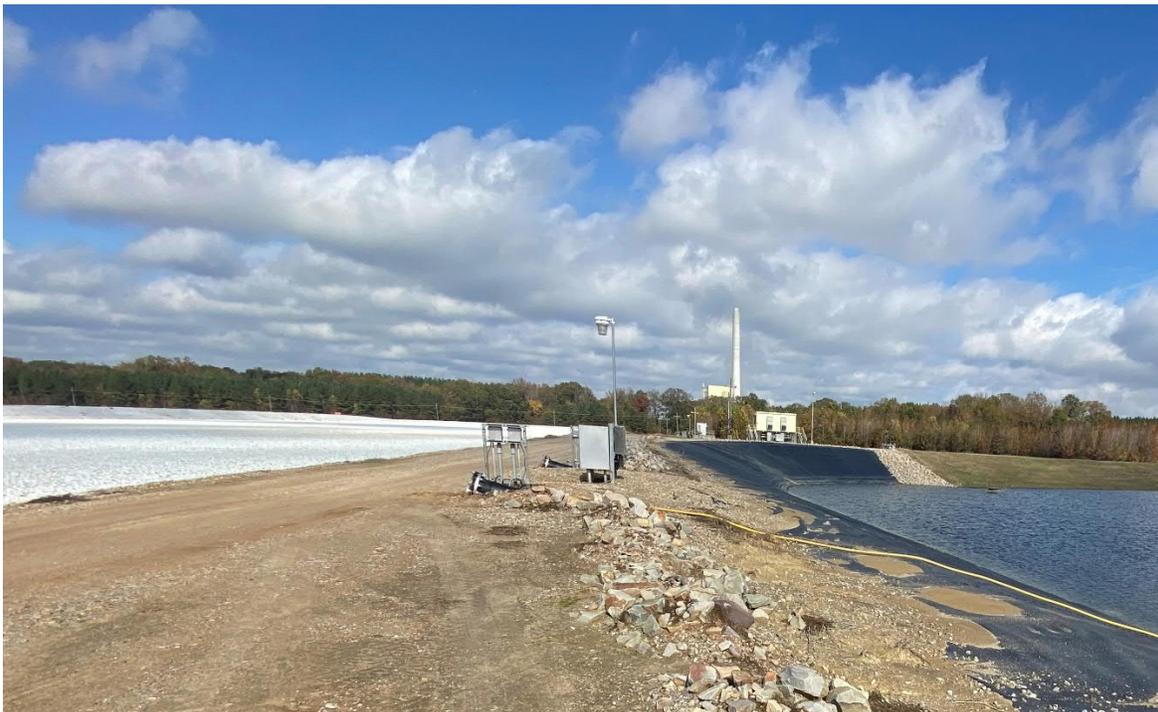
5. The leachate pond has an underdrain pumping system. The pumping system controls can be seen in **Photograph 5**.
6. The leachate pond inlet structure is shown in **Photograph 6**.

5. Underdrain pumping controls on the west side of the leachate collection pond.

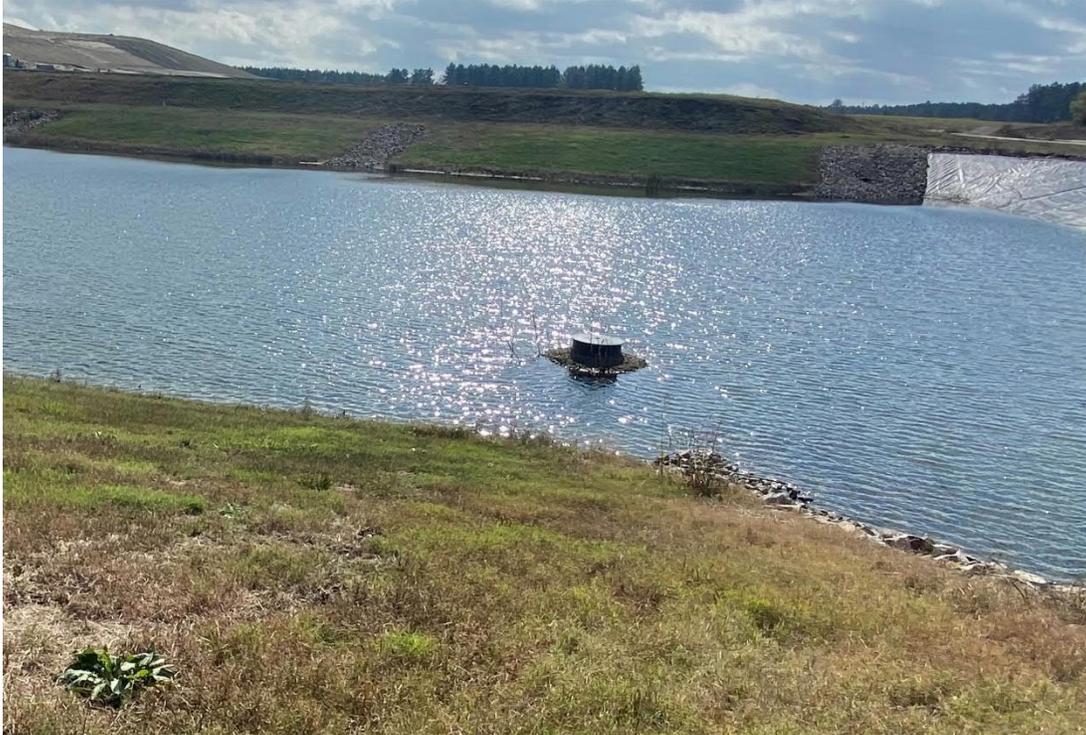
6. Leachate pond inlet structure on the northwest corner of the pond.

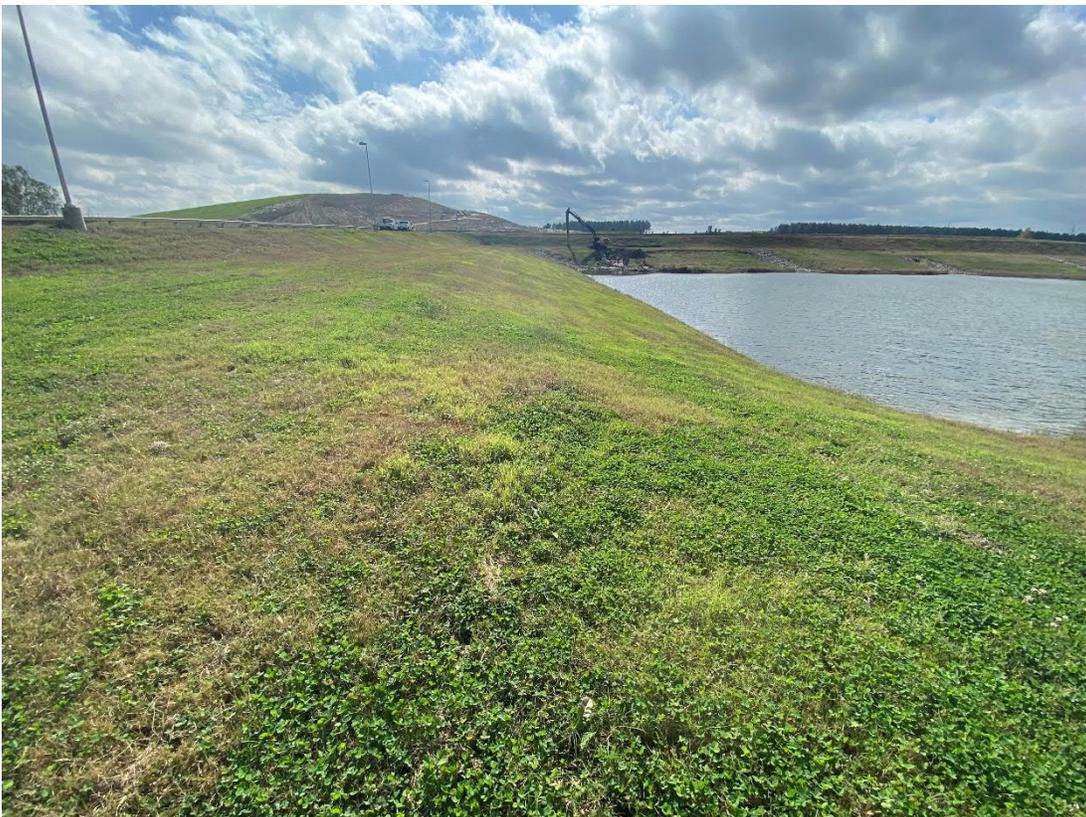
7. The east slope of the leachate pond is shown in **Photograph 7**.

7. East slope of the leachate collection pond facing south.

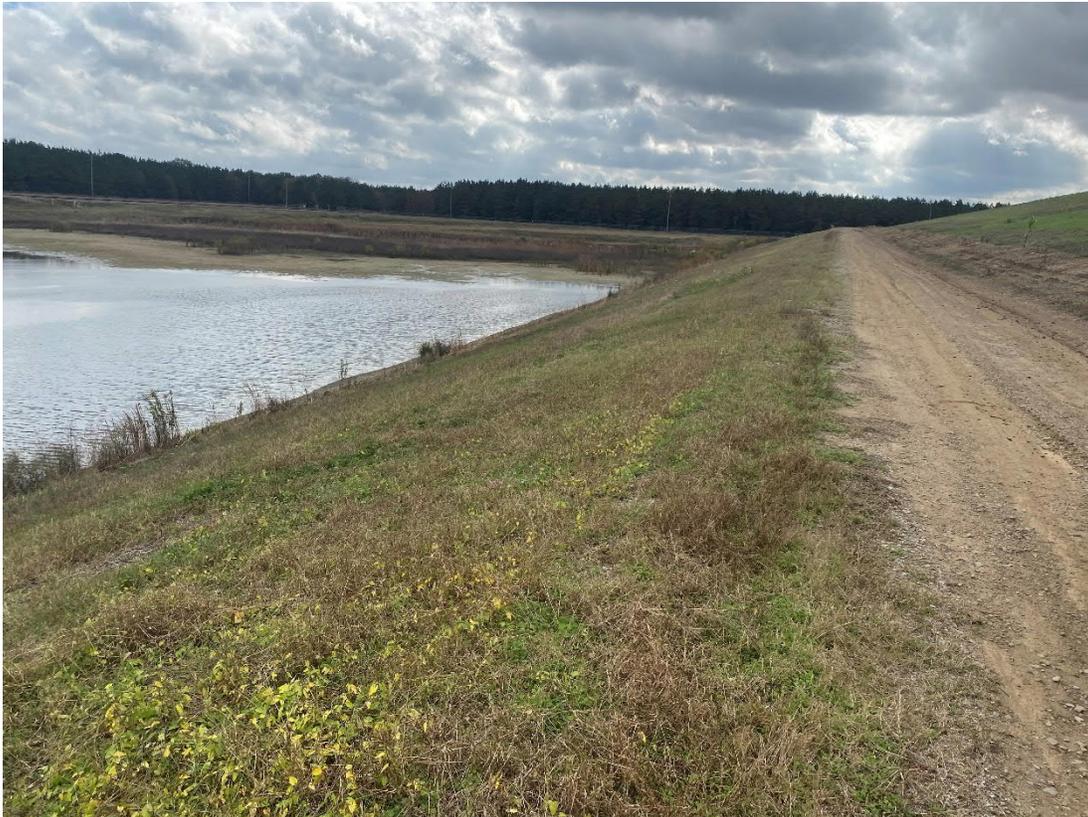
8. **Photograph 8** shows the road and berm on the east side of Cell 1. Intermediate cover was placed on the east side of Cell 1. The berms and slopes appeared in good condition.

8. The east side berm that is between Cell 1 and the stormwater pond.

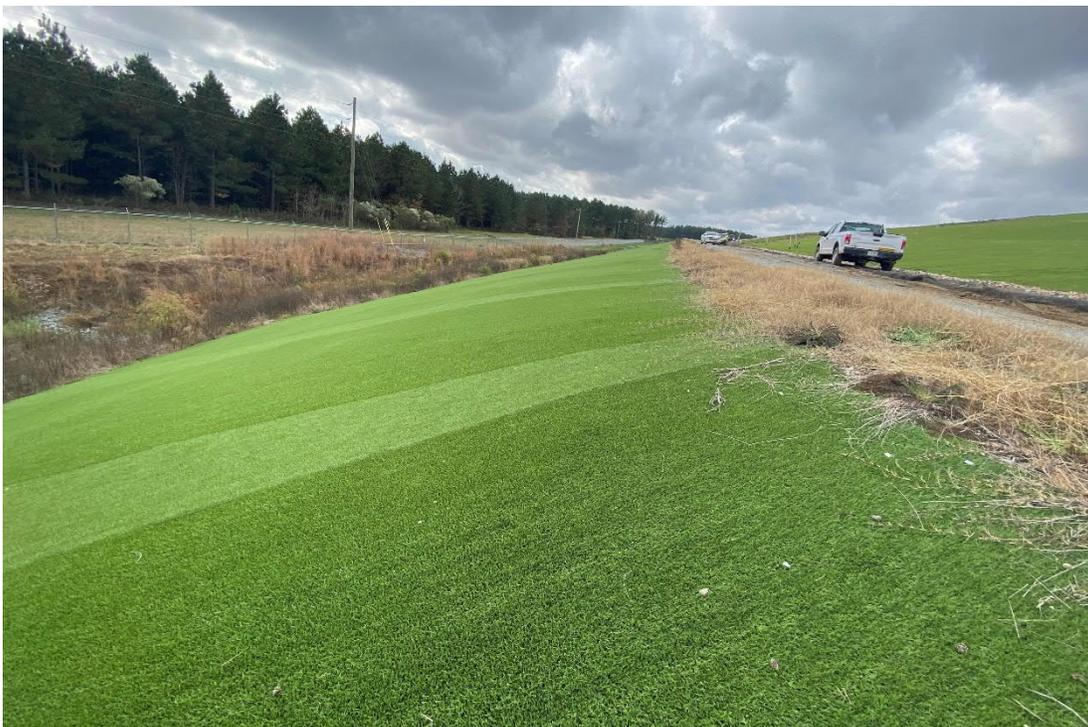
9. The south side of Cell 1 has the closure turf test pad on the south slope and has an artificial turf on the southern perimeter ditch's north slope (**Photograph 9**). The slopes looked in good condition.

9. South side berm that is covered with artificial turf below the closure turf test pad.

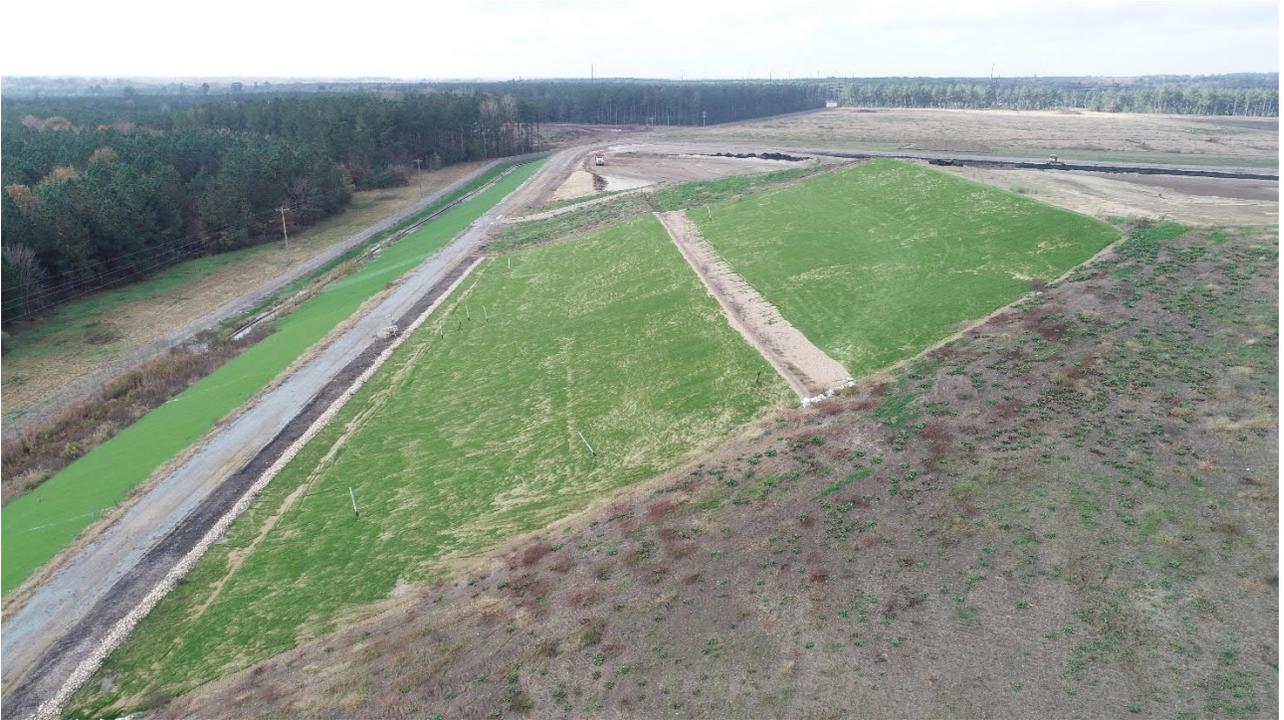
10. **Photograph 10** shows the artificial turf on the stormwater ditch sideslope to the south of Cells 1 & 2. The east side of the closure turf test pad ties into the intermediate cover placed on the east side of Cell 1. The vegetation is sparse on the east side intermediate cover.

10. The closure turf test pad located on the south side of Cell 1.

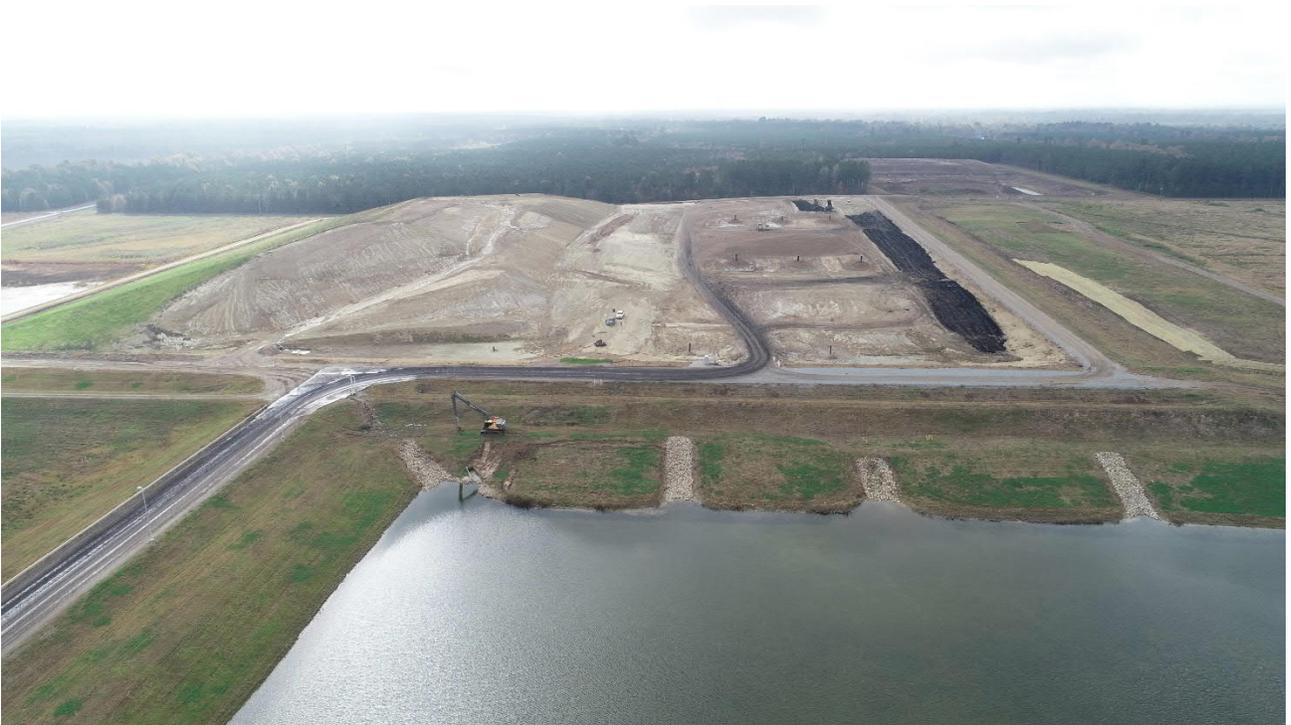
11. **Photograph 11** shows the north side of Cells 1 & 2.
12. Typical condition of the perimeter haul roads is exhibited in **Photographs 12 & 13**. The haul roads around the landfill appeared in good condition with no sign of noticeable settlement, misalignment, and cracks/erosion.

11. The north side of Cells 1 & 2 looking to the south.

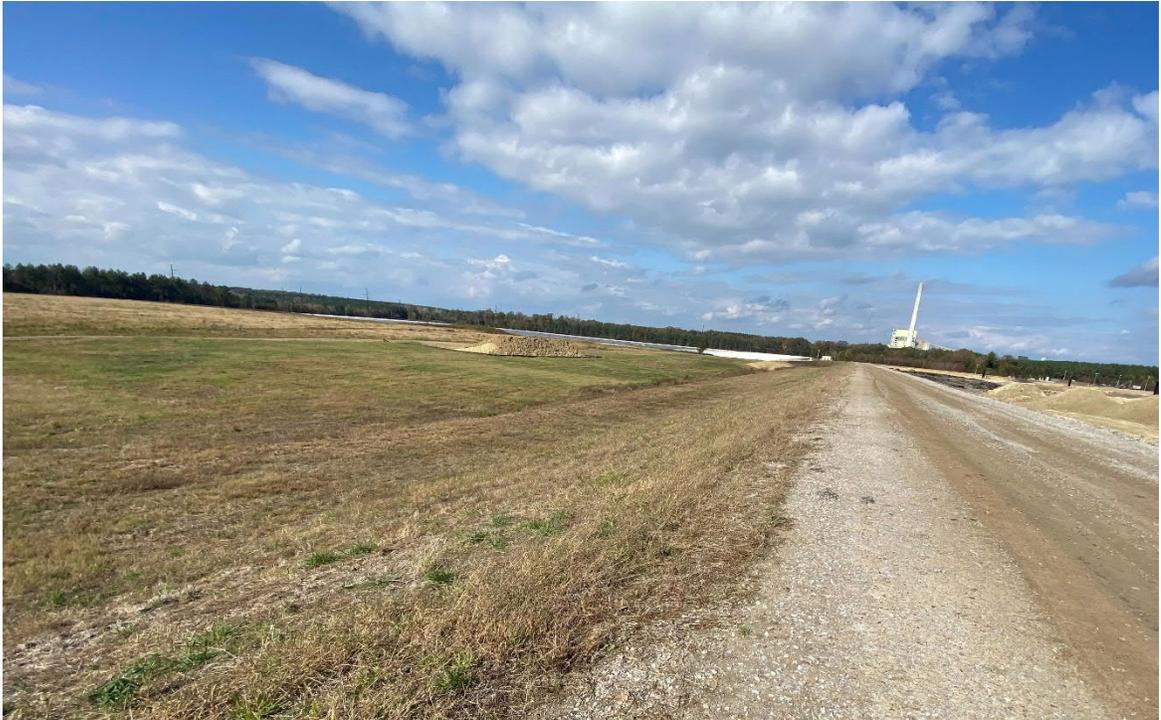
12. Road and berm on the west side of Cell 2.

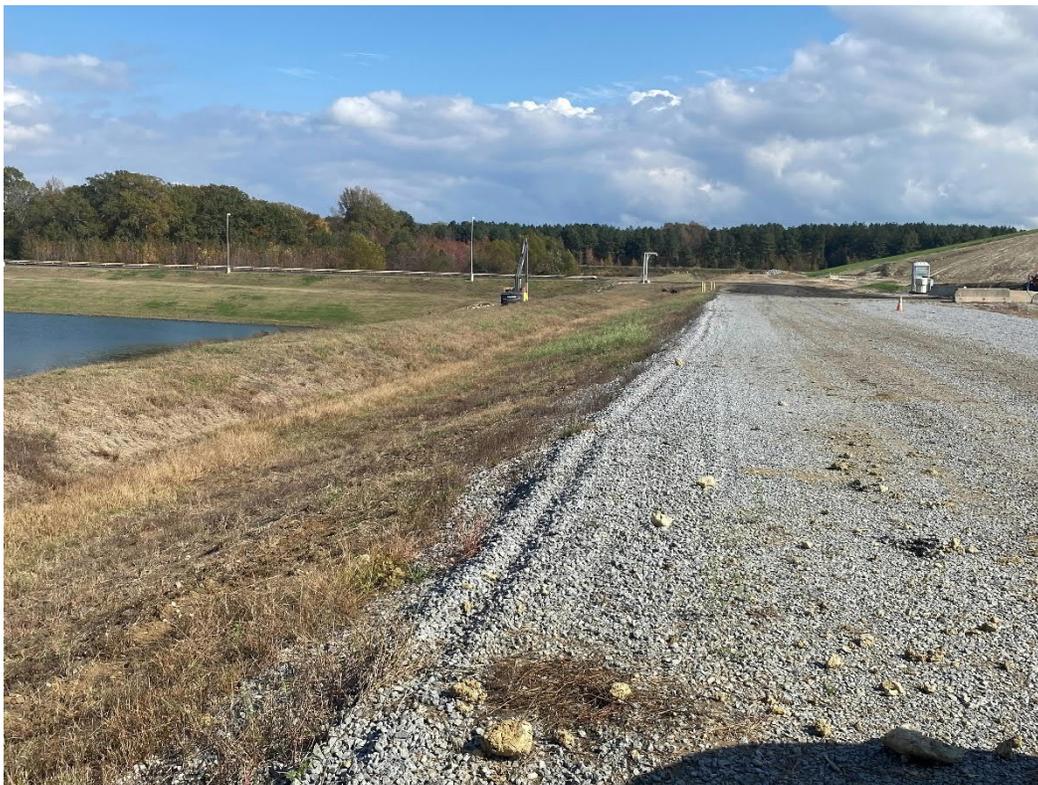
13. Road, berm and stormwater ditch between Cell 2 and the leachate collection pond.

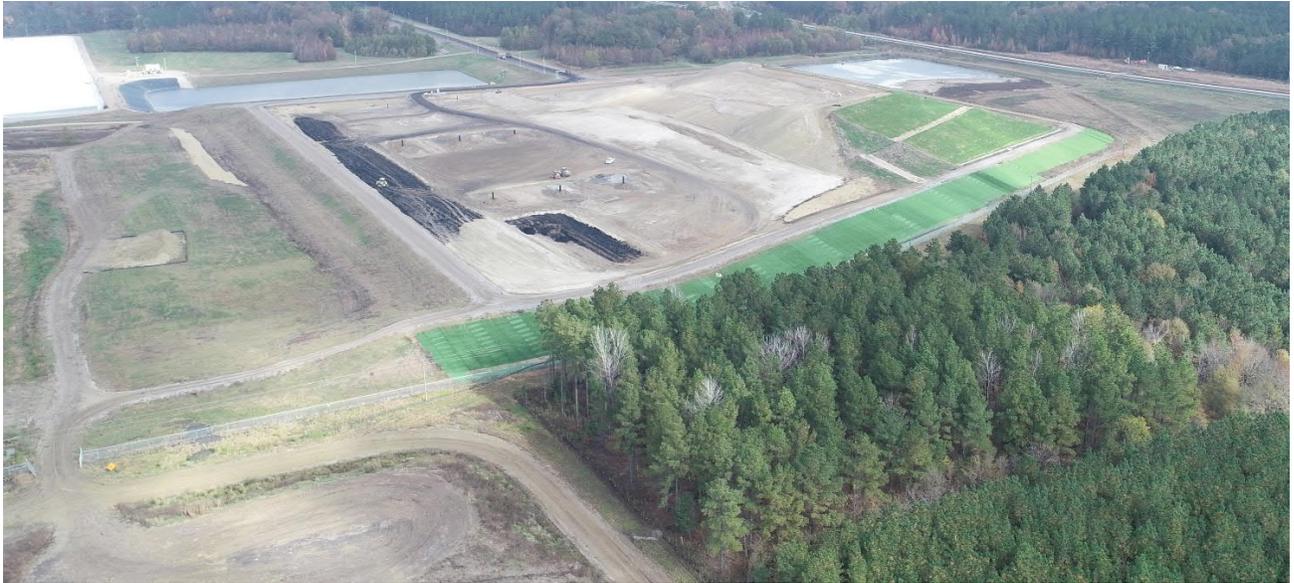
13. **Photograph 14** shows the south side of Cells 1 & 2.

14. The south side of Cells 1 & 2 looking to the north.

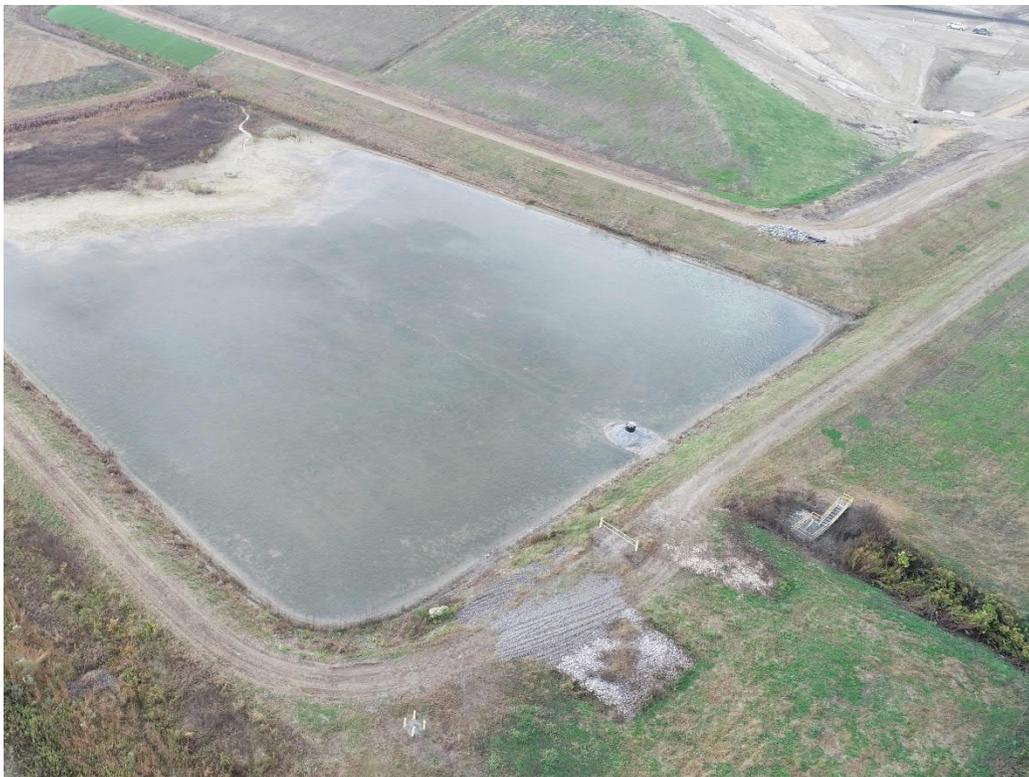
14. **Photographs 15, 16, and 17** shows an overall view of the stormwater pond, the inlet of the overflow discharge structure, and the overflow discharge structure. The stormwater pond and the structures were in good condition.

15. An overall view of the stormwater pond.

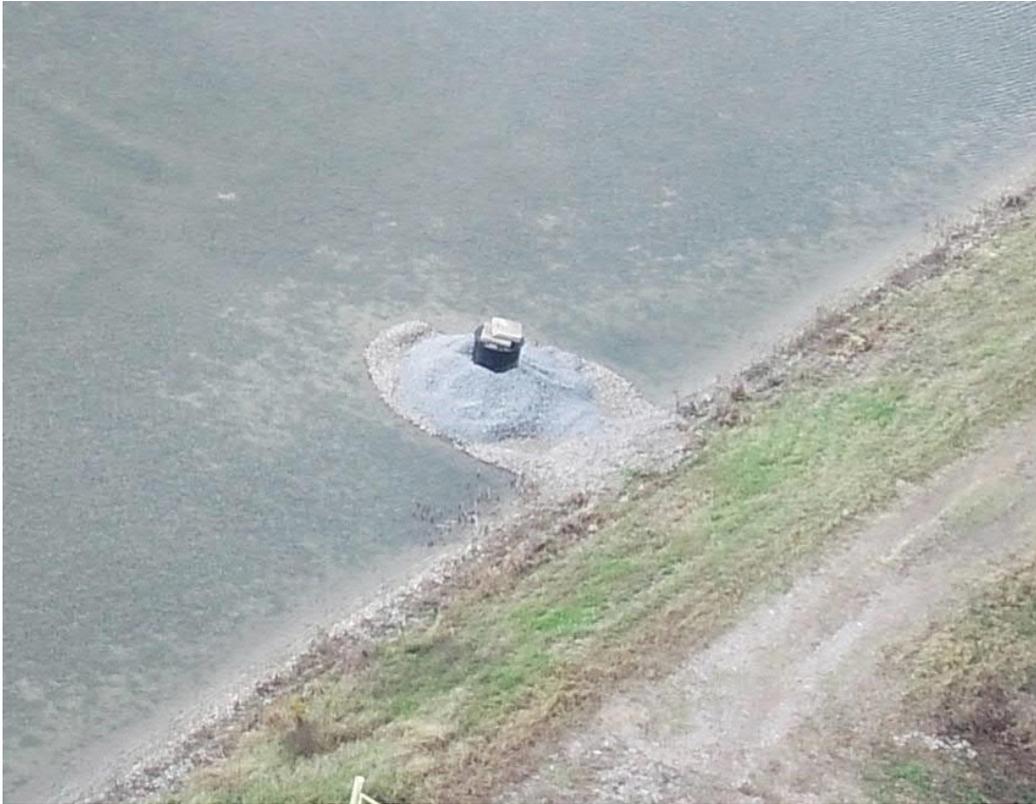
16. The inlet of the overflow discharge structure for the stormwater pond.

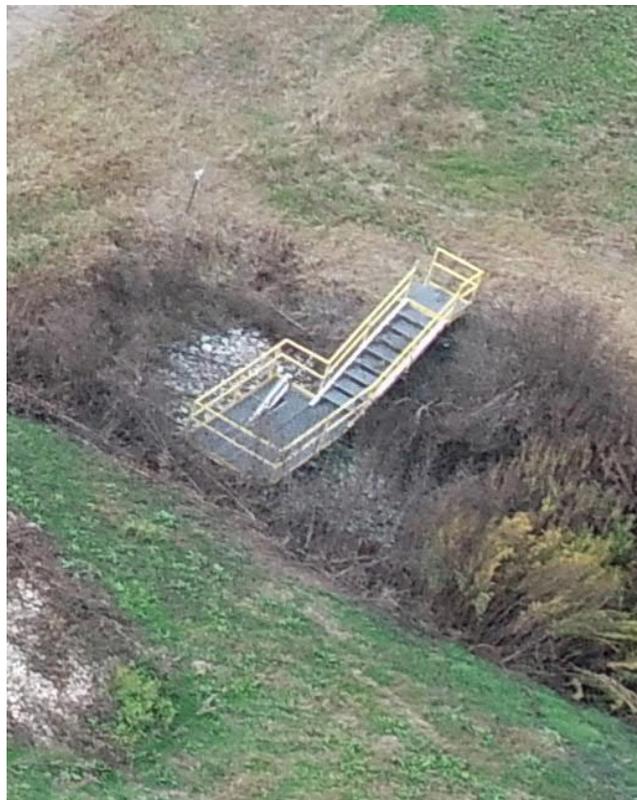
17. The overflow pipe discharge structure for the stormwater pond.
