2020 Annual CCR Landfill Inspection Report

Ash Landfill

Welsh Power Plant

Date of Inspection: November 2, 2020

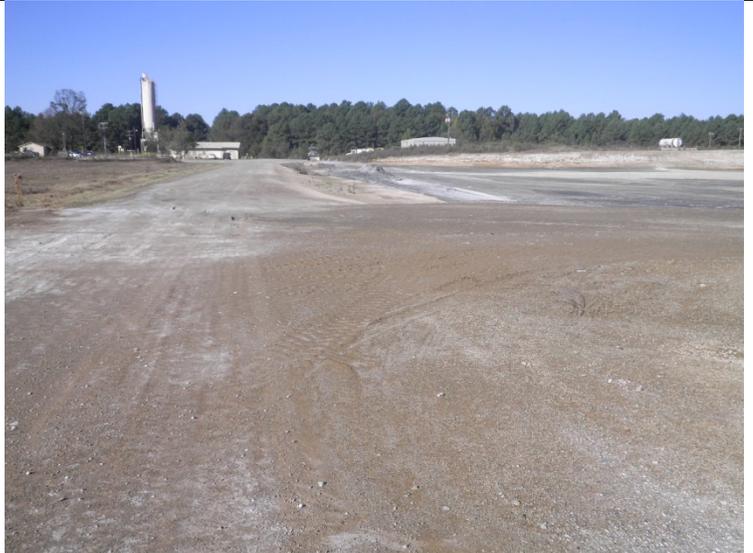
PHOTO #1

1. Photographs No. 1 and 2 illustrate the general condition of the *south side* berm and outer slopes of the landfill. The landfill cover appeared to be in overall good condition with just a few small areas with hog rutting damage (Photograph No. 3).

South berm, looking west

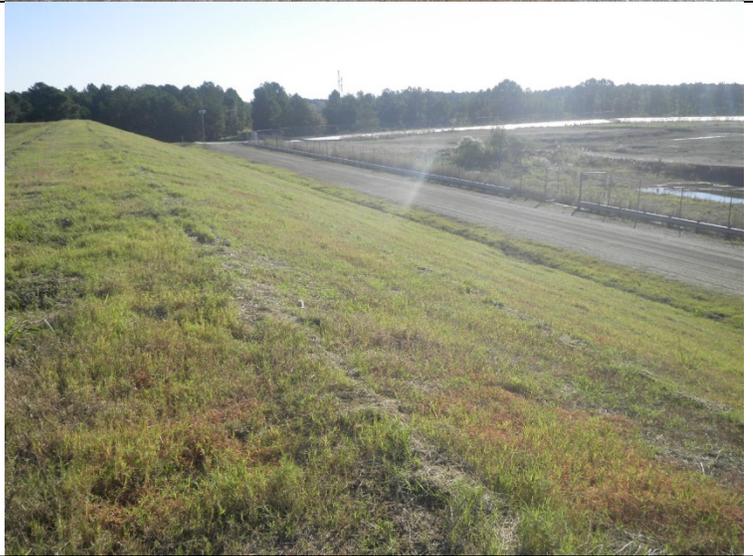
PHOTO #2

South capped and covered berm and slopes, looking east

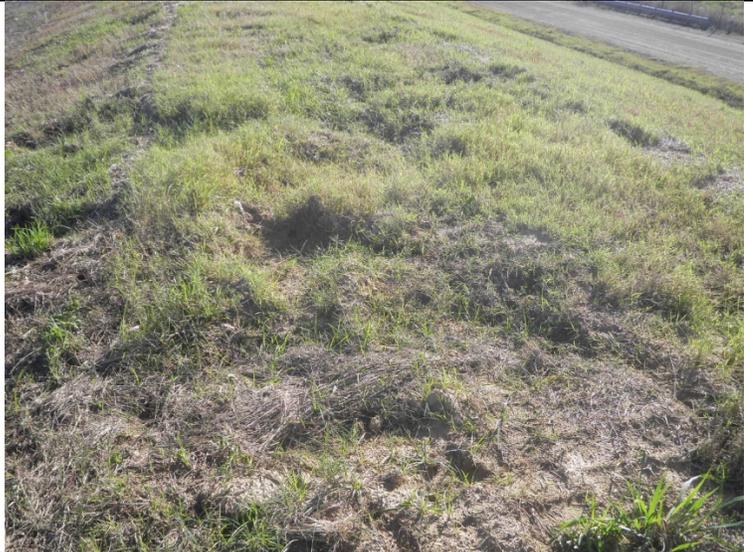
PHOTO #3

Isolated minor hog rutting damage

- 1 The small tear in the HDPE lined letdown in the northeast corner of the landfill should be repaired before it expands.
- 2 The hog rutting damage, minor erosion, and small rills discussed in detail in Section 4.4 should be repaired. Any bare areas should be re-seeded.
- 3 Ponding water was observed in two locations in the perimeter ditches due to minor sediment deposits. The sediment in the ditch needs to be cleaned out in these two areas and positive drainage needs to be established to prevent future significant ponding of water.
- 4 The ash contractor should maintain positive drainage over the processing area of the landfill.

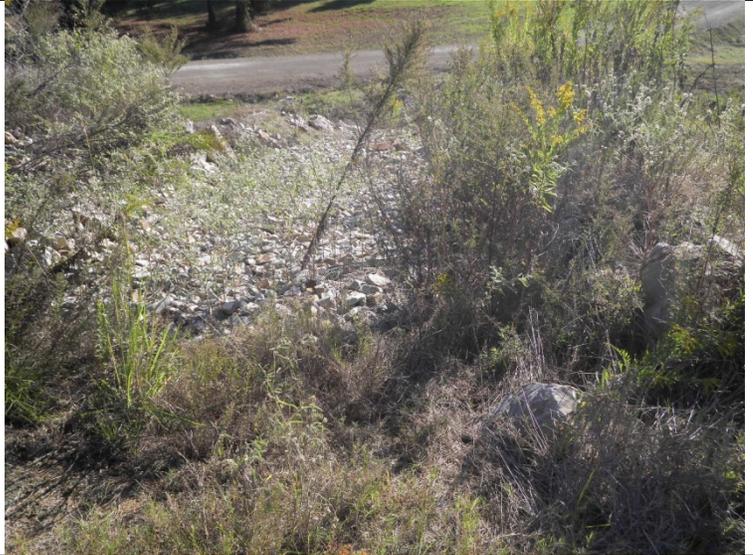
PHOTO #4

2. Photograph No. 4 illustrates the southeast corner of the landfill where the rip-rap lined letdown channel is located, which appeared to be in good, functional condition. There was some minor erosion and overgrown vegetation present.

Rip-rap lined letdown in southeast corner, overgrown vegetation

- 5 Vegetation growth on the newly capped and covered slopes is generally good, but there were some areas that had excessive vegetation that needs to be cut down, especially around letdowns and intermediate slope benches. Any bare areas should be re-seeded.

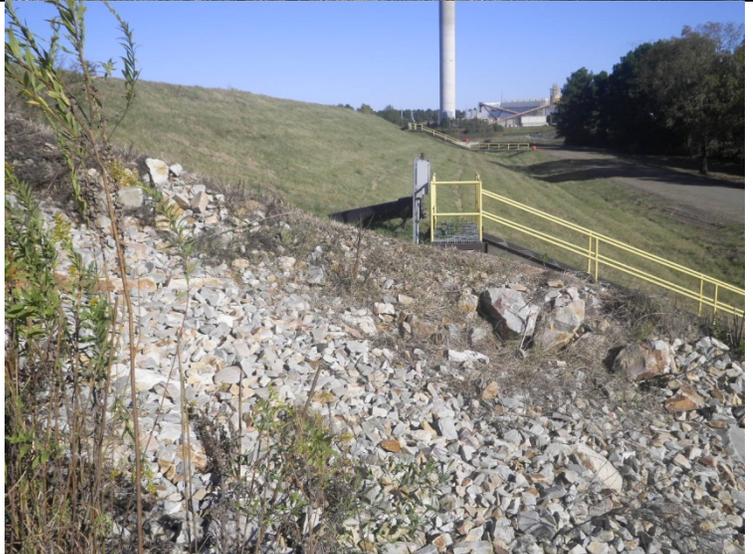
PHOTO #5

3. Photograph No. 5 illustrates the general condition of the *east side* berm and outer slopes of the landfill. The landfill cover appeared to be in overall good condition. An area of the toe ditch downstream of the northern access walkway had standing water, as shown in Photograph No. 6. There also was some minor erosion downstream of this area just upstream of the outlet in the northeast corner of the landfill. It appears that the ditch from the ponded water to the outlet could be re-graded to maintain a positive slope for the ditch, which would also mitigate the erosion.

East capped and covered berm, looking north

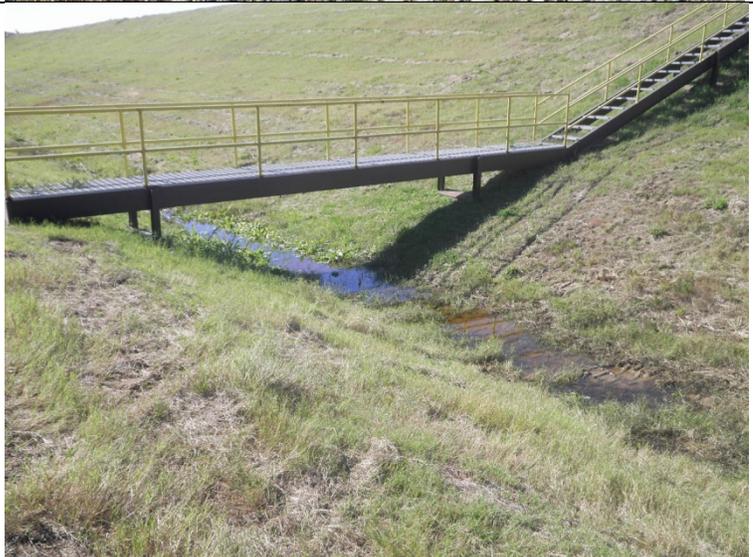
PHOTO #6

Ponding in eastern toe ditch

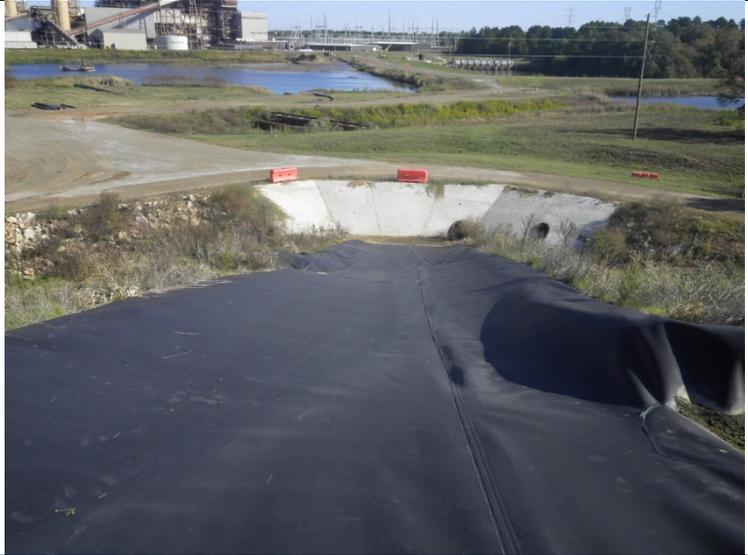
PHOTO #7

4. Photograph No. 7 illustrates the HDPE-lined letdown in the northeast corner of the landfill. This system is functioning as designed. There was a very small tear in the liner, as shown in Photograph No. 8, which should be repaired before it expands. However, this liner is for storm water purposes only, so this is simply a maintenance item and not considered a deficiency.

HDPE-lined letdown in northeast corner

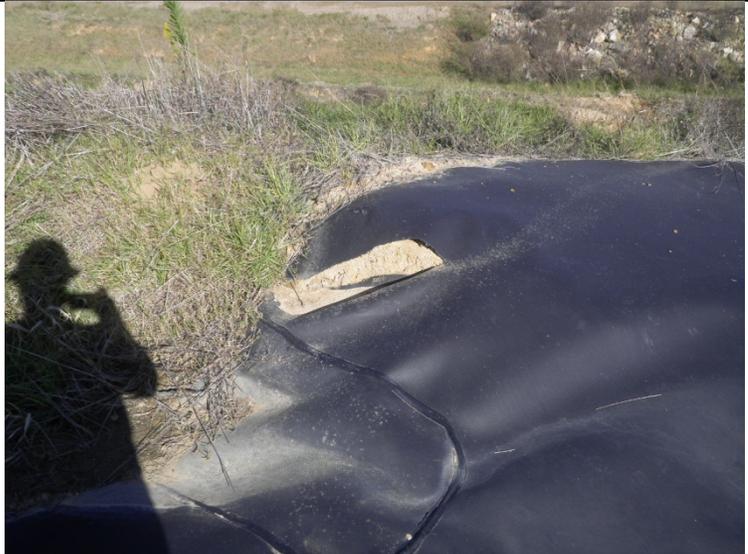
PHOTO #8

Small tear in letdown

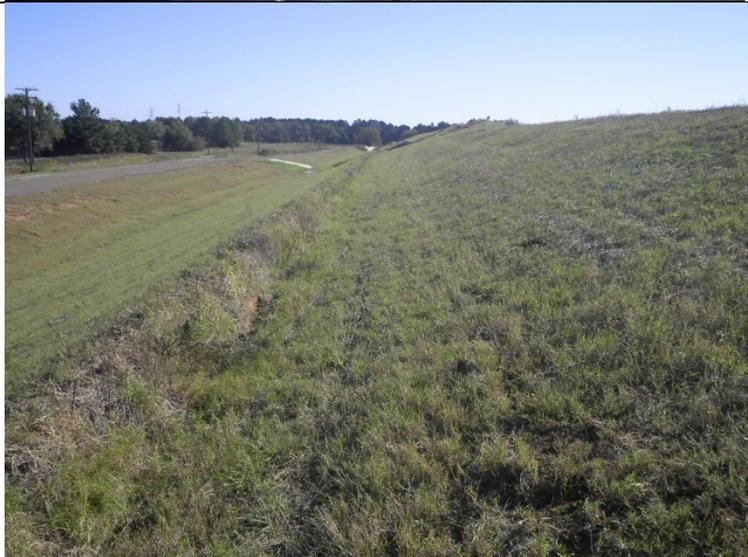
PHOTO #9

5. Photograph No. 9 illustrates the general condition of the *north side* berm and outer slopes of the landfill. The landfill cover appeared to be in overall good condition. Only minor rills were observed along the toe of the slope in the perimeter ditch. Photograph No. 10 illustrates the HDPE-lined letdown in the middle of the north slope, which was recently repaired. There was some silt located in the bottom of the letdown from

North capped and covered berm, looking east

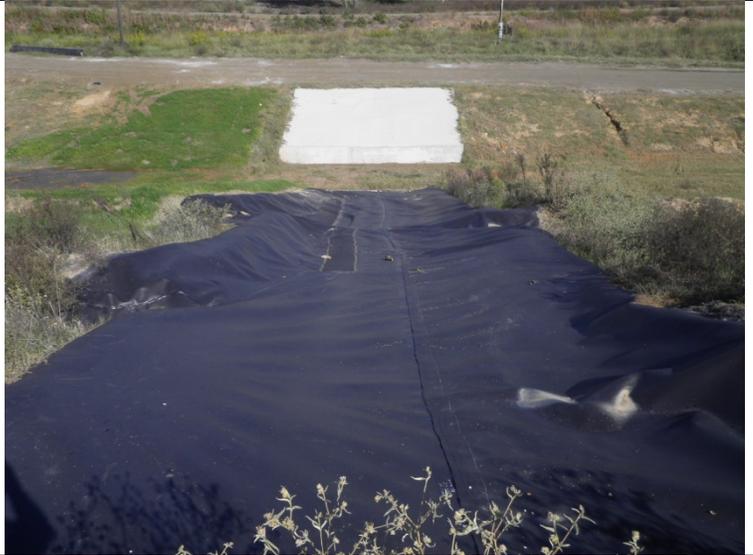
PHOTO #10

HDPE-lined letdown in center of north slope

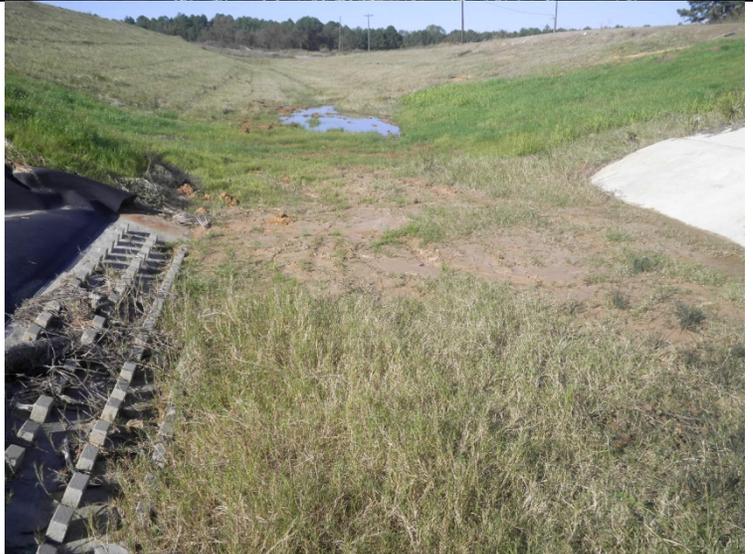
PHOTO #11

previous erosion that is causing water to pond in the perimeter ditch, as shown in Photograph No. 11. This silt should be removed to maintain positive drainage.

Silt in bottom of letdown causing minor ponding in upstream toe ditch

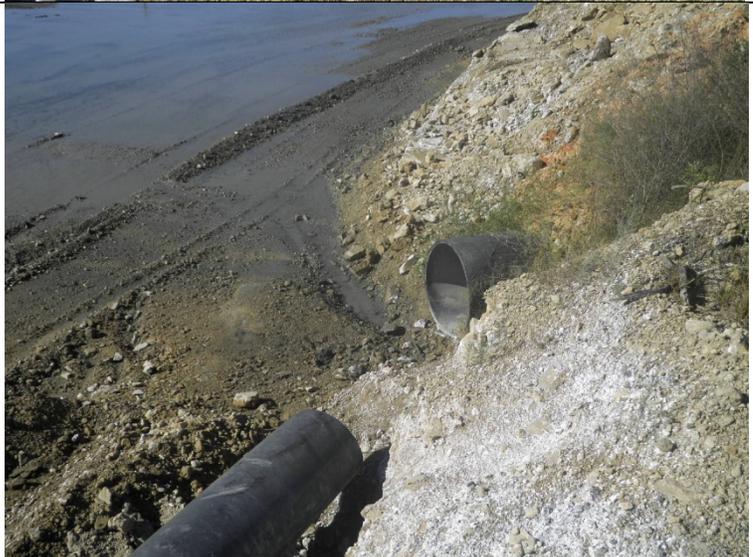
PHOTO #12

6. Photograph No. 12 illustrates the main outlet of the processing area. The outlet seems to be free flowing, and the contractor should ensure that the processing area maintains positive drainage to this outlet.

Outlet for process area through north slope

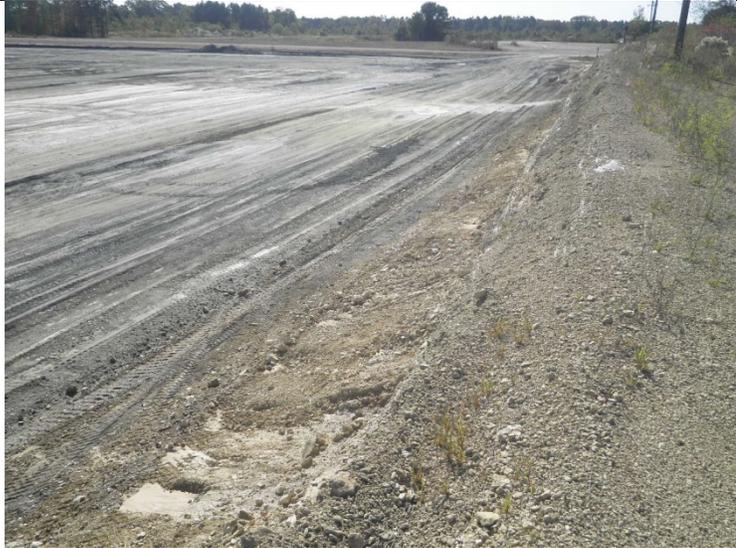
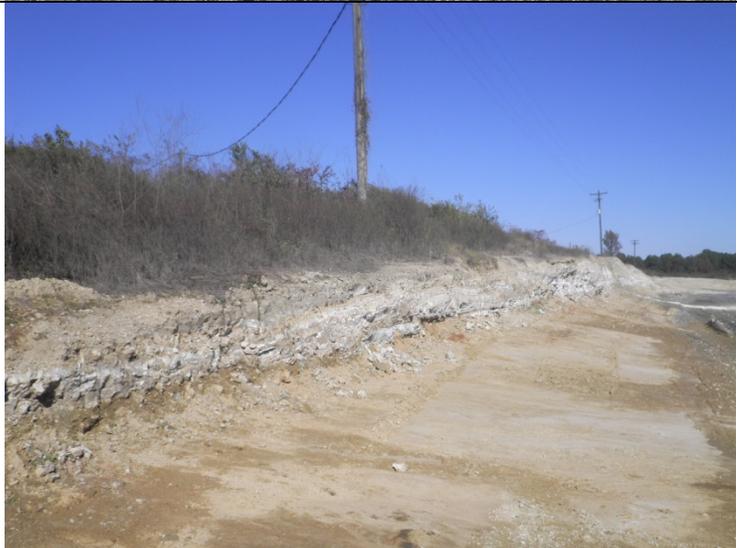
7. According to previous annual inspections, the *western side* berm and outer slopes of the landfill are partially constructed of temporary soil cover and CCR material and sparse vegetation cover. Photographs No. 13 and 14 illustrate the condition of this exterior berm and slope. The outer slopes appeared to be very steep but in satisfactory and functioning condition with no signs of seepage, erosion or sloughing. Woody vegetation was noticed on the outer slopes and in the toe ditch. However, this berm is several feet above the processing area, so it is not confining any CCR material as a traditional landfill at this time. According to plant personnel, it is anticipated that this area will continue to operate as a processing area and will only store CCR material while being processed. Therefore, the CCR material should be marginal in height and not be stacked against or above the berm. If this area ever transitions from a processing area to a traditional active landfill, this berm would need to be re-evaluated by a professional engineer at that time.

West berm, looking south

West berm, looking north

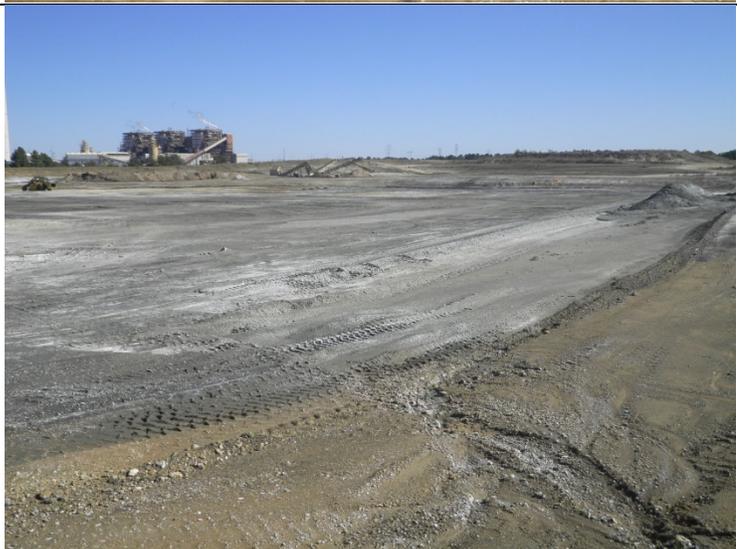
PHOTO #15

8. Photograph No. 15 illustrates the overall landfill from a vantage point of the southwest corner looking northeast. As noted previously, the eastern one-third of the area is used for waste placement, and the western two-thirds of the area is used for processing waste materials. The landfill waste placement and material processing appeared to be performed properly and did not show any impact to the components of the landfill. A storm water management concrete structure is installed to collect and direct the runoff from the southern portion to the bottom ash storage pond to the southeast. This structure appeared to be in good, functional condition.

Overall landfill from southwest corner,
looking northeast
