2020 Annual Dam and Dike Inspection Report

Clinch River Ash Pond 1A/1B

**Clinch River
Appalachian Power Company
Carbo, Virginia**

Document ID: GERS-20-015

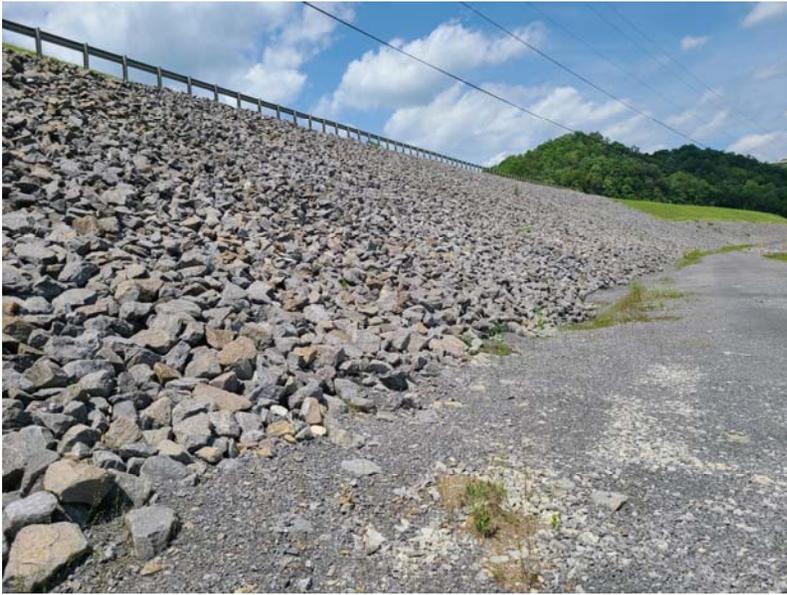
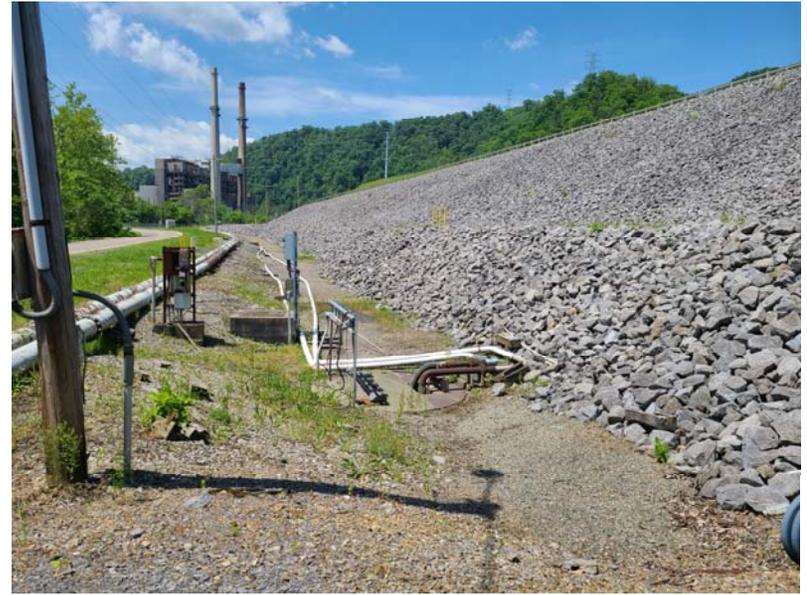
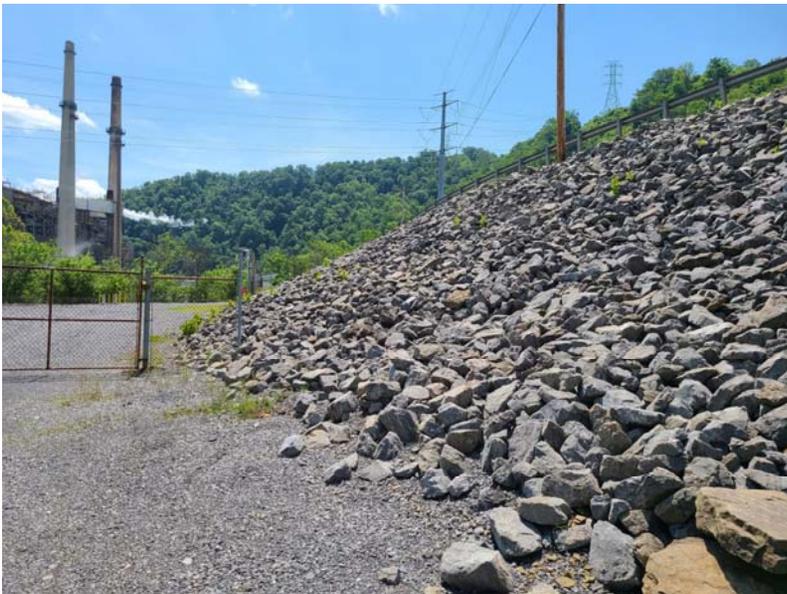
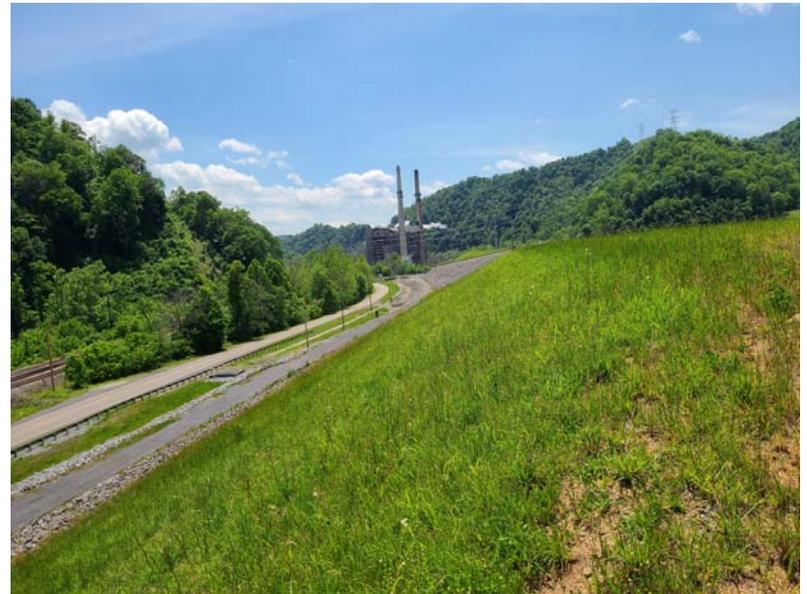
1. In general, there were no signs of slope instabilities, uncontrolled seepage, or erosion of the downstream slopes of the dam. The slopes are covered with a combination of riprap and vegetation. Vegetation is adequate and was recently mowed before the inspection. The condition of the riprap appeared sound and there was no displacement of the riprap. [photos 1-4]

Photo #1 – exterior slopes of Ponds 1A and 1B

Photo #2 – exterior slopes near transition of 1A and 1B

Photo #3 – exterior slope of Pond 1A

Photo #4 – grass cover on slopes of Pond 1B, above riprap

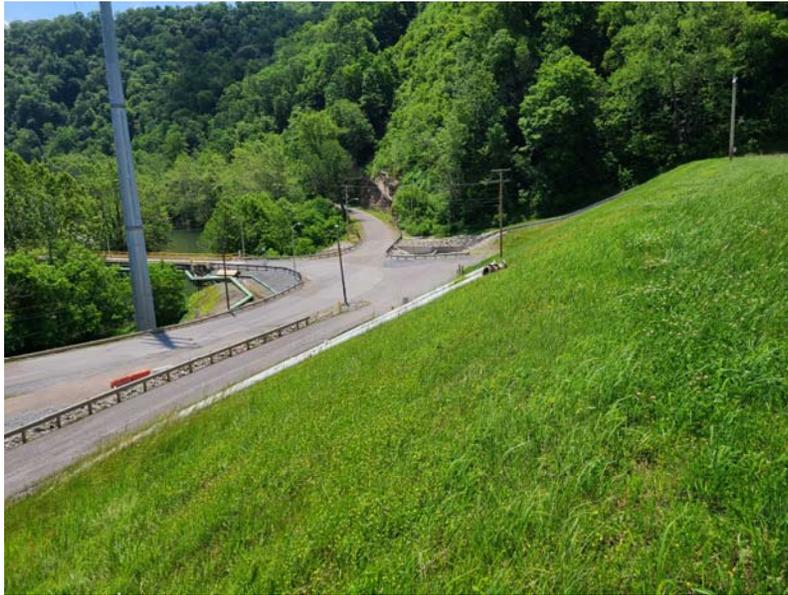
2. The slope of the most southern dike is all grassed and in good condition. There were no observed signs of instabilities, erosion or seepage [photo 5].

Photo #5 – exterior slope of south dike

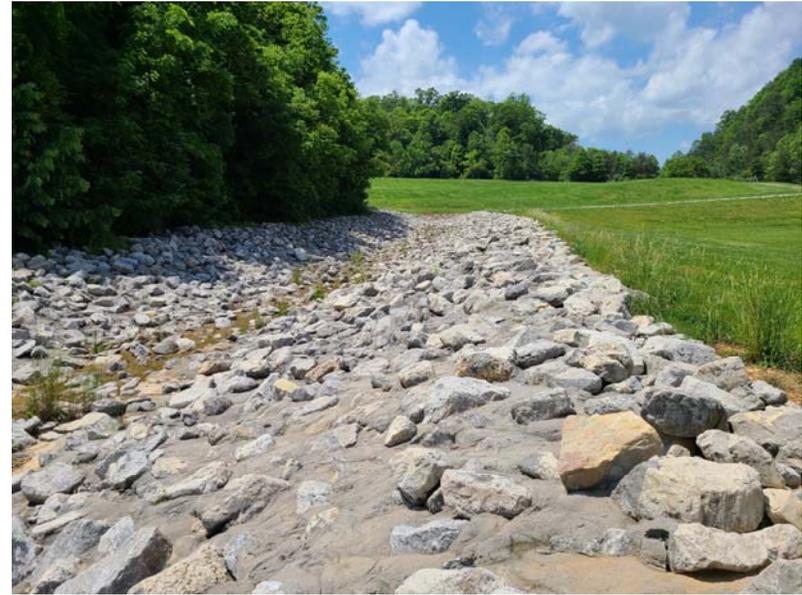
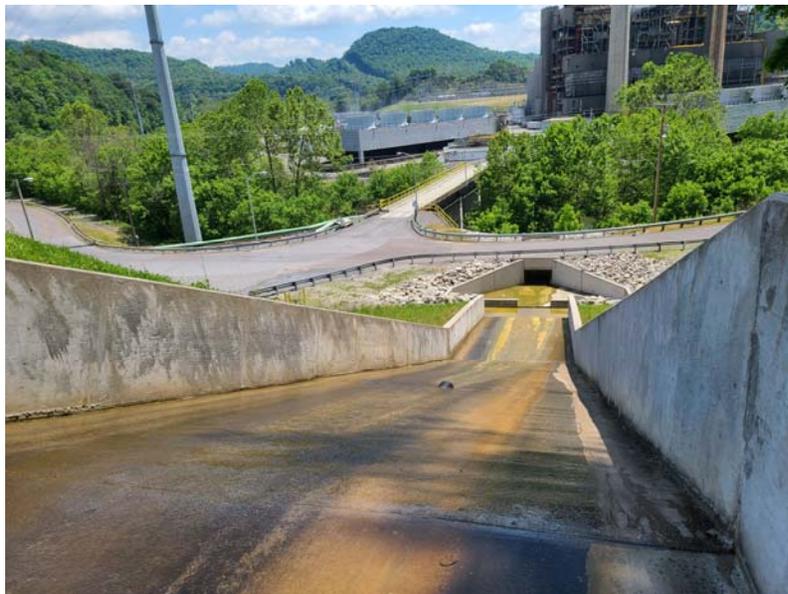
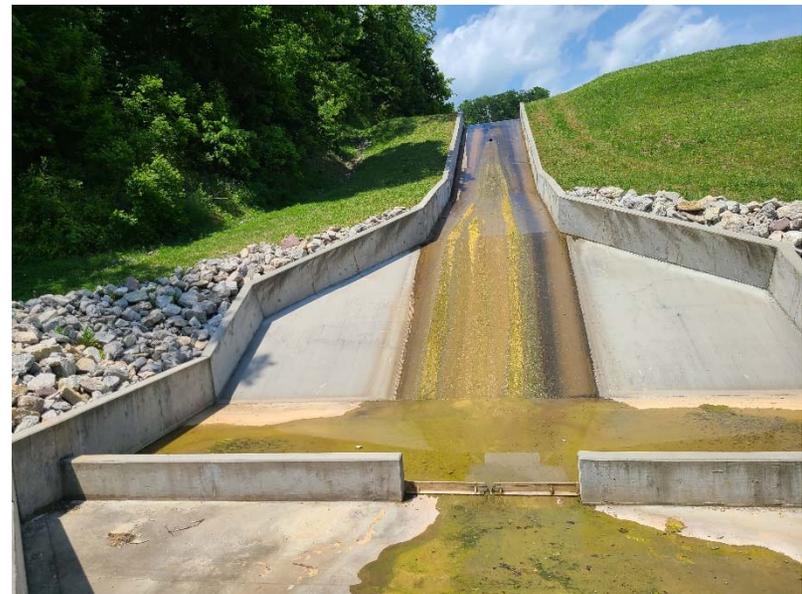
3. The Pond 1A diversion ditch along the right abutment was in good condition. The riprap lining was observed to be in good condition. The concrete downchute for the diversion ditch was also in good condition. [photos 6-8].

Photo #6 – Pond 1A diversion ditch

Photo #7 – concrete chute for Pond 1A diversion ditch

Photo #8 – concrete chute for Pond 1A diversion ditch

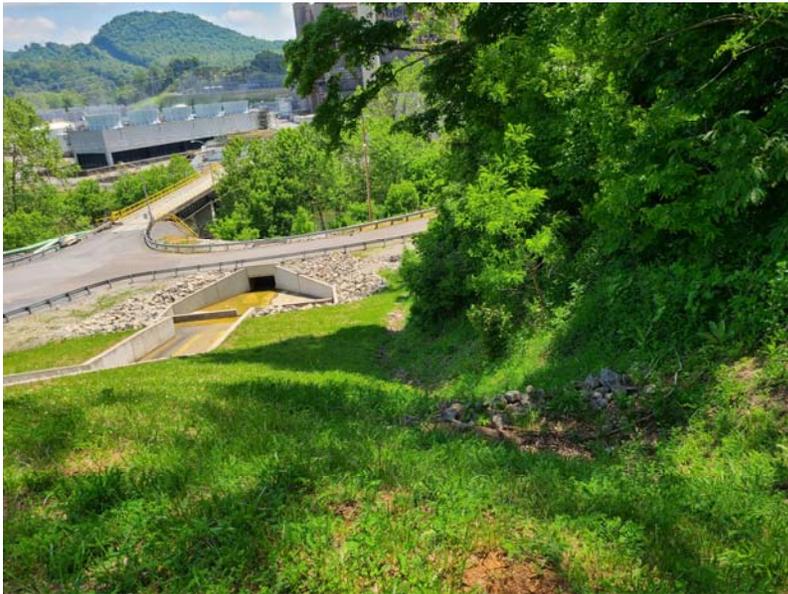
5. The right abutment area is cleared of brush within 25 feet of the dam embankment, except for a short section near the toe. [photo 9]
6. The seepage collection sump was operational at the time of the inspection. The majority of the seepage was flowing in from the left segment of the system. All of the flow appeared clear. There is significant precipitate at the ends of both inlet pipes.

Photo #9 – right abutment, 25-ft clear zone

1. Remove any mineralization and/or obstructions from the seepage weirs as noted during periodic inspections.
2. Maintain the vegetation within the regulatory 25-foot zone beyond the toe and abutments as required by VDCR Dam Safety.
3. Remove the precipitant build-up at the outlets of the toe drains in the seepage collection sump.

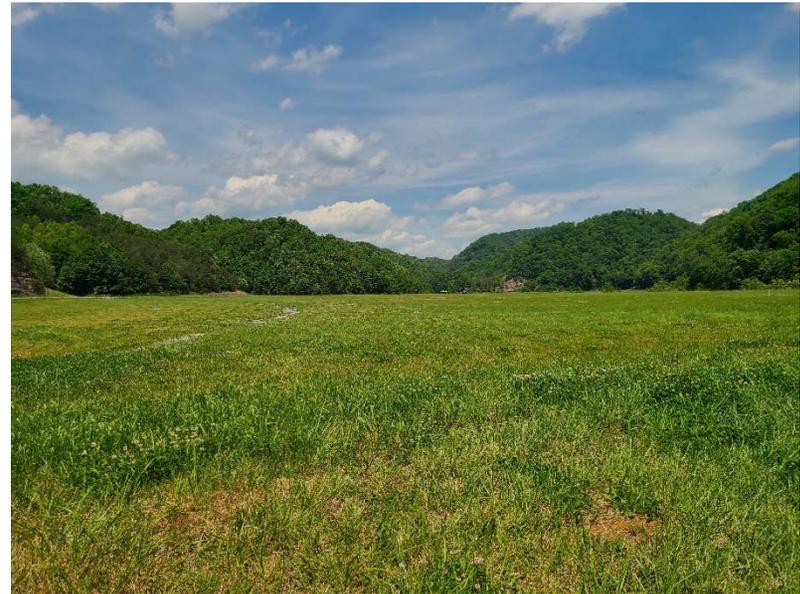
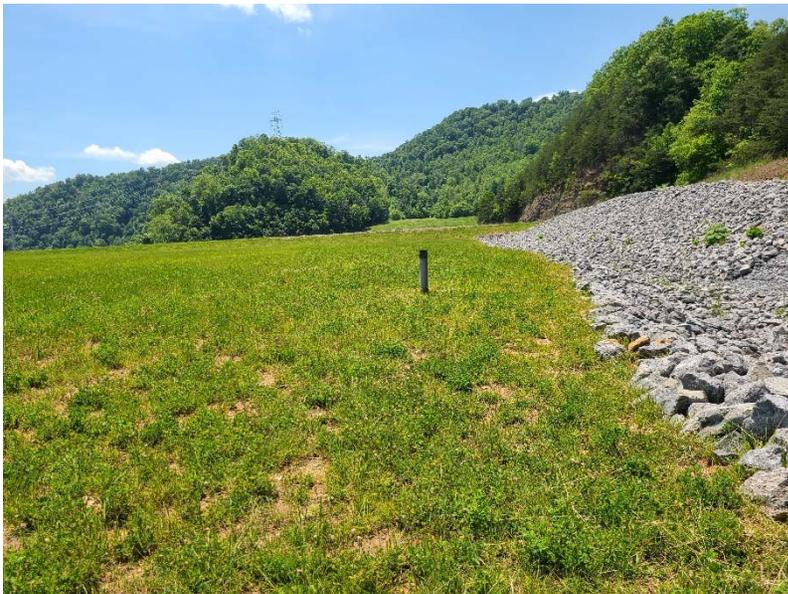
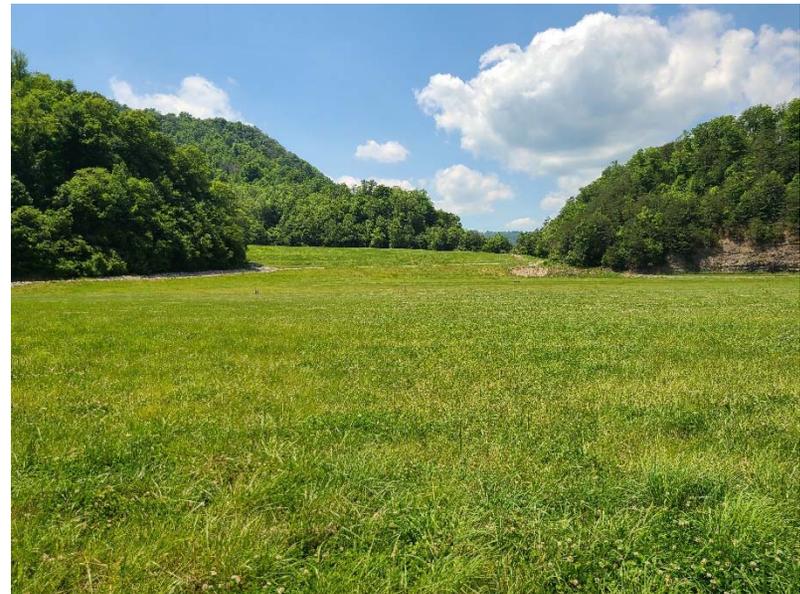
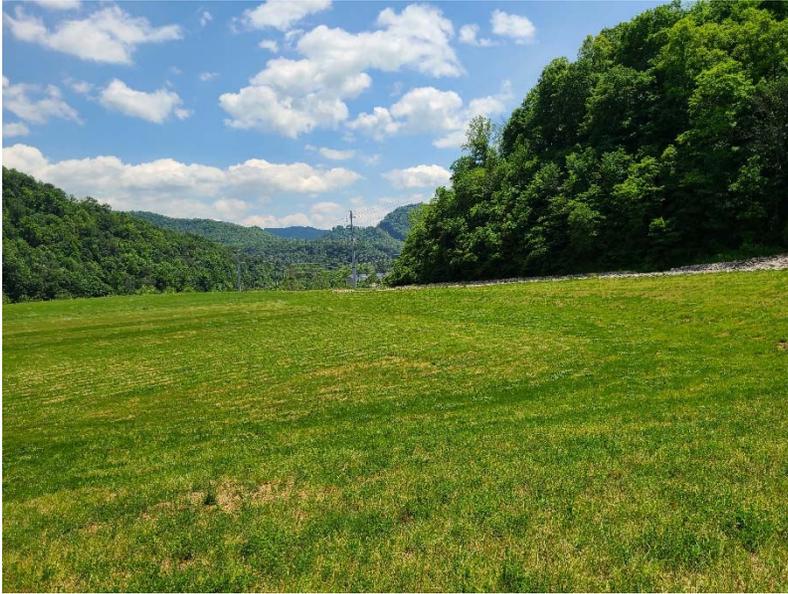
7. The surface area of the impoundment has been capped and covered. The vegetative growth is good over the entire surface. [photos 10-13]
8. Surface drainage appears adequate but there is still evidence of poor drainage at the inlet of the south swale into the east diversion ditch [photo 14]

Photo #10 – cap surface of Pond 1A

Photo #11 – cap surface of Pond 1B

Photo #12 – cap surface of Pond 1A

Photo #13 – cap surface of Pond 1A

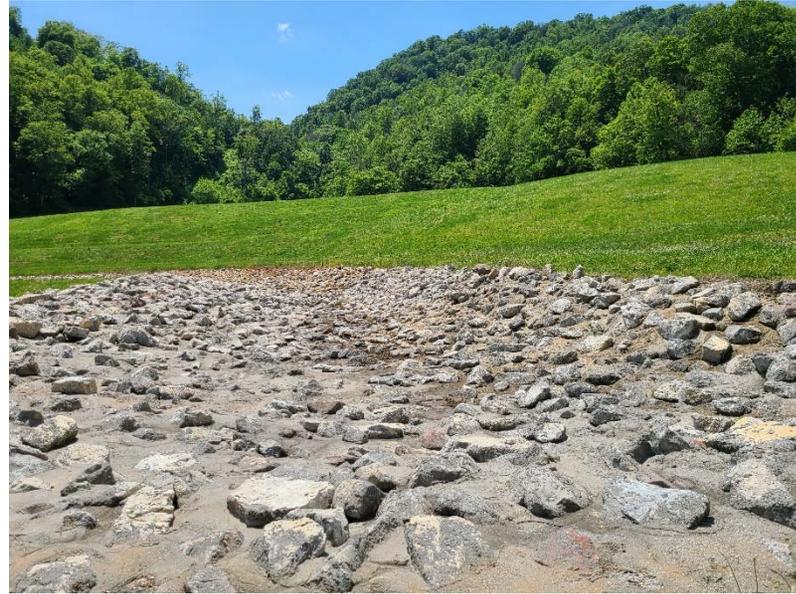
Photo #14 – drainage swale into Pond 1A diversion channel

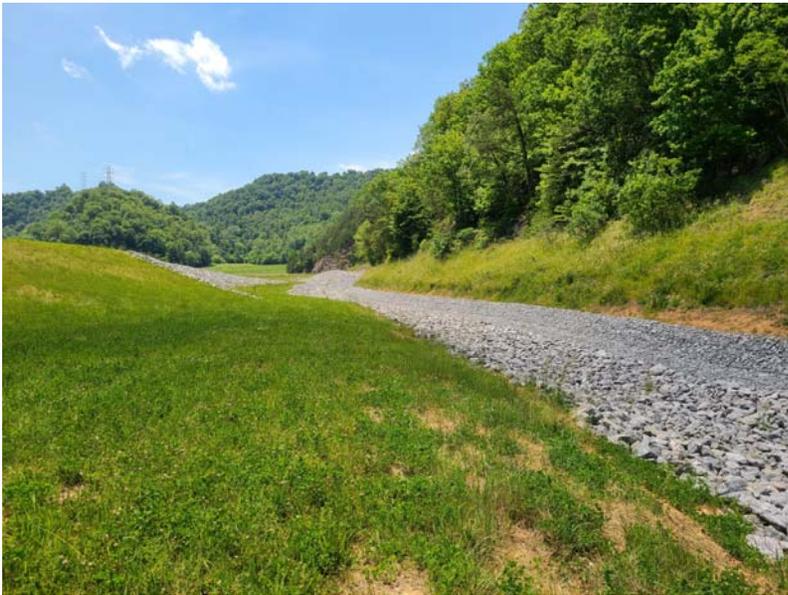
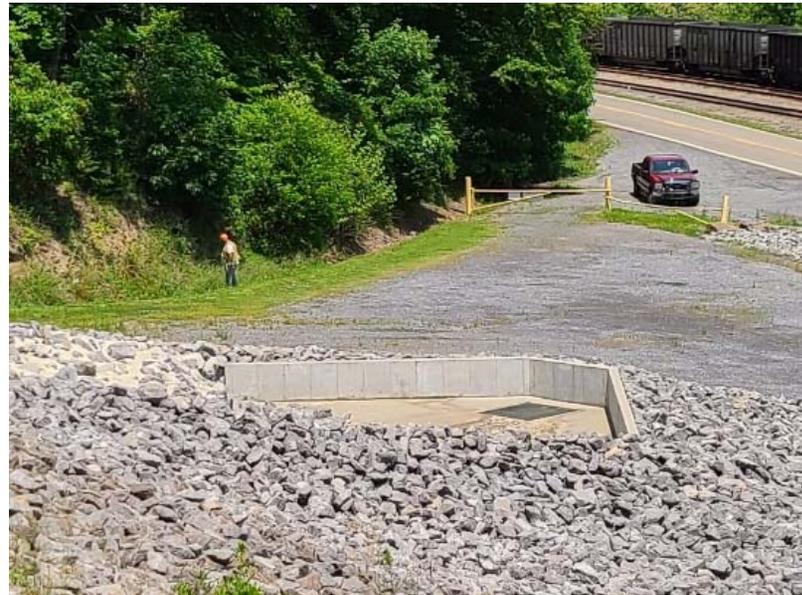
11. Pond 1B diversion ditch system and collection basin appeared to be in good condition. No debris was observed in the collection basin [photos 15-16].

Photo #15 – Pond 1B diversion ditch

Photo #16 – collection basin at toe of Pond 1B diversion ditch

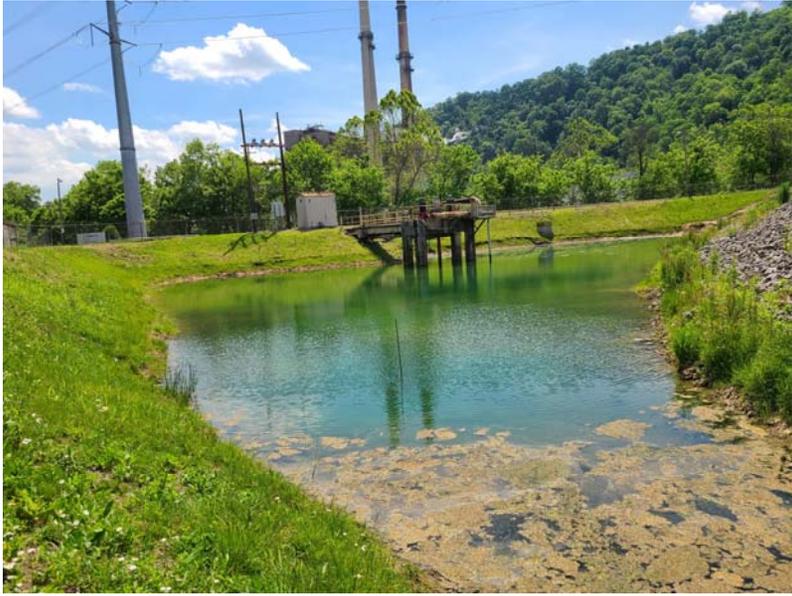
13. The interior slopes of the reclaim pond appeared stable and there was no displacement of the riprap cover or erosion of the grassed slopes [photo 17].

Photo #17 – reclaim pond interior slopes
