# **2021 Annual Dam and Dike Inspection Report**

**Primary Bottom Ash Dam**

**Flint Creek Plant**

**Document ID: GERS-21-015**

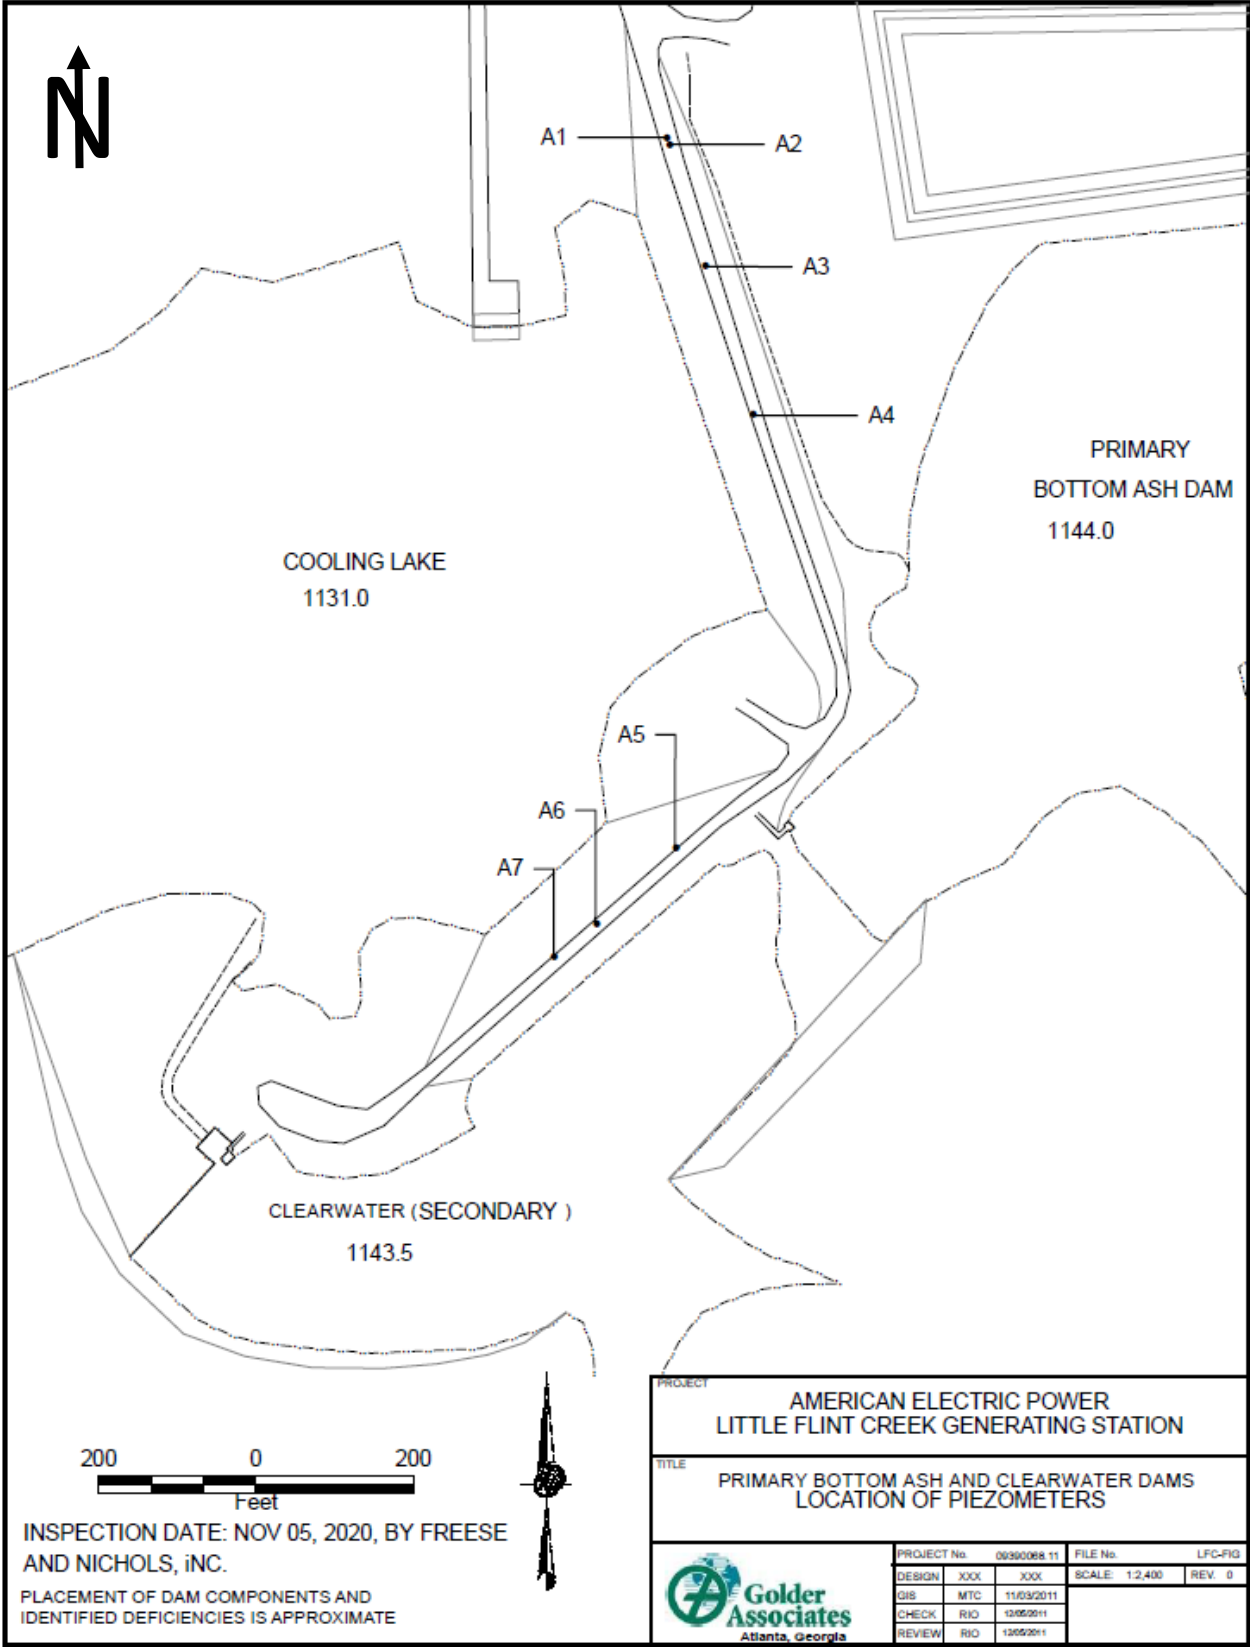
**Figure 2 – Piezometer Location Map**  
**Primary Bottom Ash Pond**  
**Flint Creek Plant, Gentry, AR**

There are four piezometers located along the crest of the dam as shown on Figure 2. These are the only instrumentation related to this facility. A review of readings since the last inspection and historical readings (2017-2021) indicate the levels are consistent and respond to the fluctuation of the cooling lake level. The piezometers are more influenced by the level of the cooling lake than the elevation of the bottom ash pond. The trend in the historical data between the piezometers reading, lake level, and pond levels are consistent.
