2021 Annual Dam and Dike Inspection Report

Bottom Ash Pond Complex

Mitchell Plant

Document ID: GERS-21-017

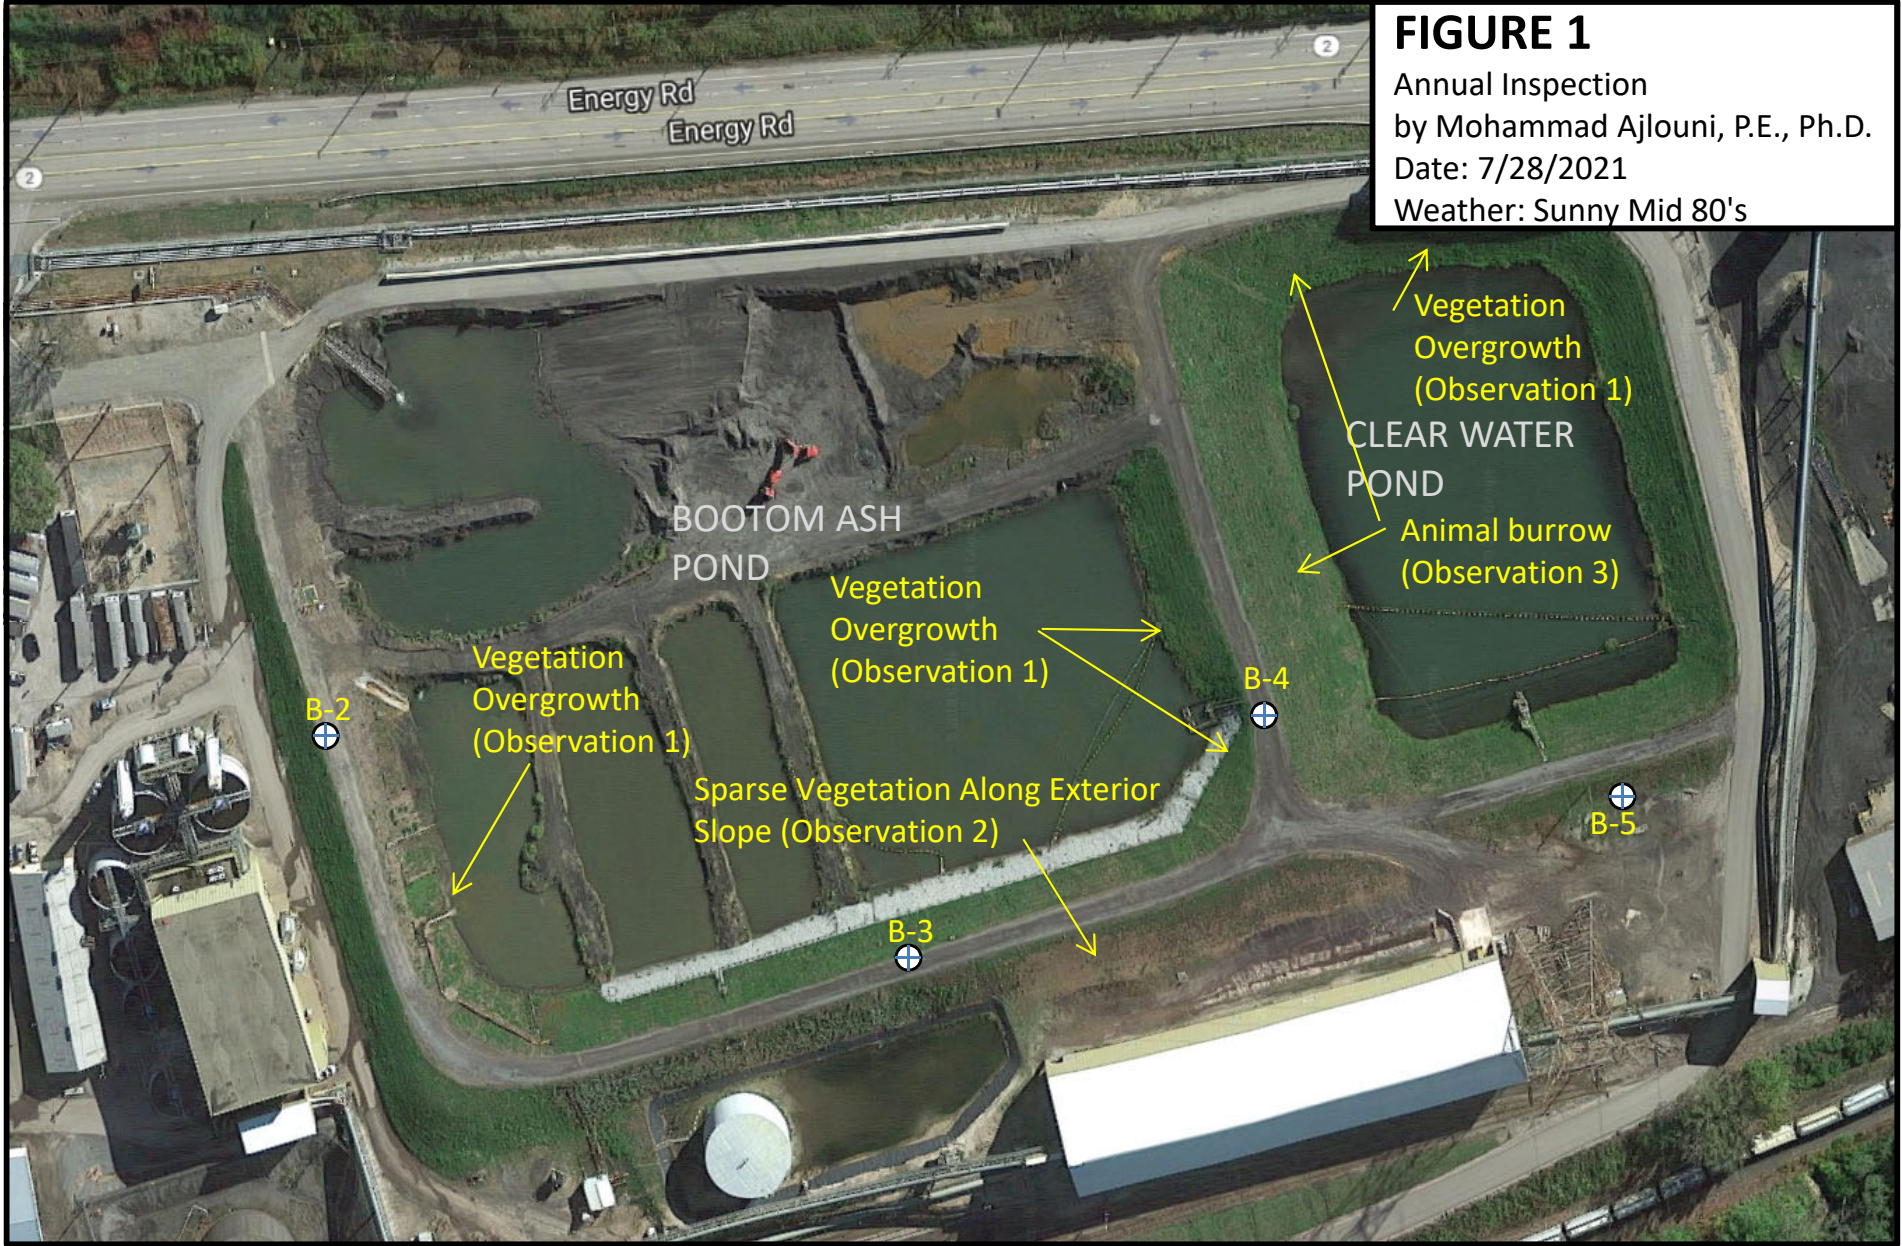
FIGURE 1
Annual Inspection
by Mohammad Ajlouni, P.E., Ph.D.
Date: 7/28/2021
Weather: Sunny Mid 80's

Overall the facility is in good condition. The impoundment is functioning as intended with no signs of potential structural weakness or conditions which are disrupting to the safe operation of the impoundment. Inspection photos are included in Attachment A. Additional pictures taken during the inspection can be made available upon request. A map presenting locations of the inspection observations is included Figure 1.
