SAFETY FACTOR ASSESSMENT PERIODIC 5-YEAR REVIEW

Bottom Ash Complex

Mountaineer Plant
New Haven, West Virginia

Geotechnical Engineering Report

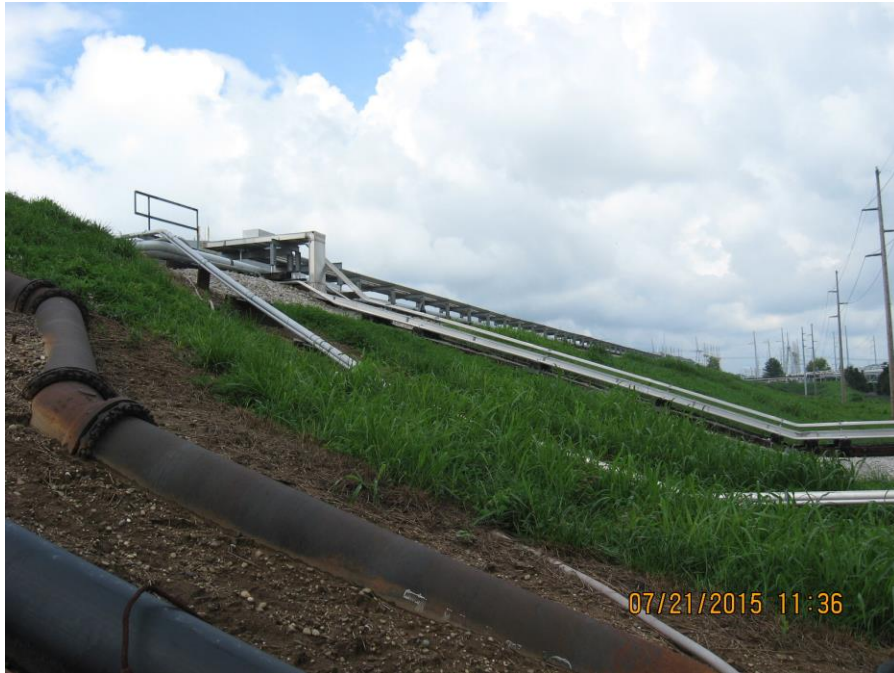
Photo 43: East Wastewater Pond, east dike: piping along exterior slope.

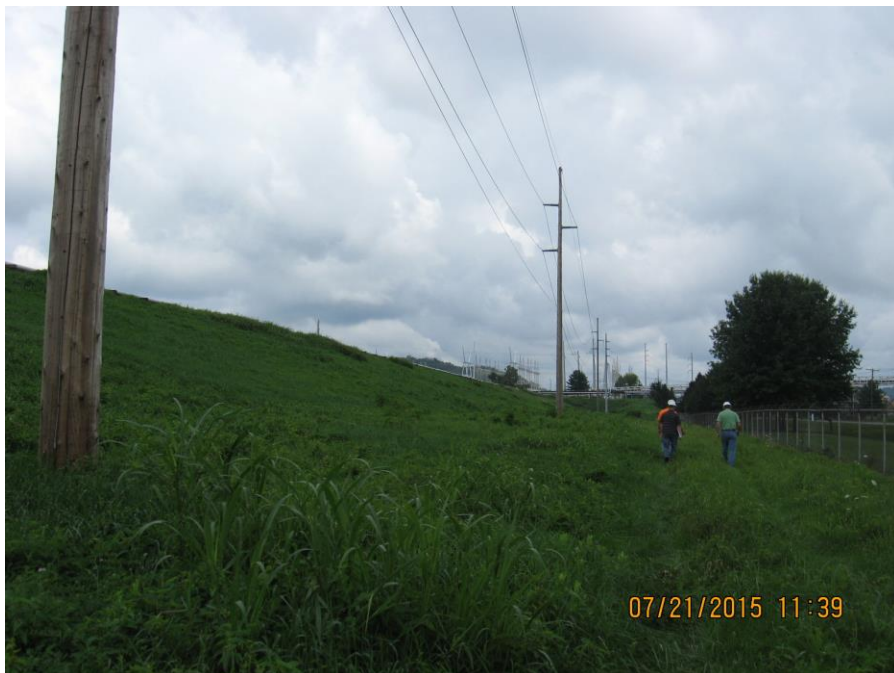
Photo 44: East Wastewater Pond, east dike.

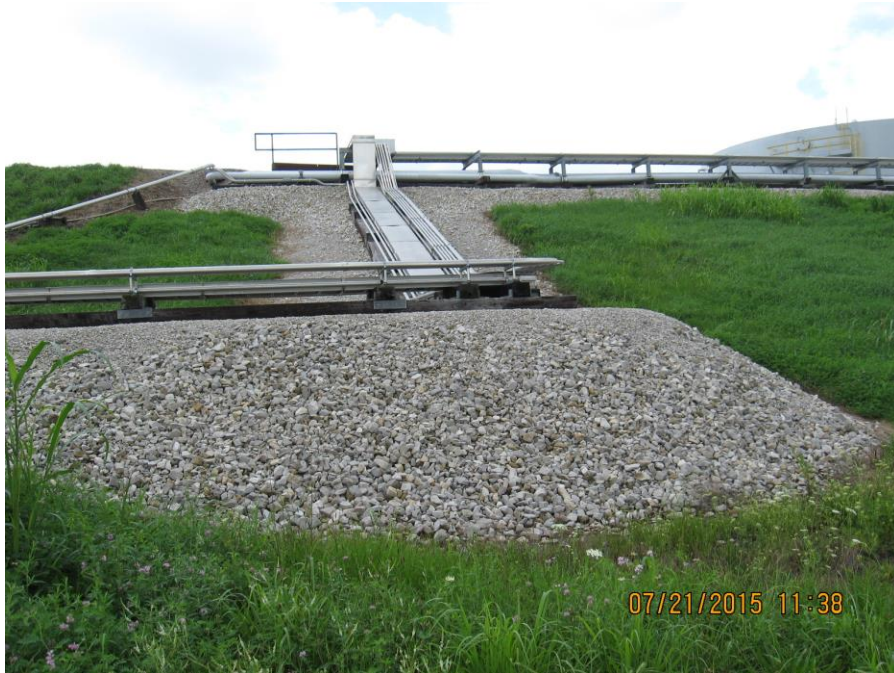
Photo 45: East Wastewater Pond, east dike: piping along exterior slope.

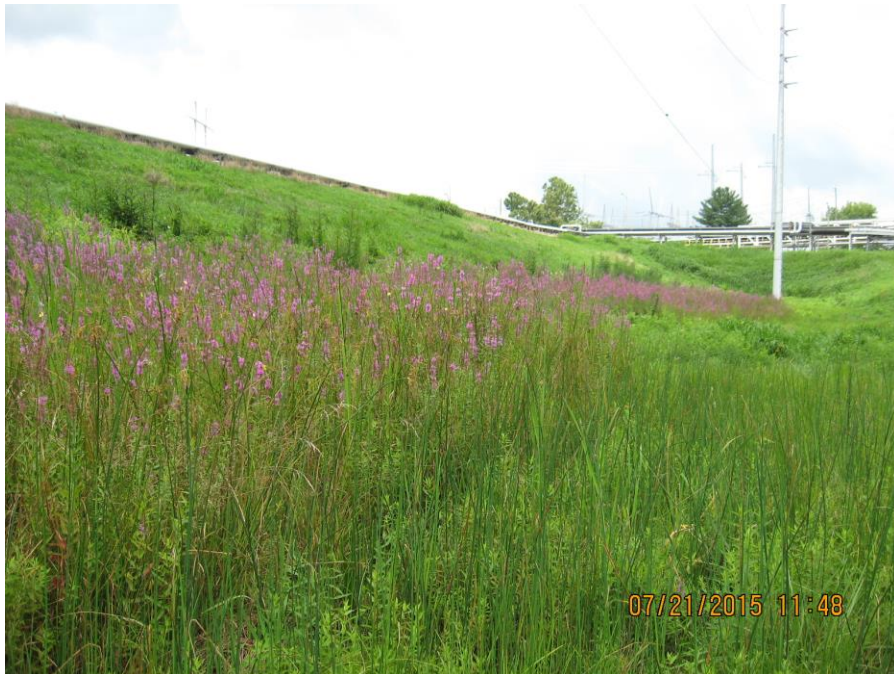
Photo 48: East Bottom Ash Pond, east dike: exterior slope.

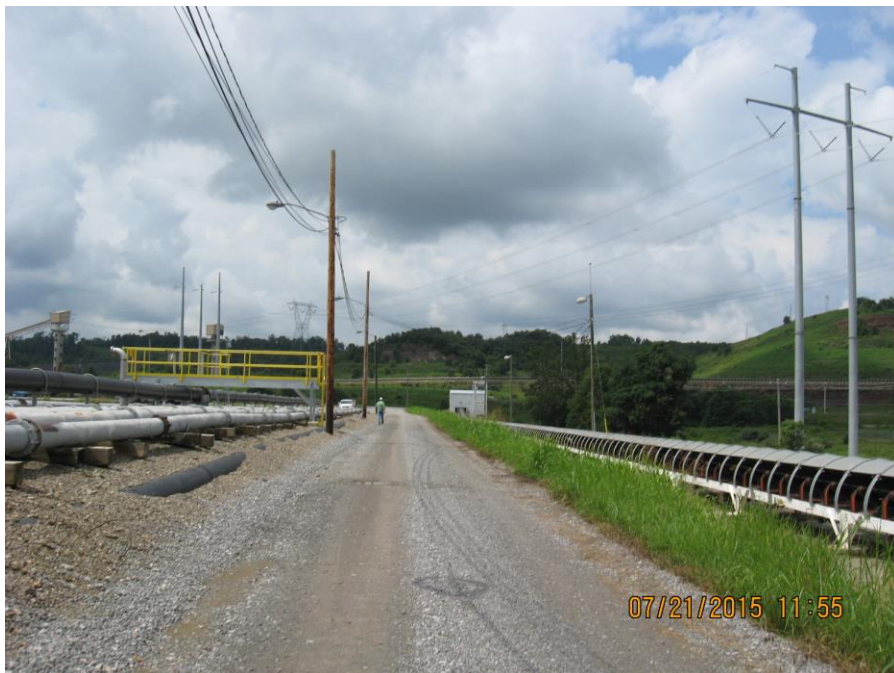
Photo 52: East Bottom Ash Pond, north dike.

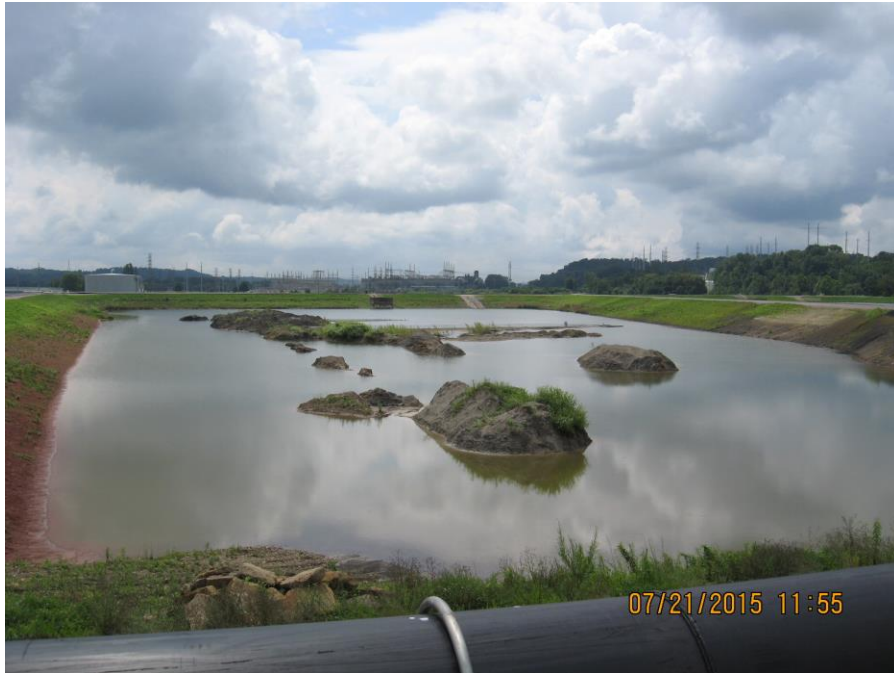
Photo 53: East Bottom Ash Pond.

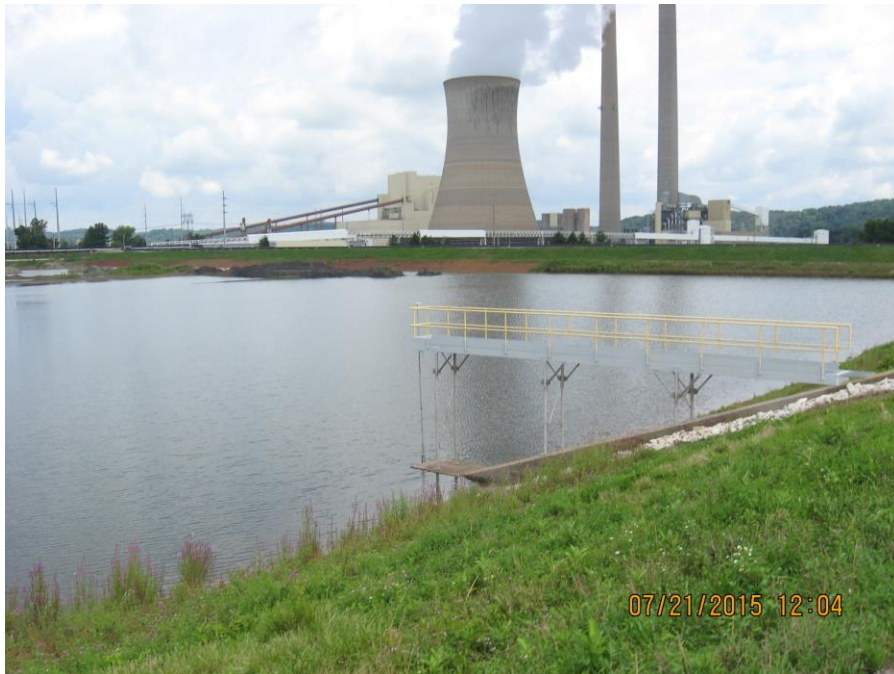
Photo 54: East Bottom Ash Pond, south dike: outlet structure.

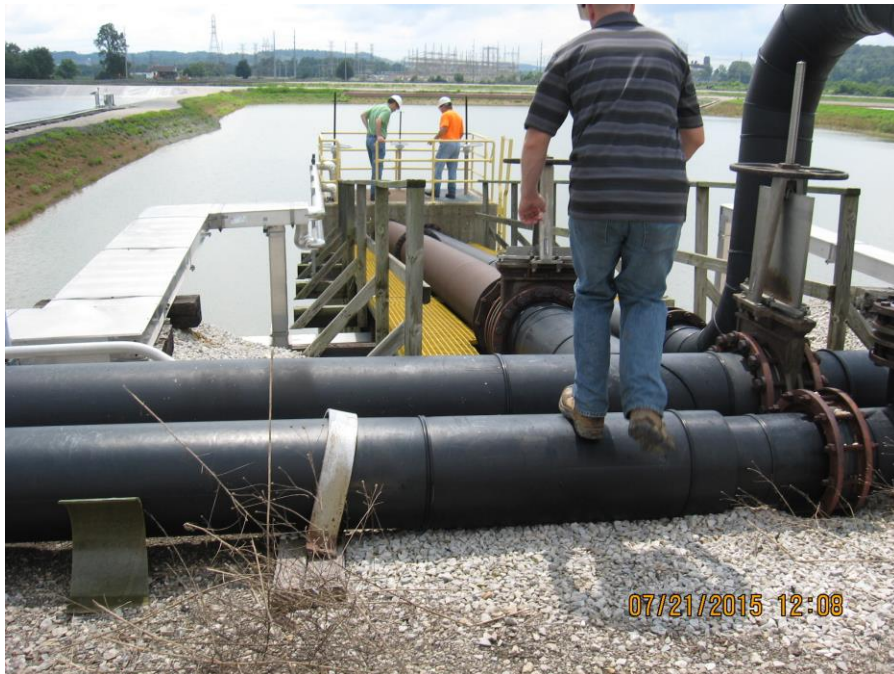
Photo 56: East Waste Water Pond: outlet structure.

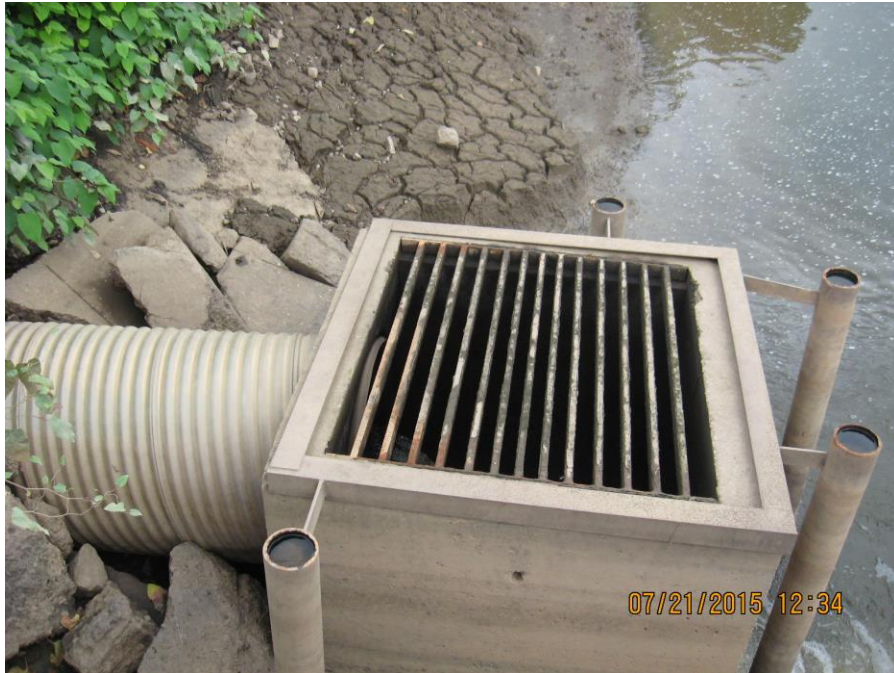
Photo 61: Ohio River outlet structure.
