2020 DAM AND DIKE INSPECTION REPORT GEVR-20-014

WELSH POWER PLANT CCR ASH PONDS

CASON, TEXAS

INSPECTION DATE October 12, 2020

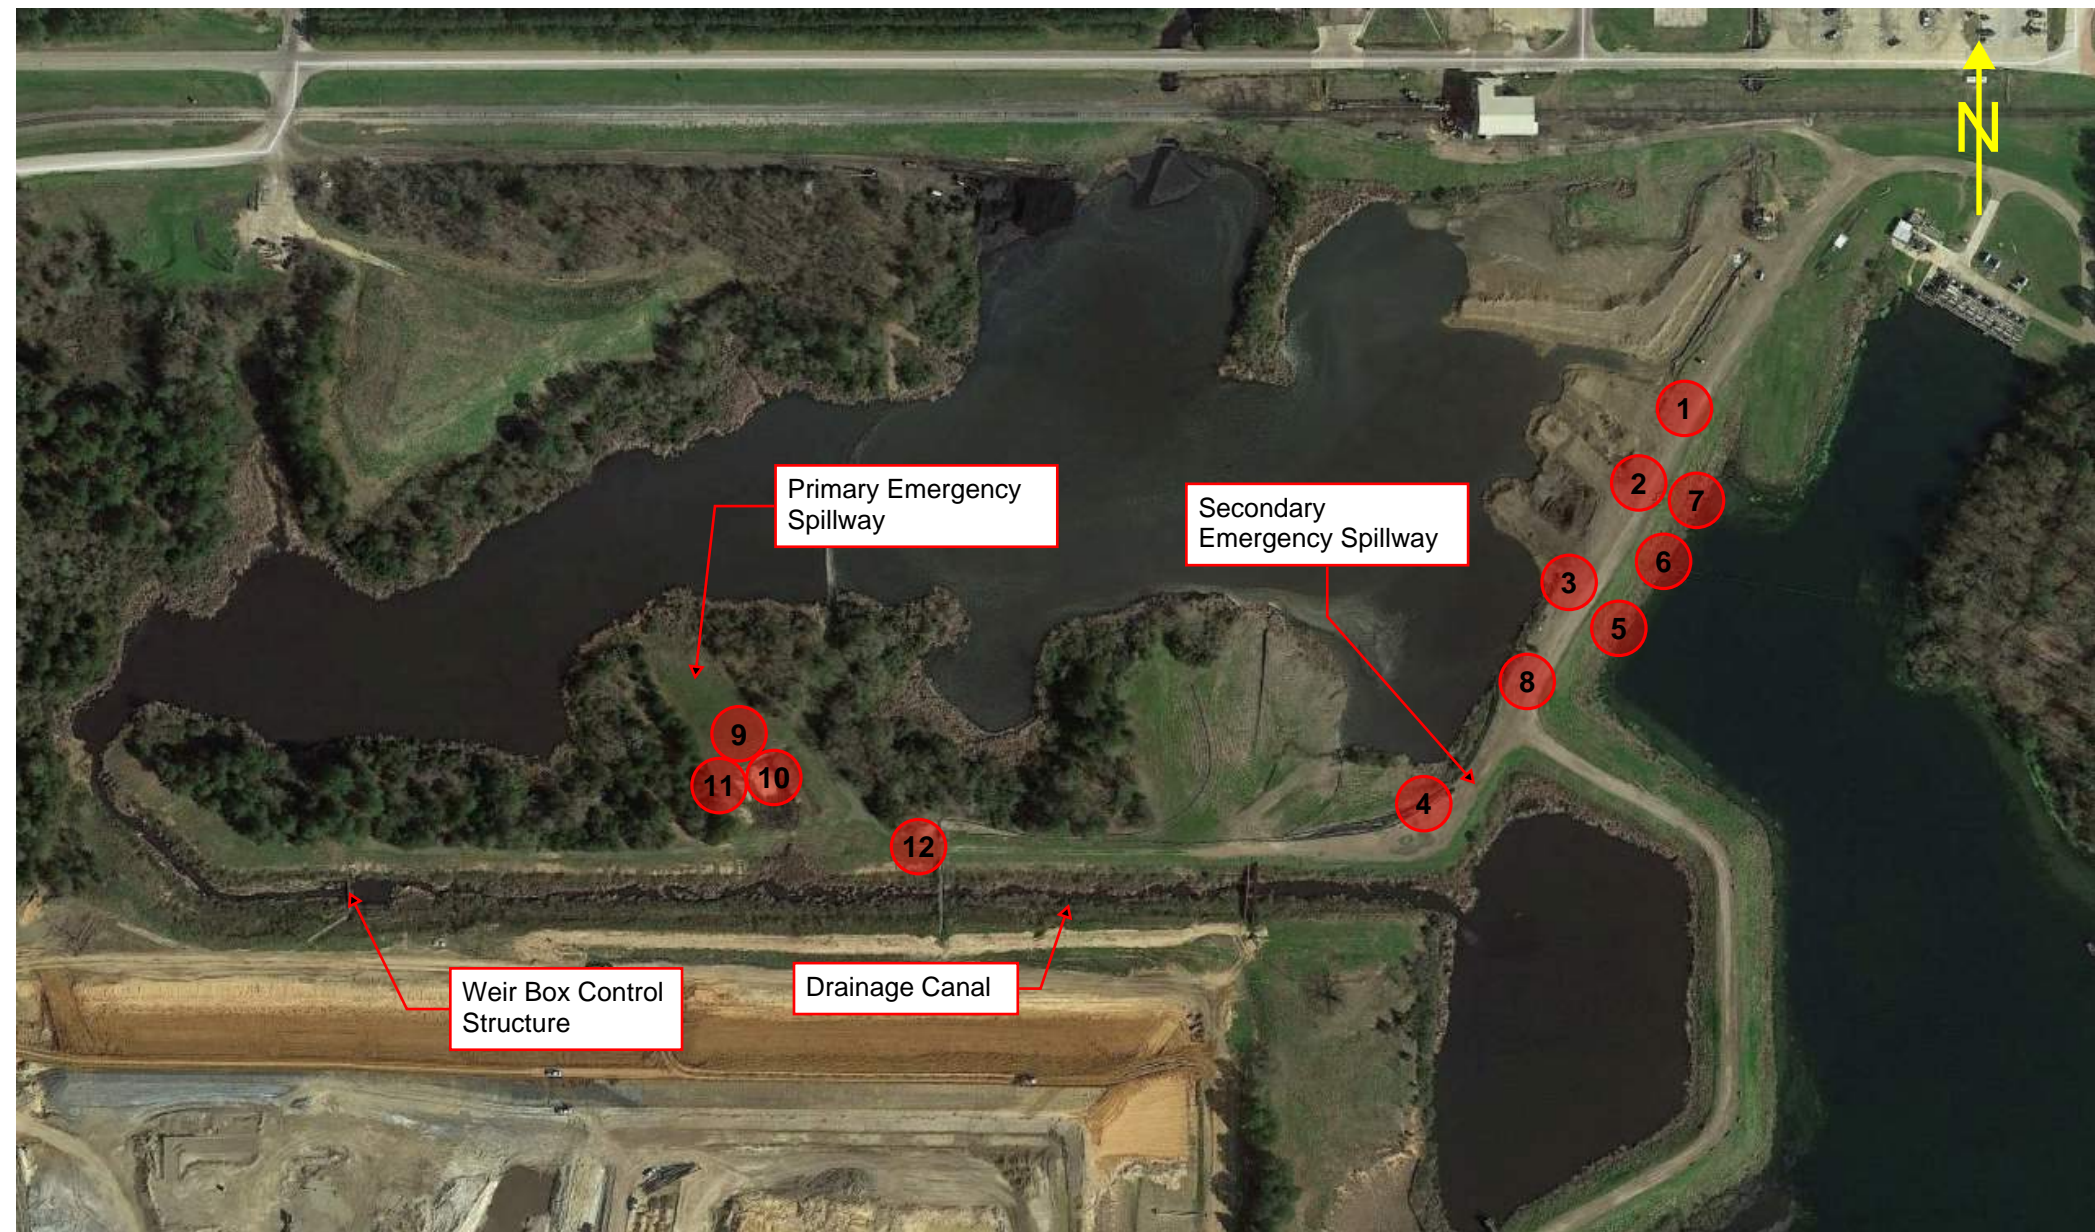
Photograph 1: View along crest, looking left. Arrow points to location of recent boring locations.

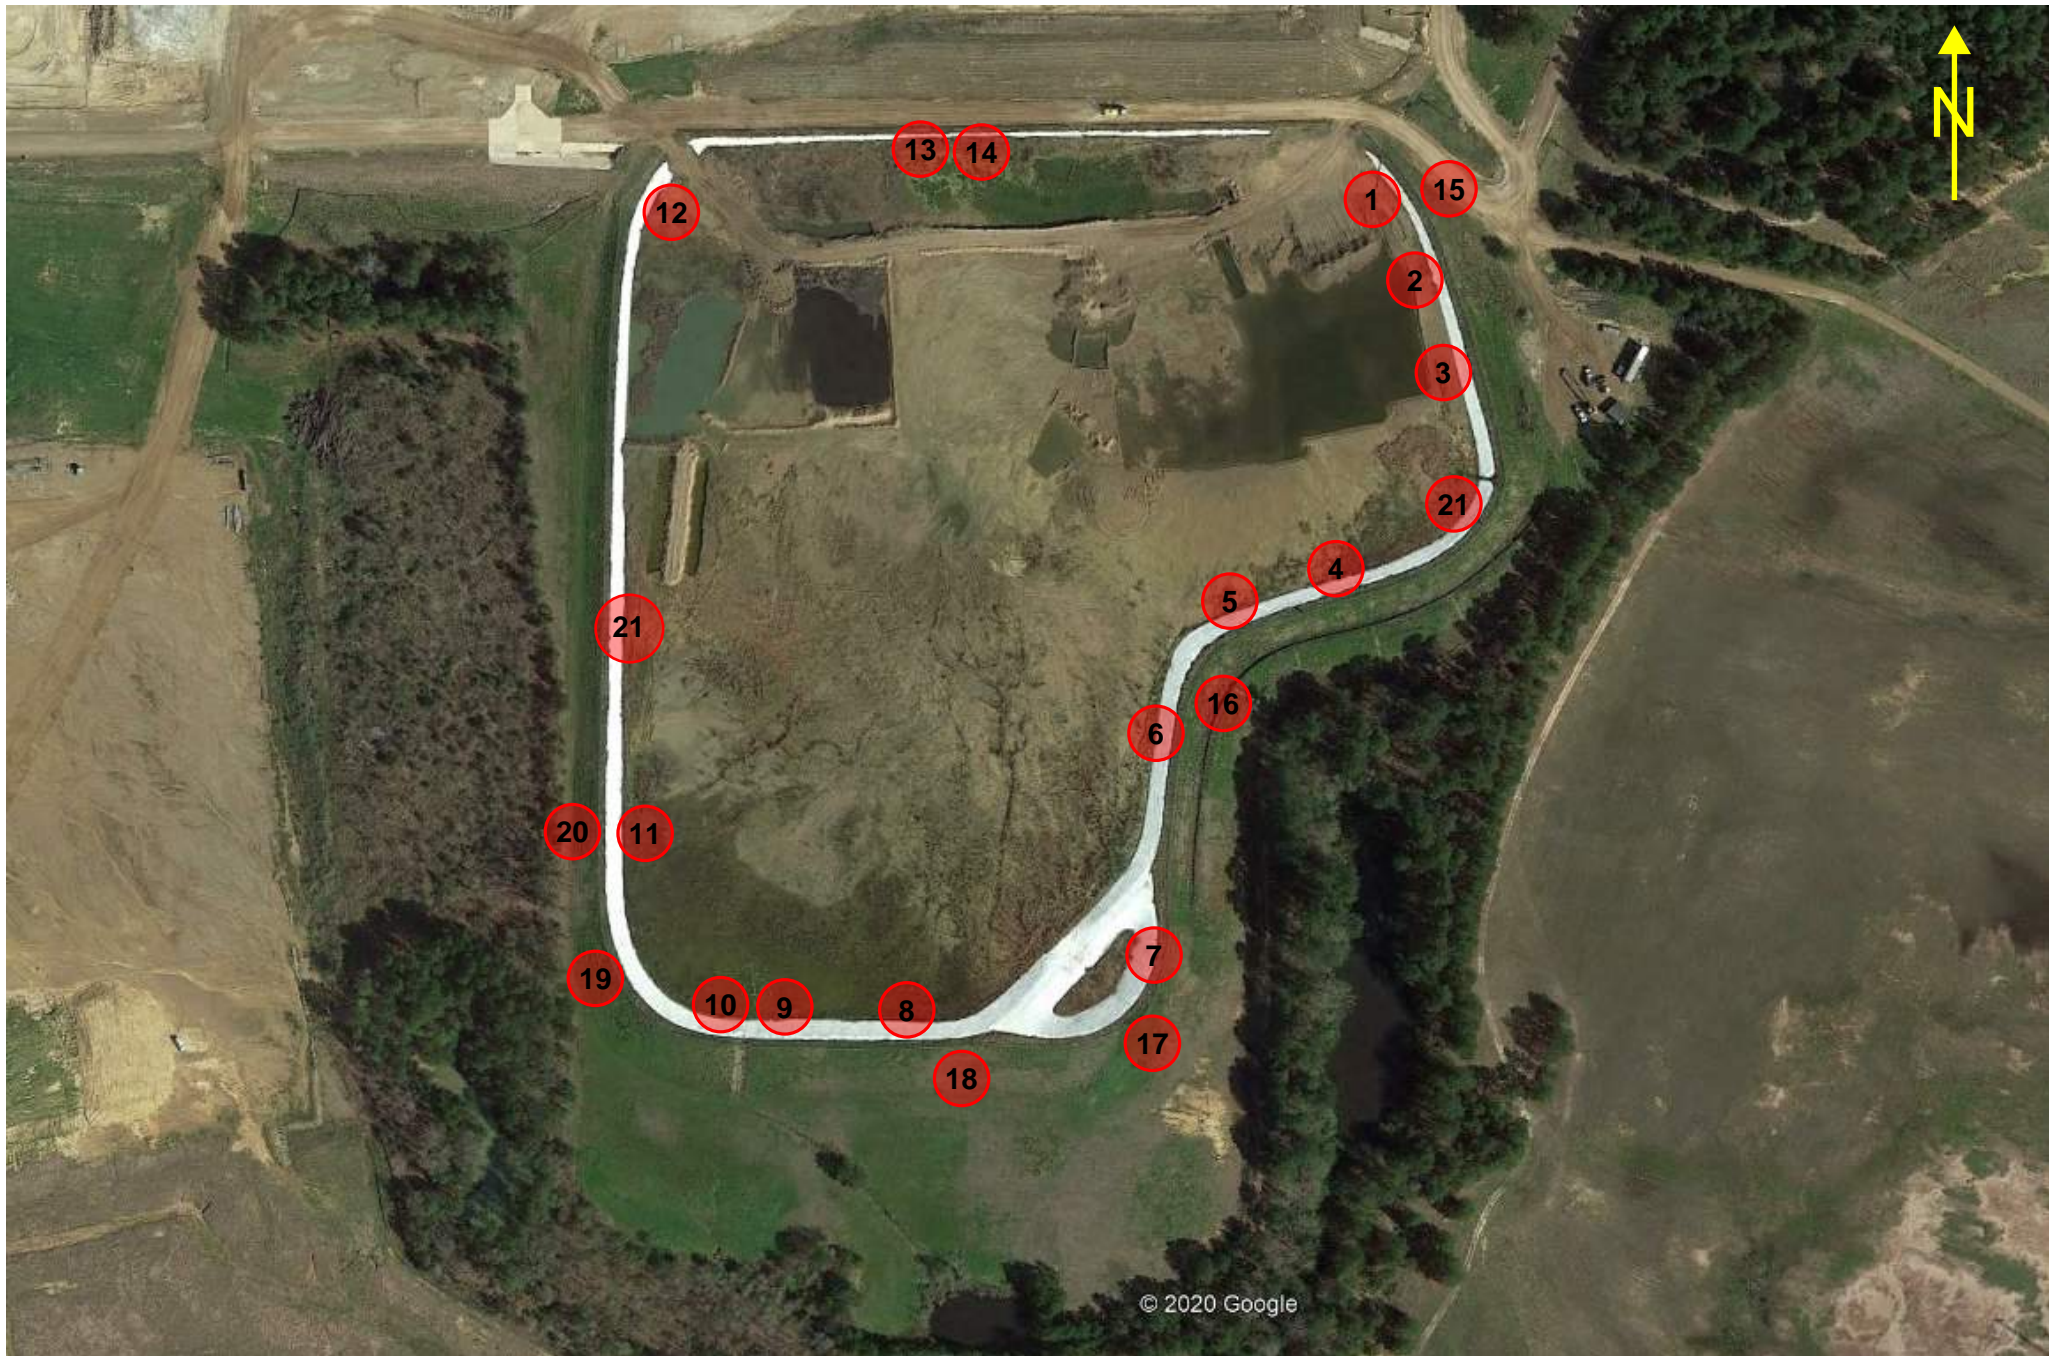
Photograph 1: Typical view of upstream slope and crest along east embankment, looking south. Note the crest had been recently mowed in this section

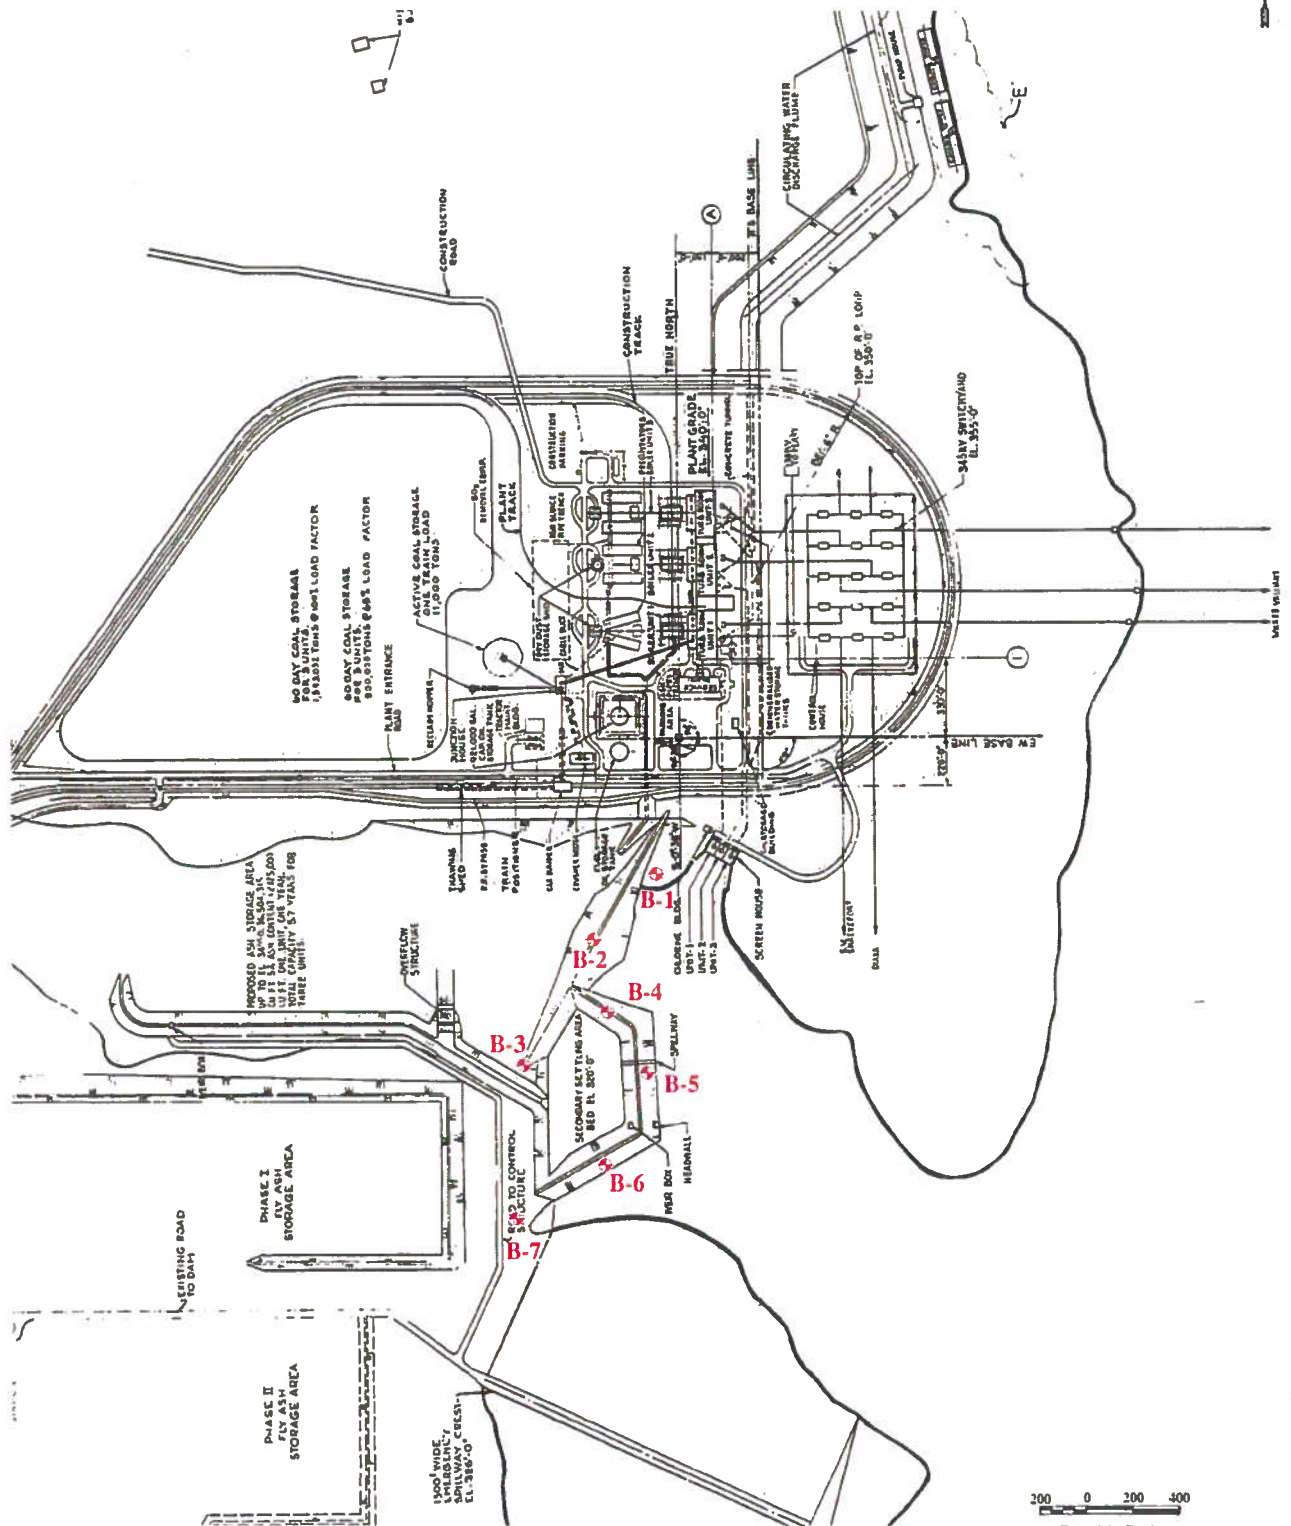
FIGURE 4A - INSTRUMENT LOCATION MAP

The monitoring instrumentation for the Primary Ash Pond consists of one (1) active piezometer (B-2) located through the main embankment area. There is no monitoring instrumentation for the Bottom Ash Storage Pond (Winston Pond). The location of the instrumentation is shown on Appendix D, Figure 4A. The maximum and minimum readings of Piezometer B-2 since the last annual inspection, a time period of September 2019 to September 2020, were 326.47 ft msl and 321.77 ft msl, respectively. Piezometer B-2 levels appeared consistent from month to month, and reacted to the fluctuation in tailwater levels (i.e. main lake). The results of the measurements of the piezometer is shown in Appendix D, Figure 4B.
