# Dam & Dike Inspection Report

## CCR Ash Ponds

### WELSH POWER PLANT CASON, TEXAS

INSPECTION DATE September 19, 2018

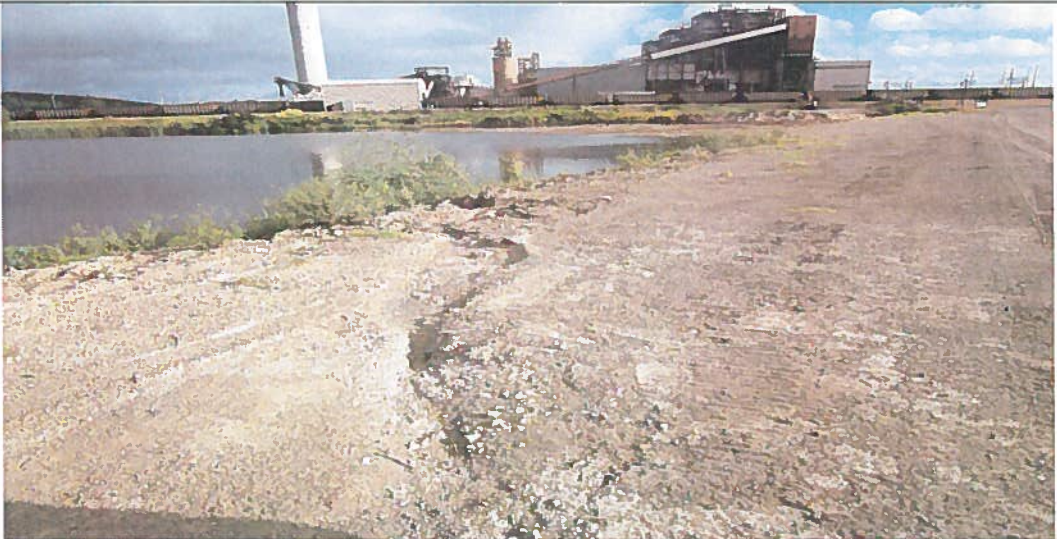
<p><u>Photo #2</u></p>

<p>A significant erosion at the upstream slope.</p>

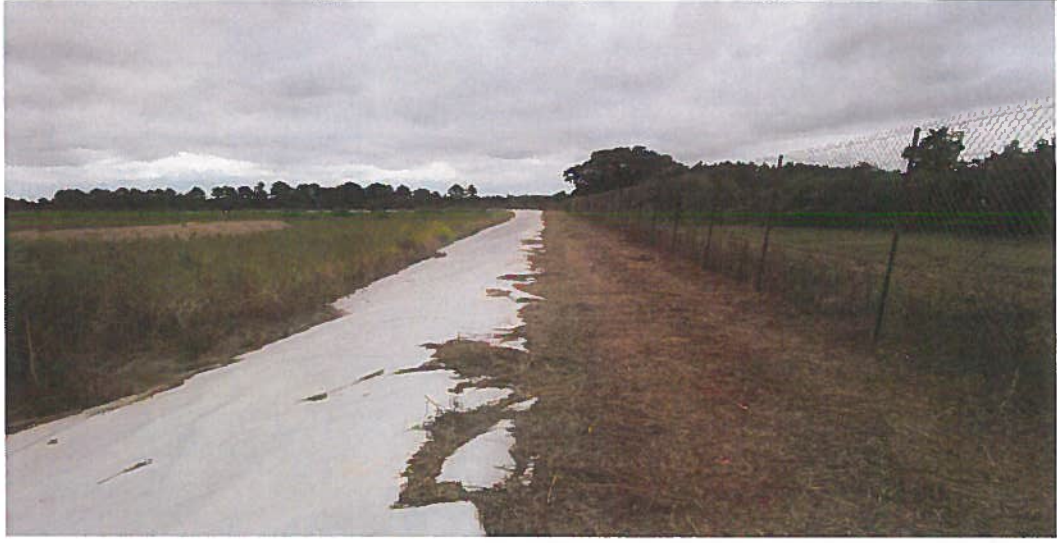
- (i) Two pipe culverts are located at the northwest corner of the pond (Photograph No. 1). The pipe culverts are part of the landfill storm water control system and discharge its contact water into this pond. The pipe culverts appeared clear of obstructions and in good and functional condition.
- (ii) Photograph No. 2 depicts the upstream slope and crest of the west dike. The upstream slope appeared to be in good and stable condition and mostly buttressed with ash. The geosynthetic liner appeared intact and in good condition. The crest appeared in good and stable condition. Slightly overgrown vegetation was noticed within the upstream slope. Photograph No. 3 shows overall condition of the interior of the pond. Ash management

A photograph of a long, narrow concrete channel filled with water, running through a grassy field. The channel is bordered by a grassy slope on the right side. In the background, there is a line of trees and a cloudy sky.
<p><u>Photo #3</u></p> <p>Overall condition of the pond interior.</p>

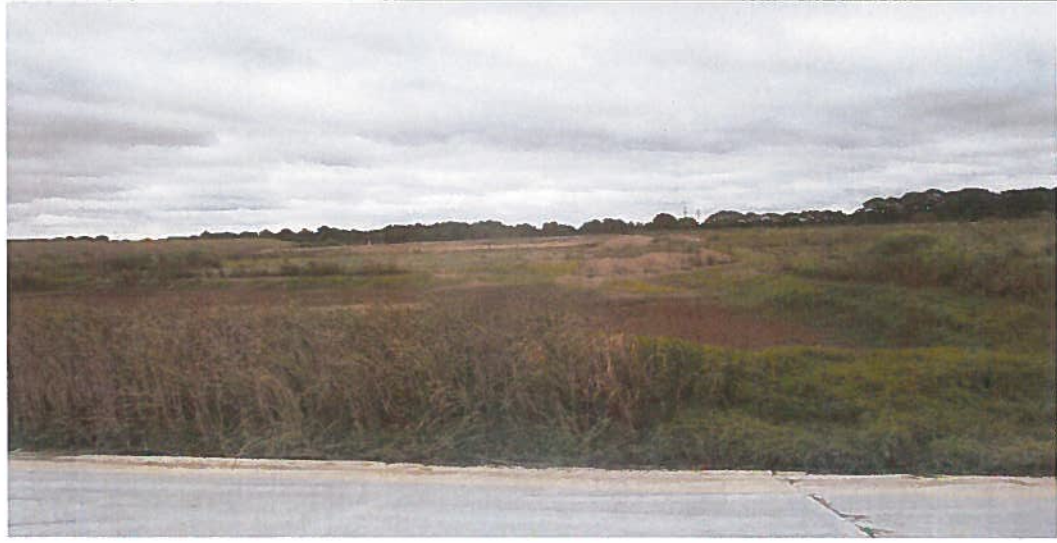
<p><u>Photo #4</u></p>

- (iii) A small area within the pond is used as a clearwater pool that is centrally located at the south dike (Photograph No. 4). Excessive vegetation was noticed within the clearwater pool area. The access to the staff gauge via sloped liner was unsafe, specifically during wet condition.

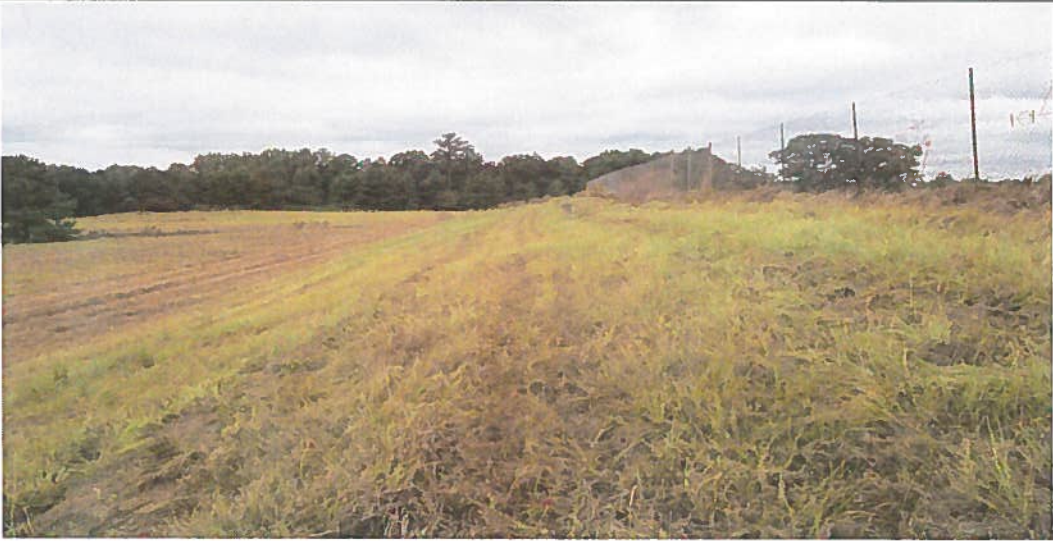
<p>Typical condition of the downstream slope of the west dike (looking north)</p>	
<p><u>Photo #9</u></p>

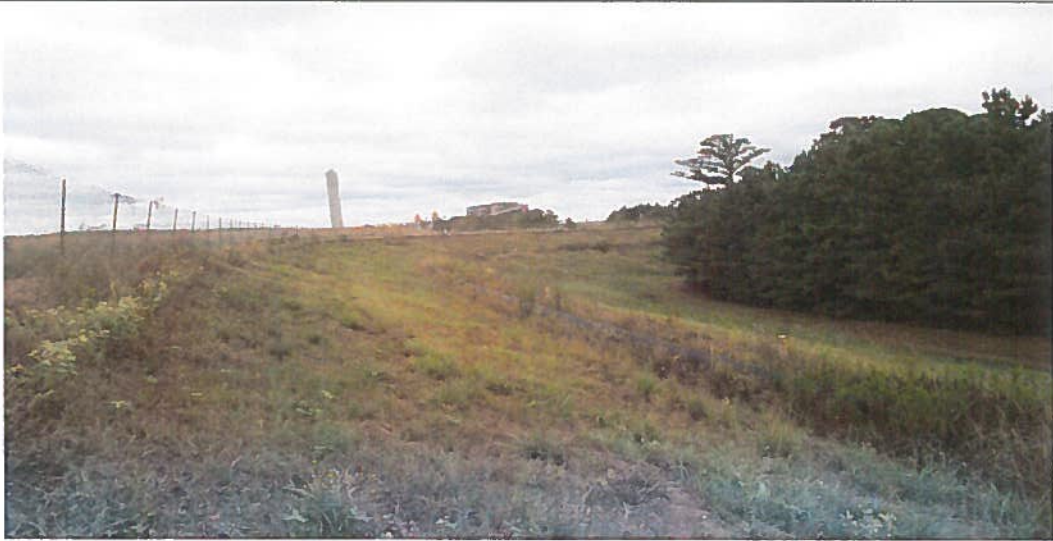
<p><u>Photo #10</u></p>

<p>Typical condition of the downstream slope of the southeast dike (looking north)</p>

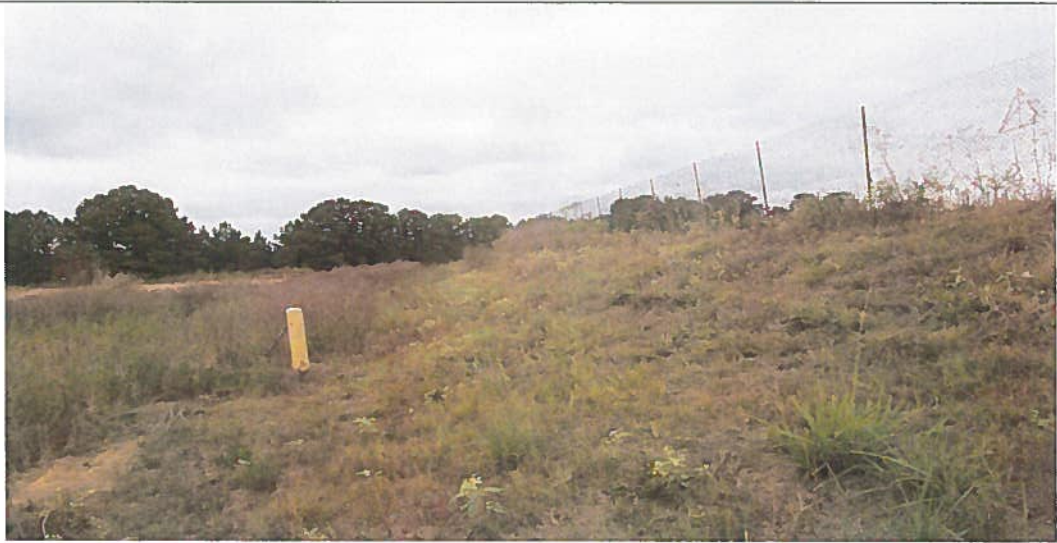
- (vi) An animal burrow 54-inch deep was encountered at the downstream slope of the east dike (Photograph No. 10).
- (vii) Typical condition of the downstream slope and toe area of the east dike (north section) is depicted in Photograph No. 11. The slope appeared in good and stable condition. The toe area consists overgrown vegetation that could have potential for accumulation of standing water.

A close-up photograph showing a hole in the ground. The hole is filled with reddish-brown soil and some roots. A white measuring stick is placed vertically in the hole for scale. The surrounding area is covered with dry, brown grass and some green weeds.
<p>Significant animal hole.</p>

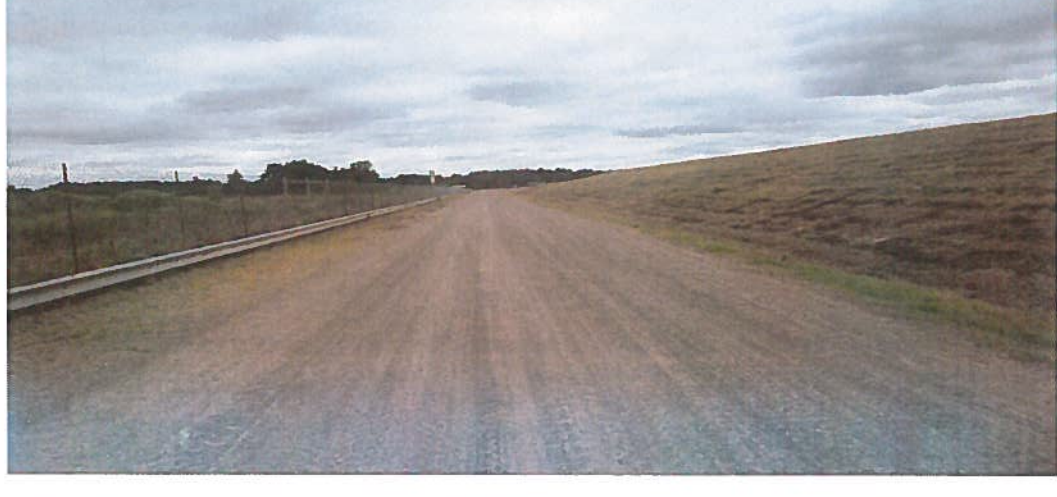
<p><u>Photo #12</u></p>

- (viii) Photograph No. 12 depicts the crest of the dike, which is also used as an access road. CCR landfill is located north of the dike's crest. The crest appeared in good condition without any settlement and misalignment.

A wide-angle photograph showing the crest and access road of the north dike. The road is a dirt/gravel path that runs along the crest of the dike. The dike is covered with dry, brown grass. In the background, there are trees and a fence line under a cloudy sky.
<p>Crest and access road of the north dike.</p>
