2020 DAM AND DIKE INSPECTION REPORT GEVR-20-010

PRIMARY BOTTOM ASH DAM FLINT CREEK PLANT SOUTHWESTERN ELECTRIC POWER COMPANY

GENTRY, ARKANSAS

2020 Annual Dam and Dike Inspection Report

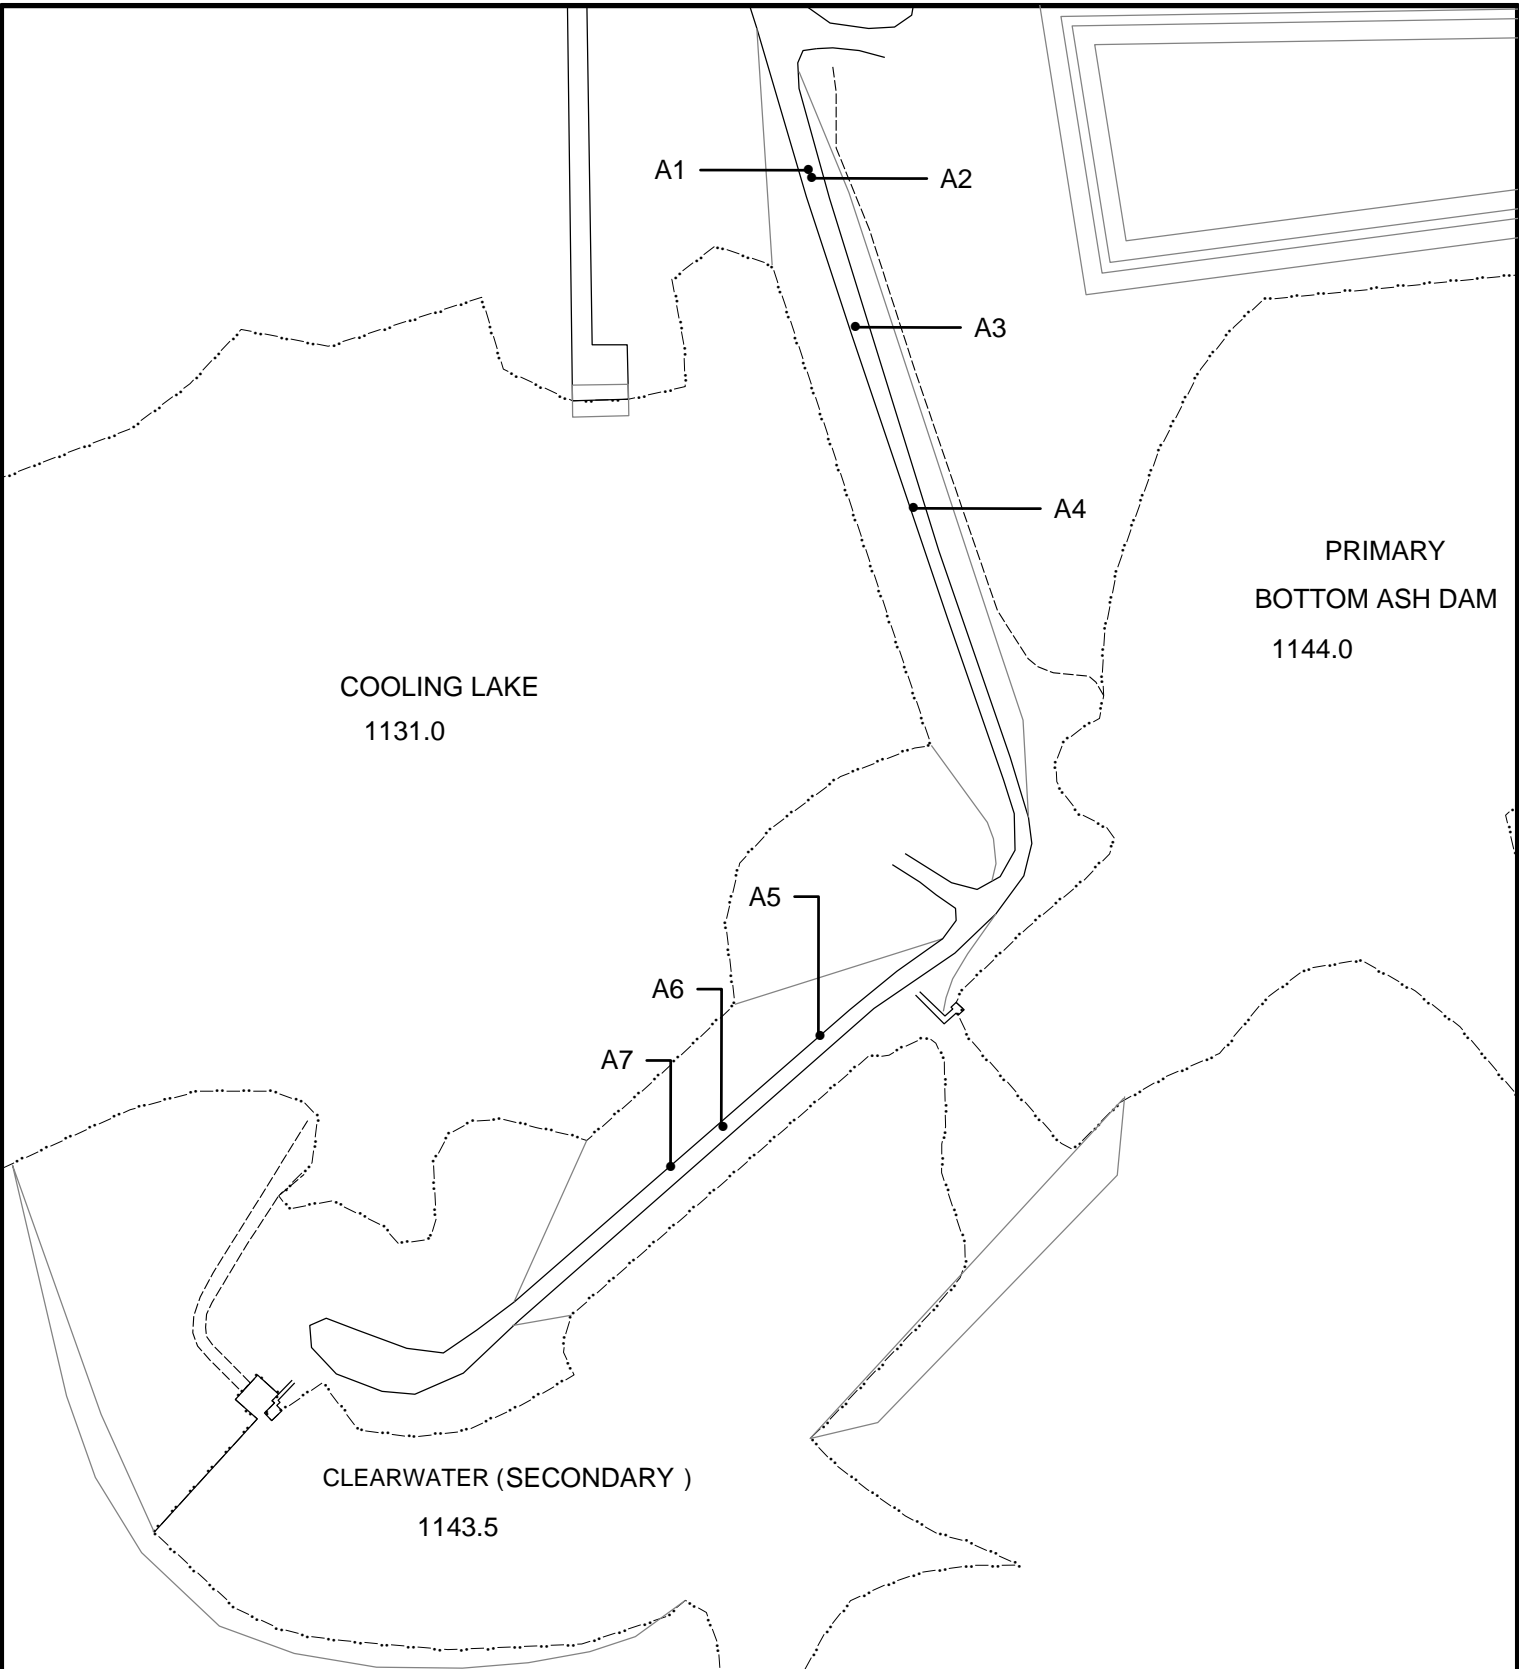
INSPECTION DATE: NOV 05, 2020, BY FREESE AND NICHOLS, INC.

PLACEMENT OF DAM COMPONENTS AND IDENTIFIED DEFICIENCIES IS APPROXIMATE
