# 2021 Annual Dam and Dike Inspection Report

**Fly Ash Pond**

**John E. Amos Plant  
Appalachian Power Co.  
Putnam County, West Virginia**

**December 2021**

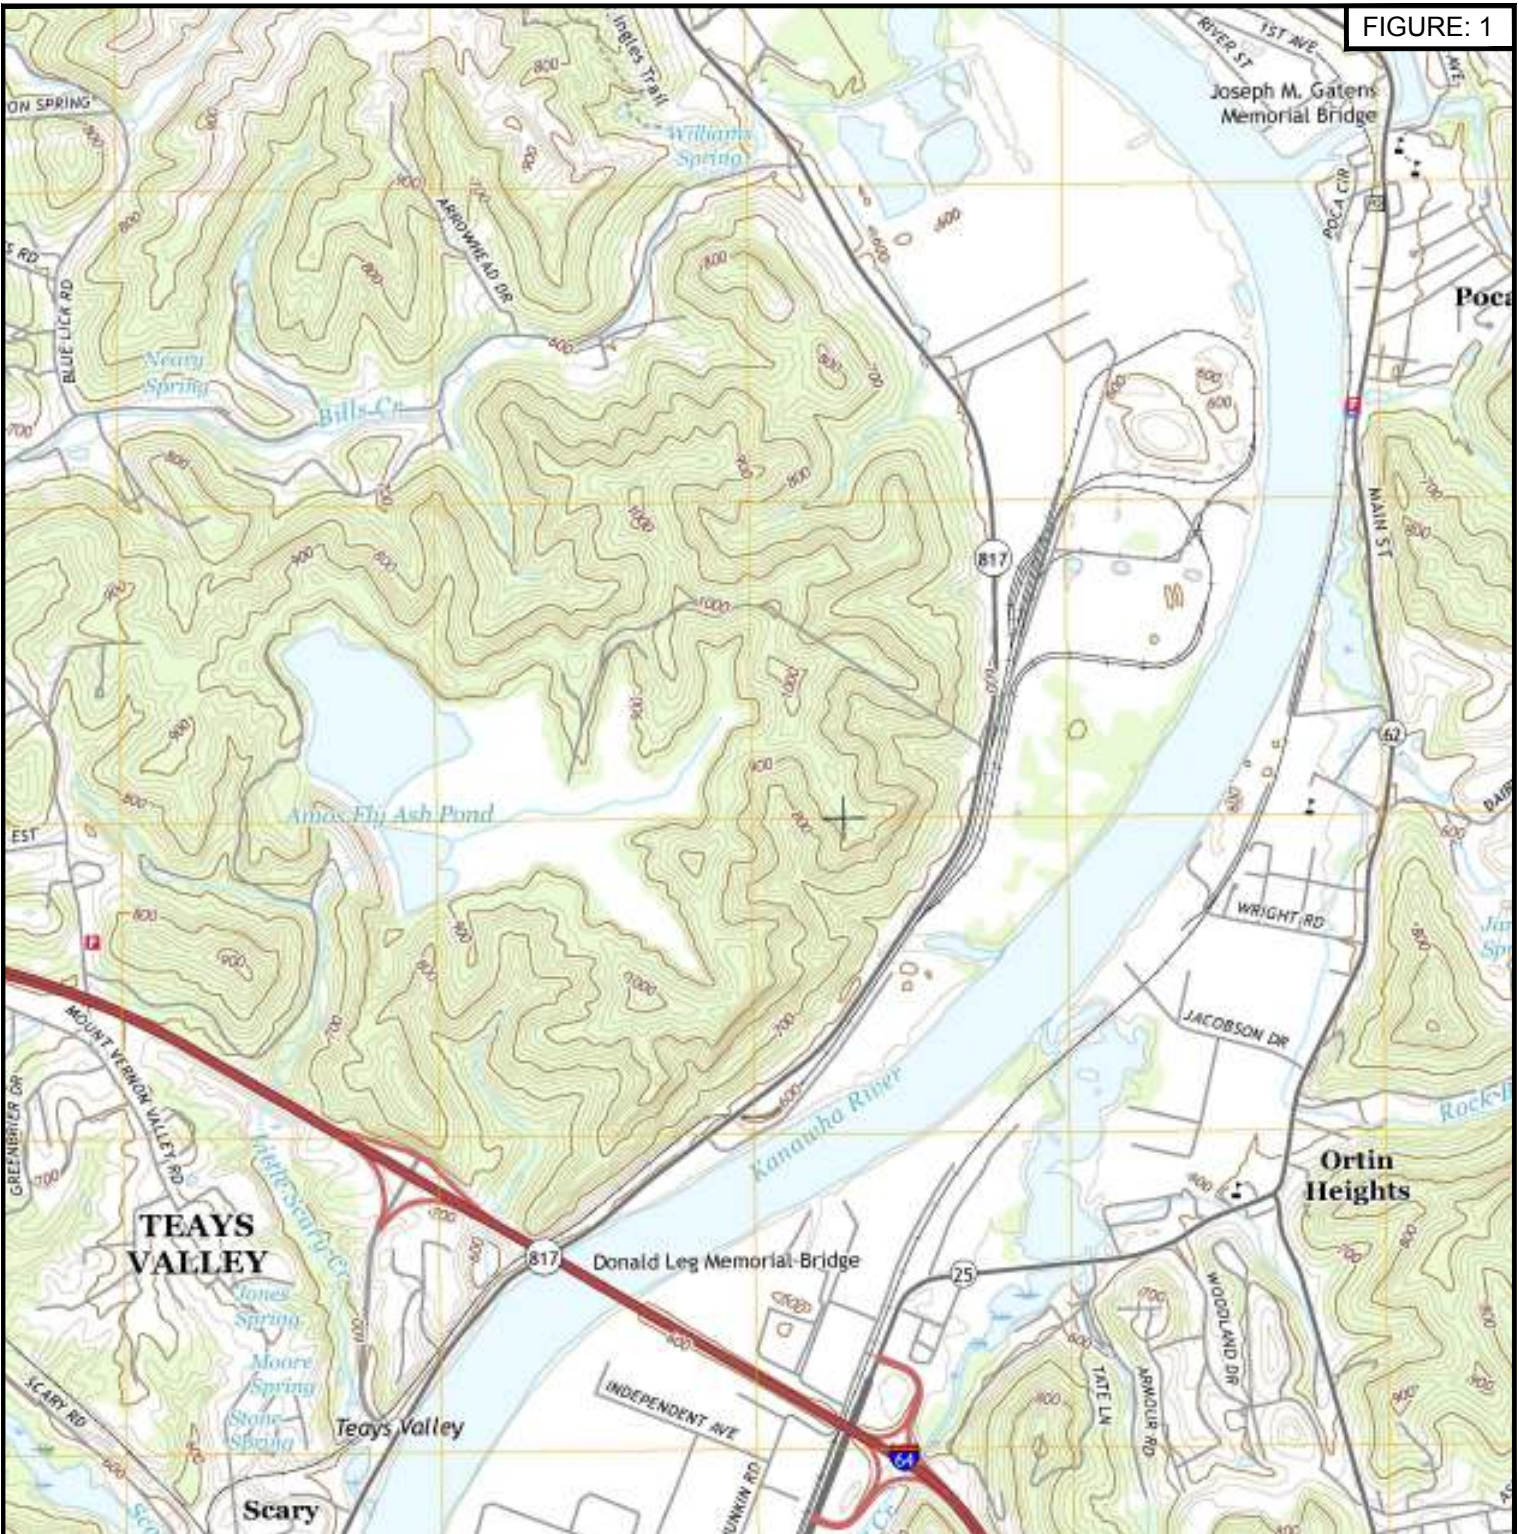
FIGURE: 1

The fly ash pond is located in Putnam County, West Virginia southwest of the John E. Amos (JEA) Power Plant between State Route 817 and Interstate I-64. The watershed for the fly ash pond drains to the Kanawha River (Figure 1). The JEA fly ash pond was used for sedimentation and storage of fly ash produced as a waste product in burning pulverized coal at the JEA Power Plant.

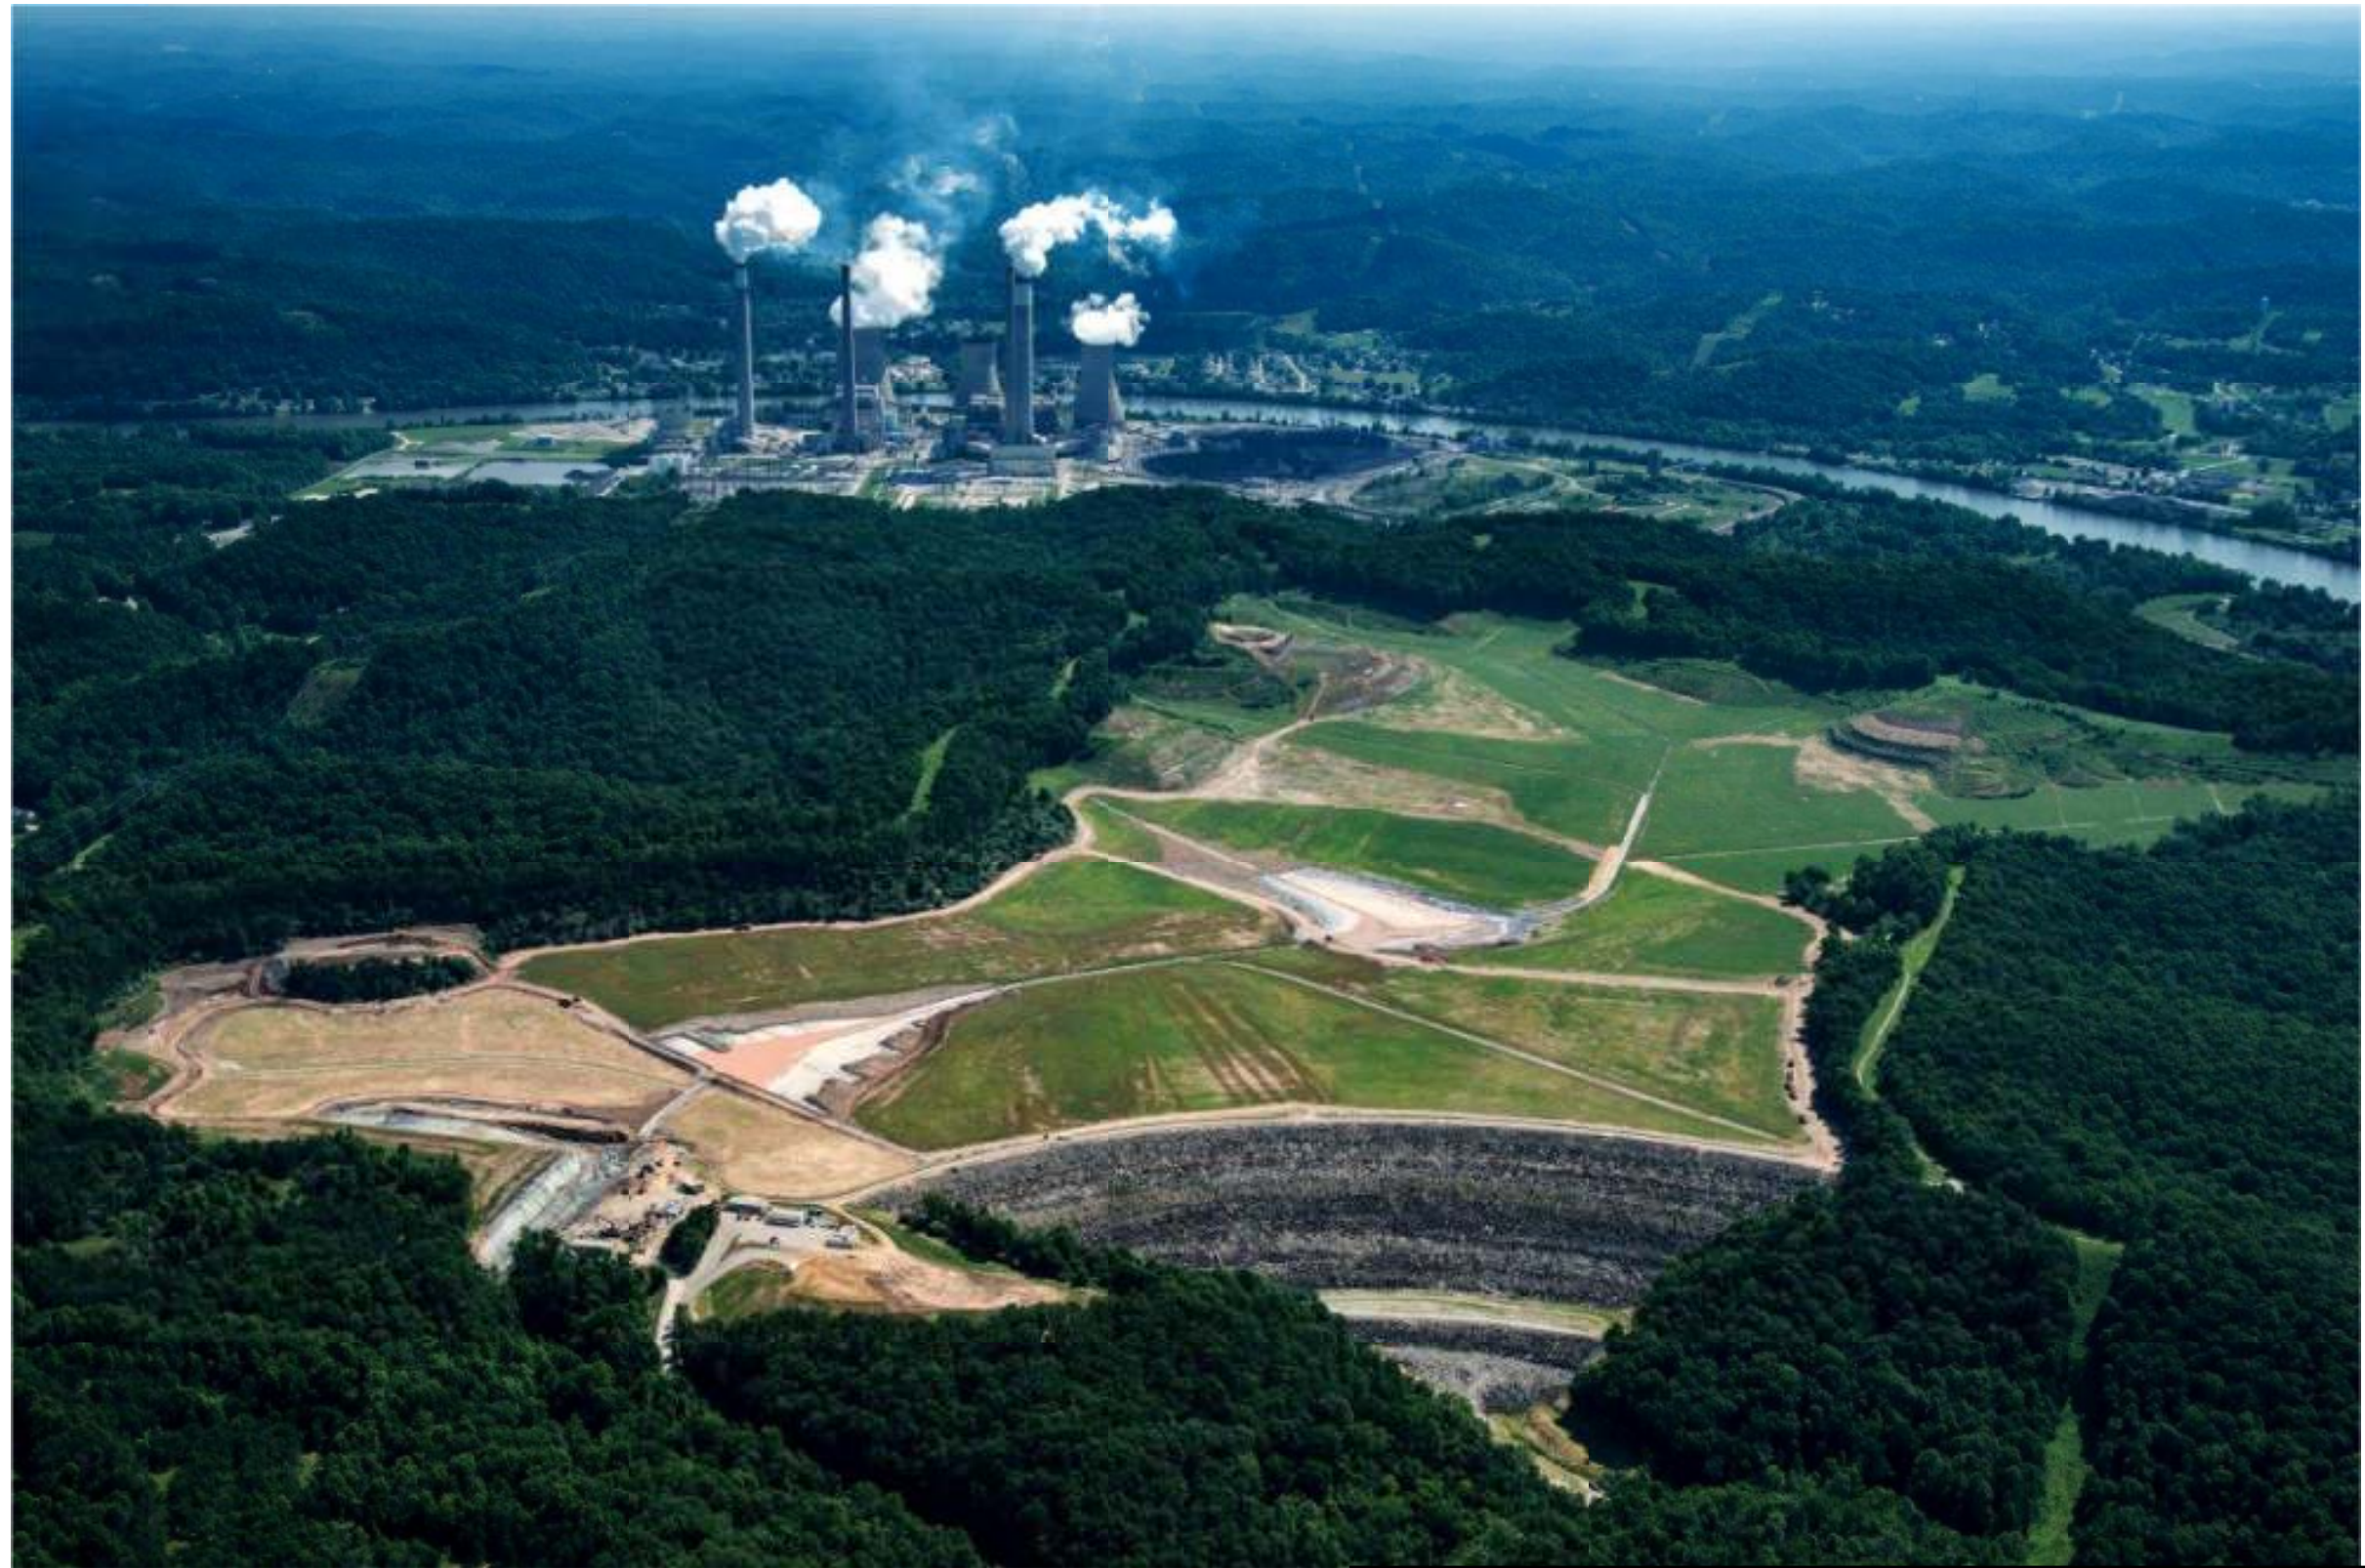
UNIT:	DRAWING NUMBER: <b>FIGURE 2</b>	REV:
SCALE:		
DR:		
CH:		
SUP:		
ENG:		
DATE:		
APPROVED BY		
<b>AEP AMERICAN ELECTRIC POWER</b>		
AEP SERVICE CORP. 1 RIVERSIDE PLAZA COLUMBUS, OH 43215

WV DEP dam safety approved APCo's permit application on June 10, 2013 to modify the facility to eliminate the free pool within the impoundment by grading the ash and placement of additional soil fill eventually capping it with a synthetic liner overlain with a soil cover allowing non-contact water to be discharged through a new spillway. There is no open pool of water behind the dam and precipitation that falls within the pond's watershed is conveyed via surface channels to an outlet channel cut in the ridgeline to the west of the dam. The Notice of Closure Completion was placed on January 10, 2018 in the operating record. Figures 2 (aerial image – plan view) shows the locations of closure and capping activities for the fly ash pond and dam.

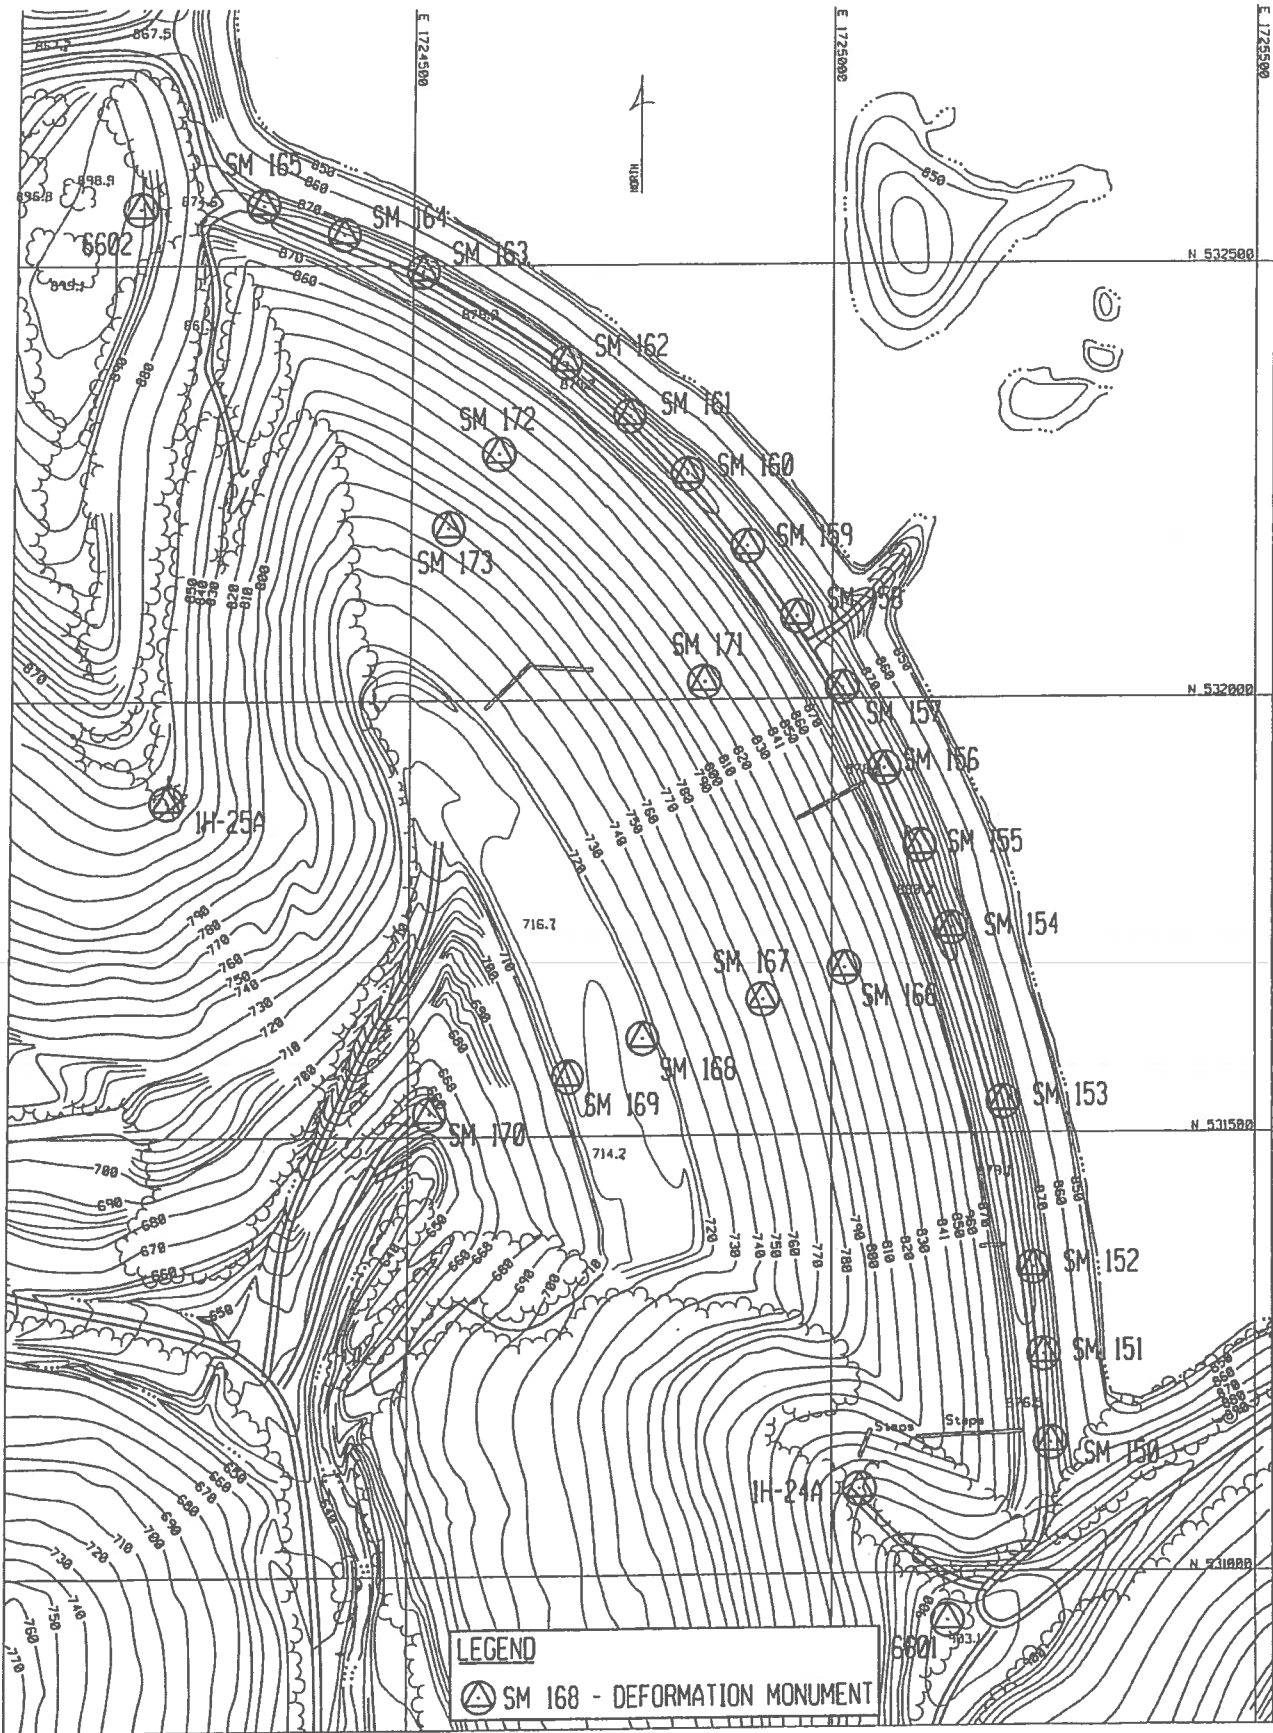
LOCATION MAP DEFORMATION MONUMENTS

historically been monitored using 24 permanent reference points (survey monuments). The deformation surveys were conducted on a semi-annual basis until November 2015 when 30-day monitoring was implemented in accordance with 40CFR257.83 for 12 of the permanent survey monuments. The reports provide graphs of the vertical and horizontal displacements as a function of time for the survey monuments. The deformation of all the monuments have been reviewed as a part of this annual inspection and no unusual or unexpected behavior has been observed.

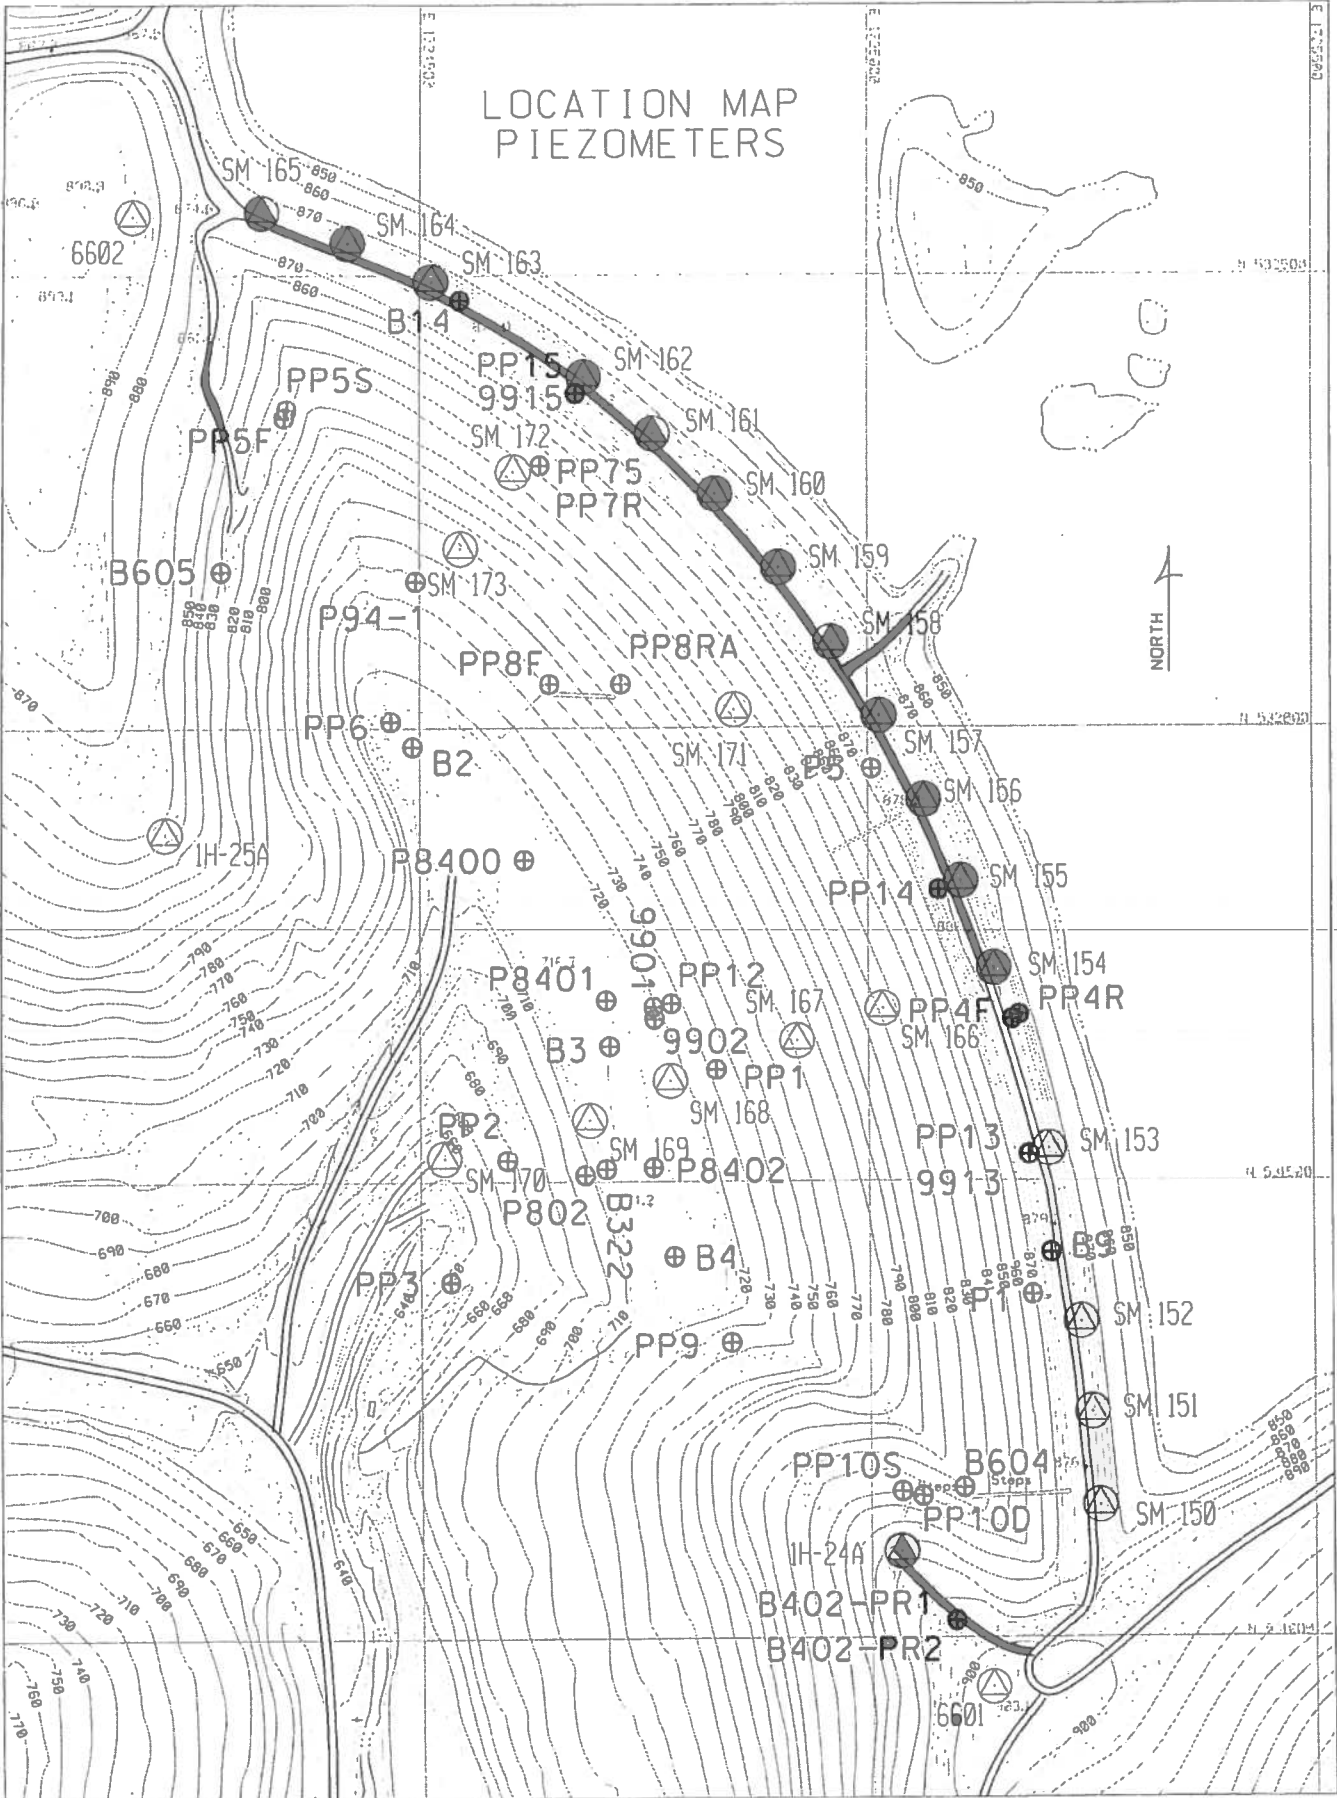
# LOCATION MAP PIEZOMETERS

Most of piezometers readings continue to show consistent water elevations in the dam. Piezometers 8400, 8401, and 8402 have historically shown wide swings in water elevations and those observed since the last inspection are consistent with those trends. A graph of the piezometer readings is included in Attachment C. A notable departure is recorded at PP1 and PP7R that may represent erroneous measurements since subsequent measurements appear to have returned to normal conditions. A blockage was noted and repaired in P1 and there were several dates with no readings while the issue was evaluated and repaired.
