2022 Dam and Dike Inspection Report

Bottom Ash Pond

**Northeastern 3&4 Plant
Public Service Company of Oklahoma
Oologah, OK**

Document Number: GERS-22-018

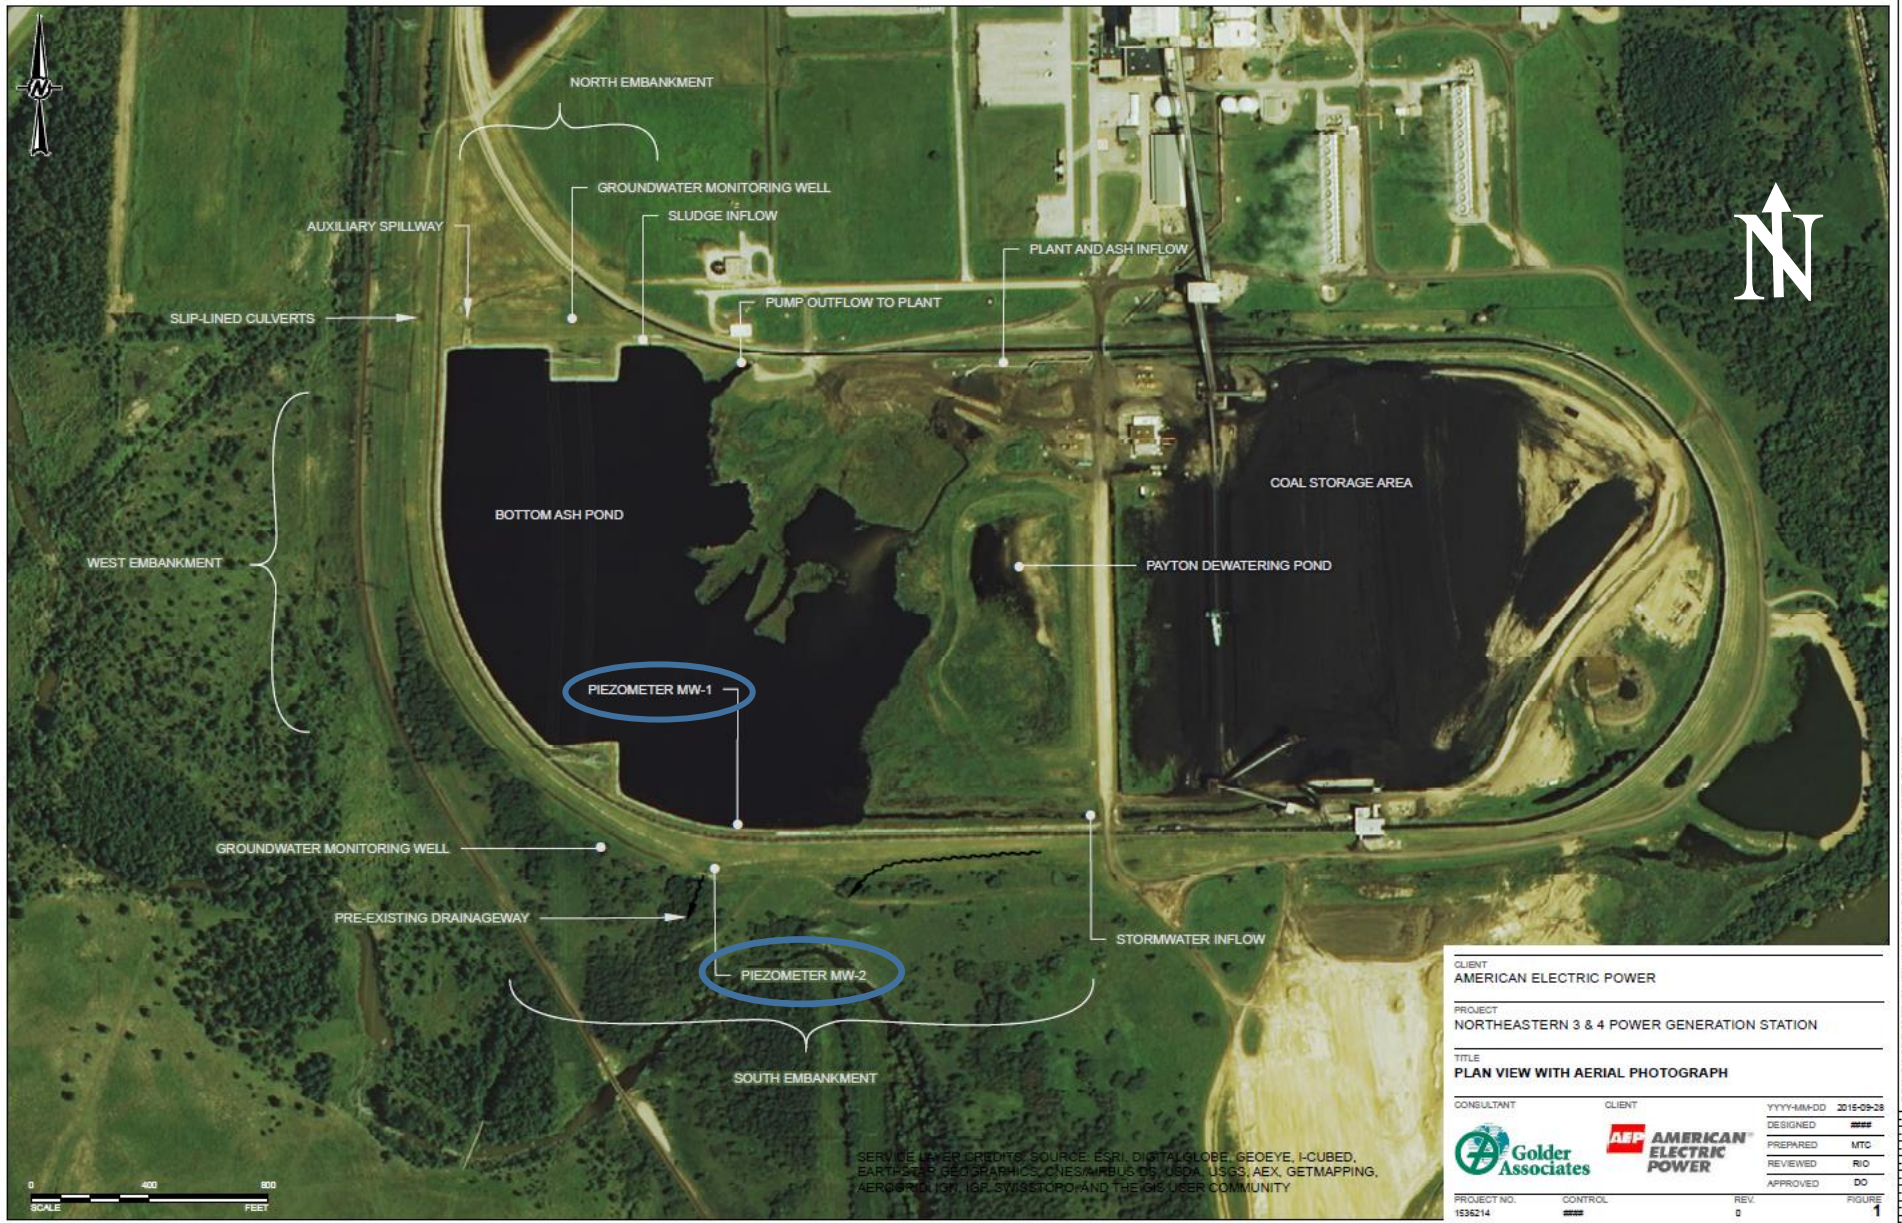
Figure 2 – Facility Map
Bottom Ash Pond
Northeastern Plant, Oologah, OK

Figure 2 provides a plan view of the bottom ash pond, the embankment (dikes) structure of dam, pertinent dam features, and the dam's appurtenances. The dam is a 4,200-foot long cross-valley fill on an unnamed tributary to Fourmile Creek. The dam is roughly U-shaped and has been divided into north, west, and south embankments for reference in this inspection report.

There is no principal spillway at the bottom ash pond, water is typically recirculated back to the power plant for reuse. The auxiliary spillway at the bottom ash pond is a concrete overflow structure with a design crest elevation of 625 feet. Overflow from the spillway discharges to a low area and then flows through culverts under a railroad and off site. Figure 2 shows the spillway and discharge culverts locations.

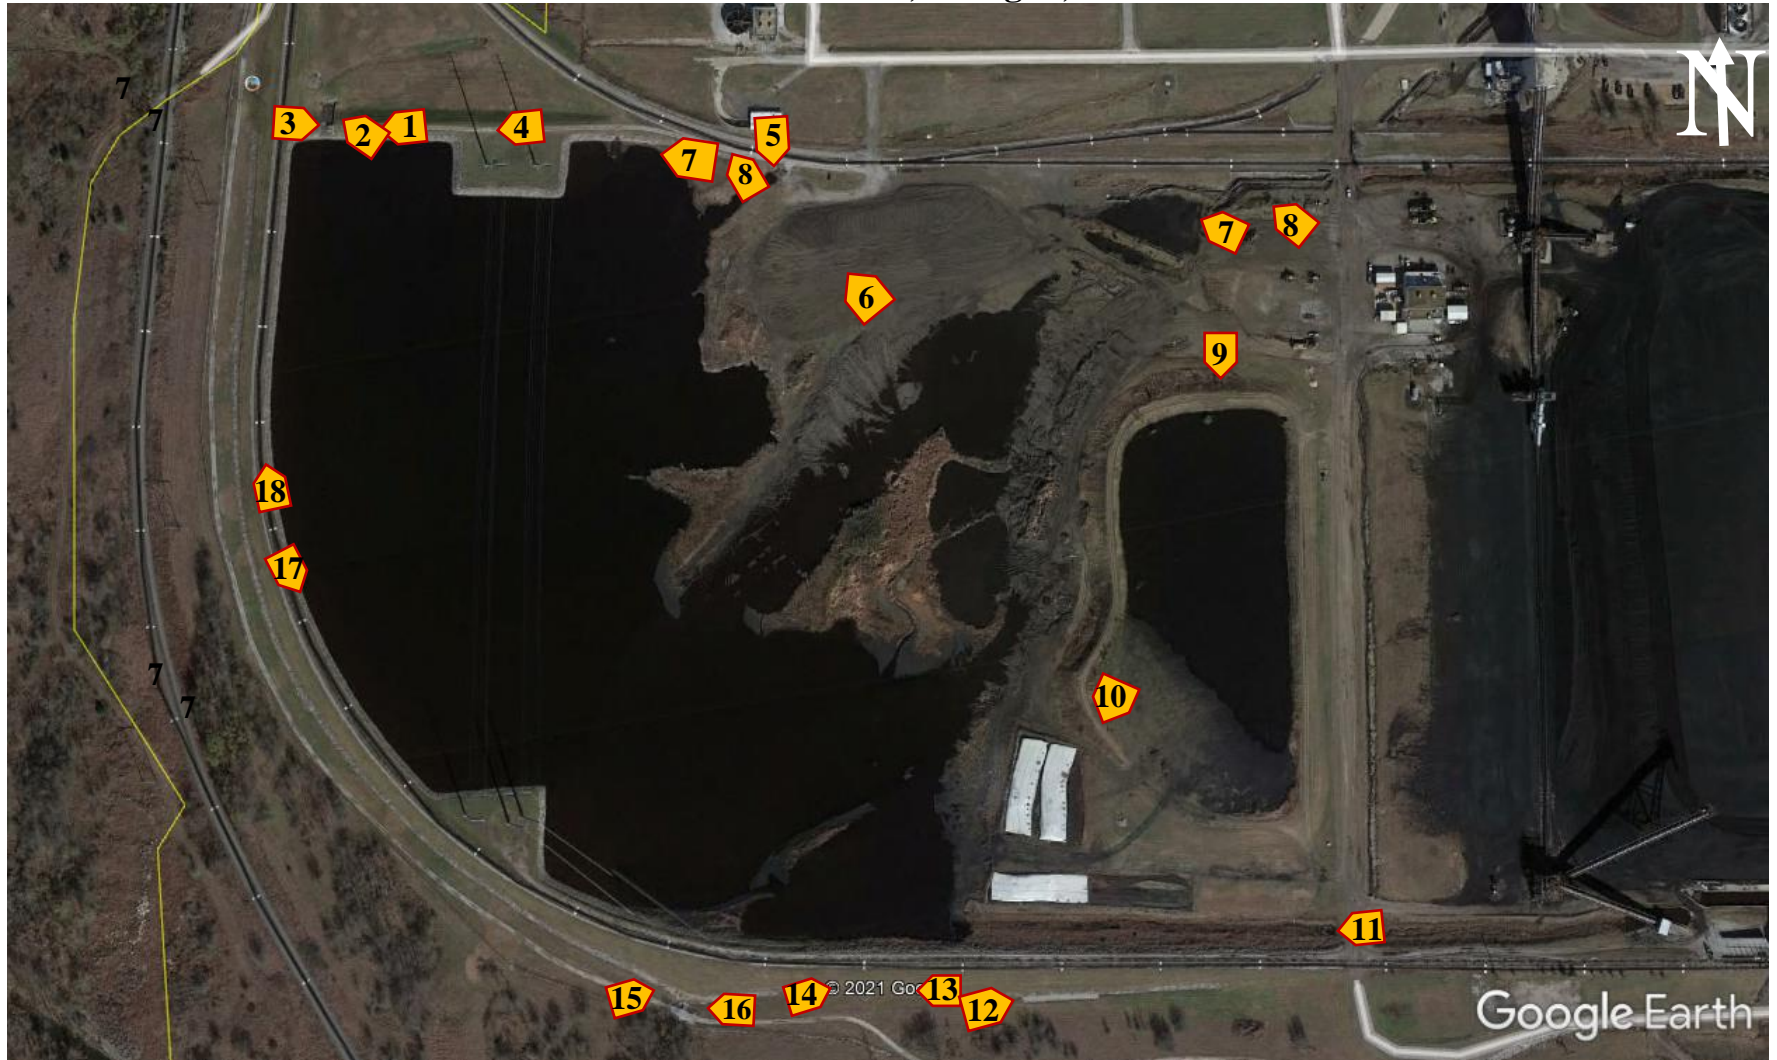
Figure 4 – Inspection Photograph Location Map
Bottom Ash Pond
Northeastern Plant, Oologah, OK

A visual inspection of the Bottom Ash Pond was conducted to identify any signs of distress or malfunction of the impoundment and appurtenant structures. Specific items inspected included all structural elements of the dam such as inboard and outboard slopes, crest, and toe; as well as appurtenances. Figure 4 illustrate the visual inspection photograph location.
