# **2022 ANNUAL DAM AND DIKE INSPECTION REPORT**

**CCR ASH PONDS**

**WELSH POWER PLANT  
CASON, TEXAS**

DOCUMENT ID: GERS-22-043  
Revision 0

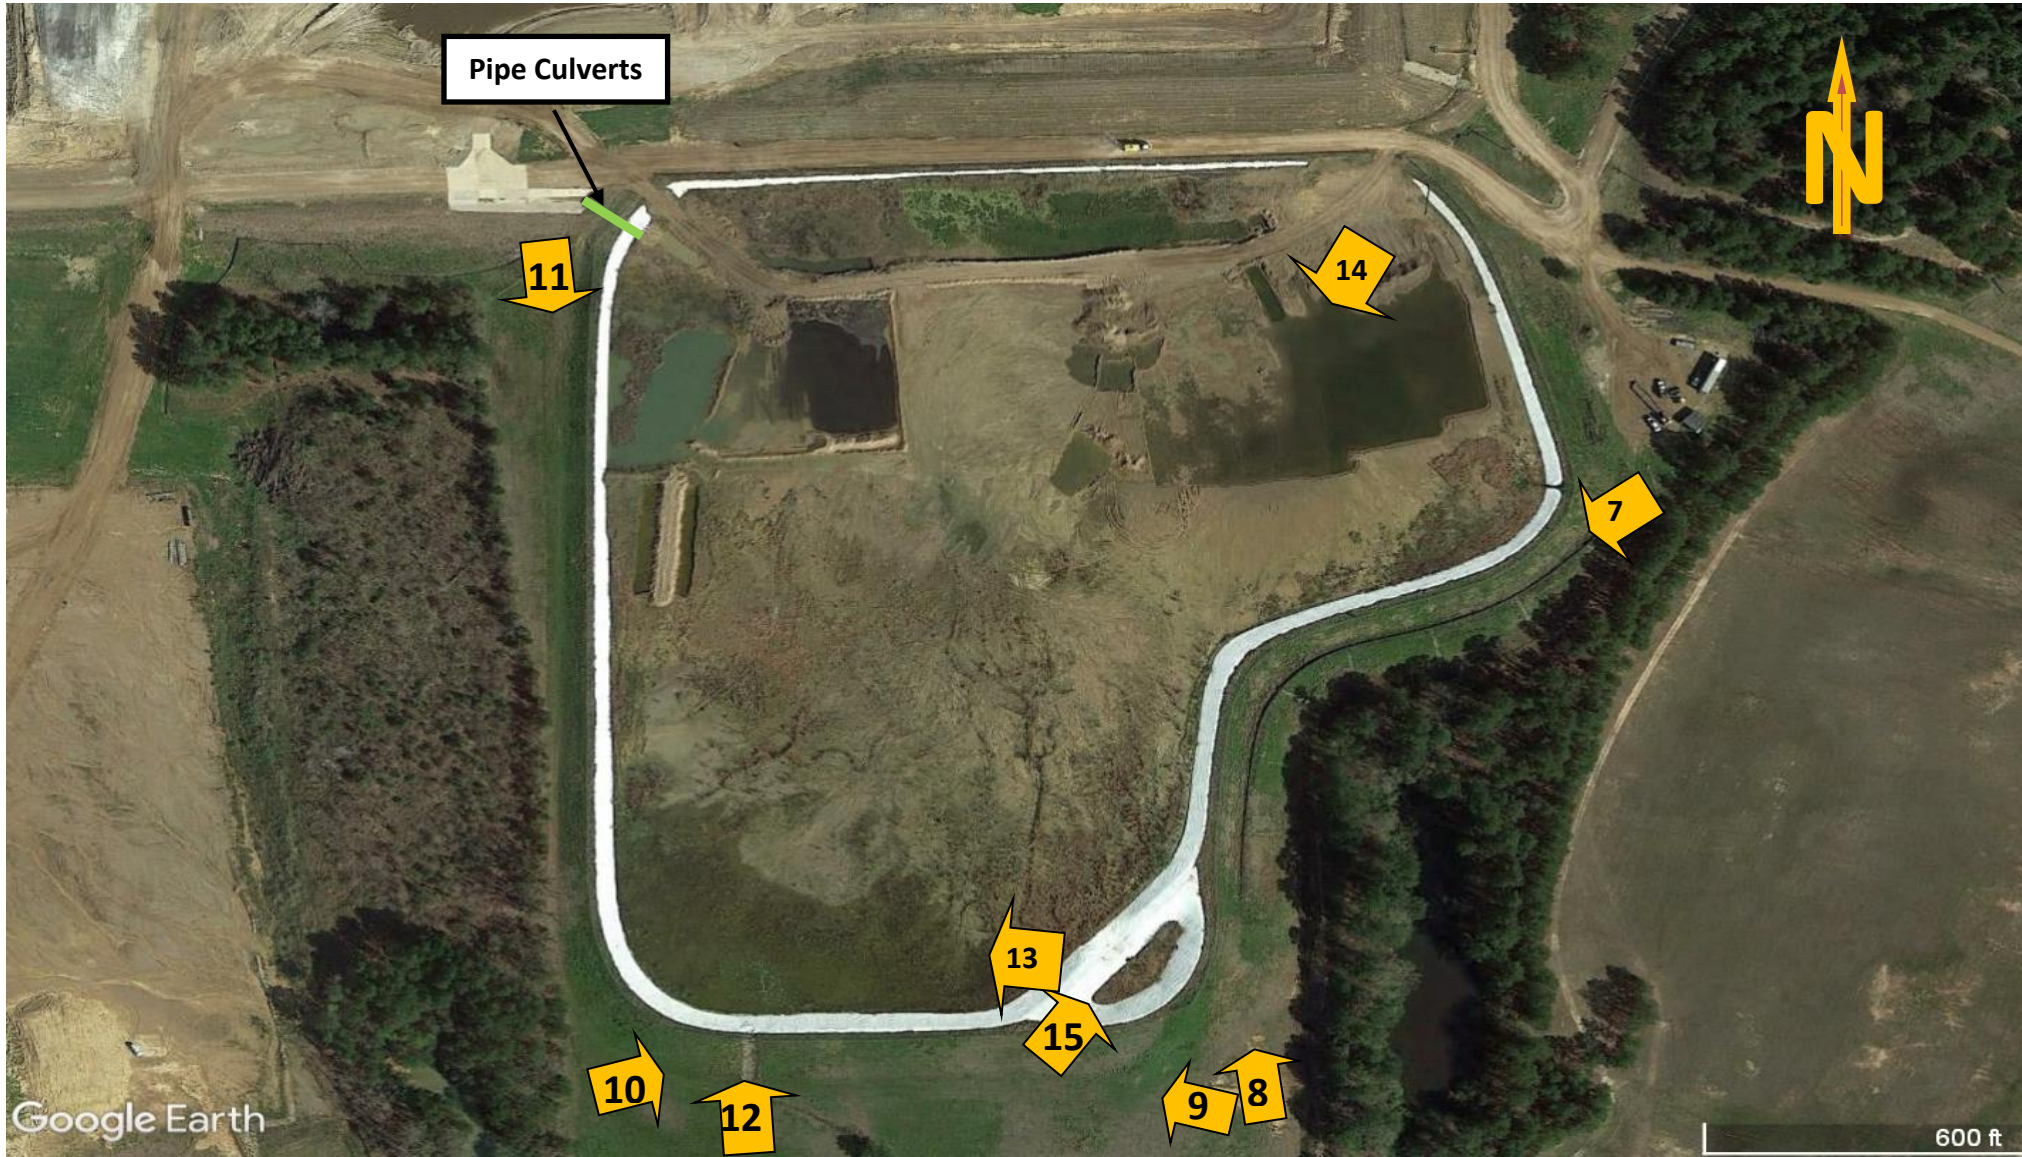
Photo # 7

- (i) The east portion of the downstream slope is illustrated in Photographs No. 7 and 8. Slightly overgrown vegetation was noticed on these slopes. The slope appeared in satisfactory and stable condition with no signs of settlement, misalignment, sloughing or erosion.

Bottom Ash Storage Pond (Winston Pond) looking at downstream slope conditions on east side.
