**2015 DAM & DIKE INSPECTION REPORT  
Rockport Plant  
Bottom Ash Pond Complex**

**GERS-15-013**

**ROCKPORT POWER PLANT**

**August 13, 2015**

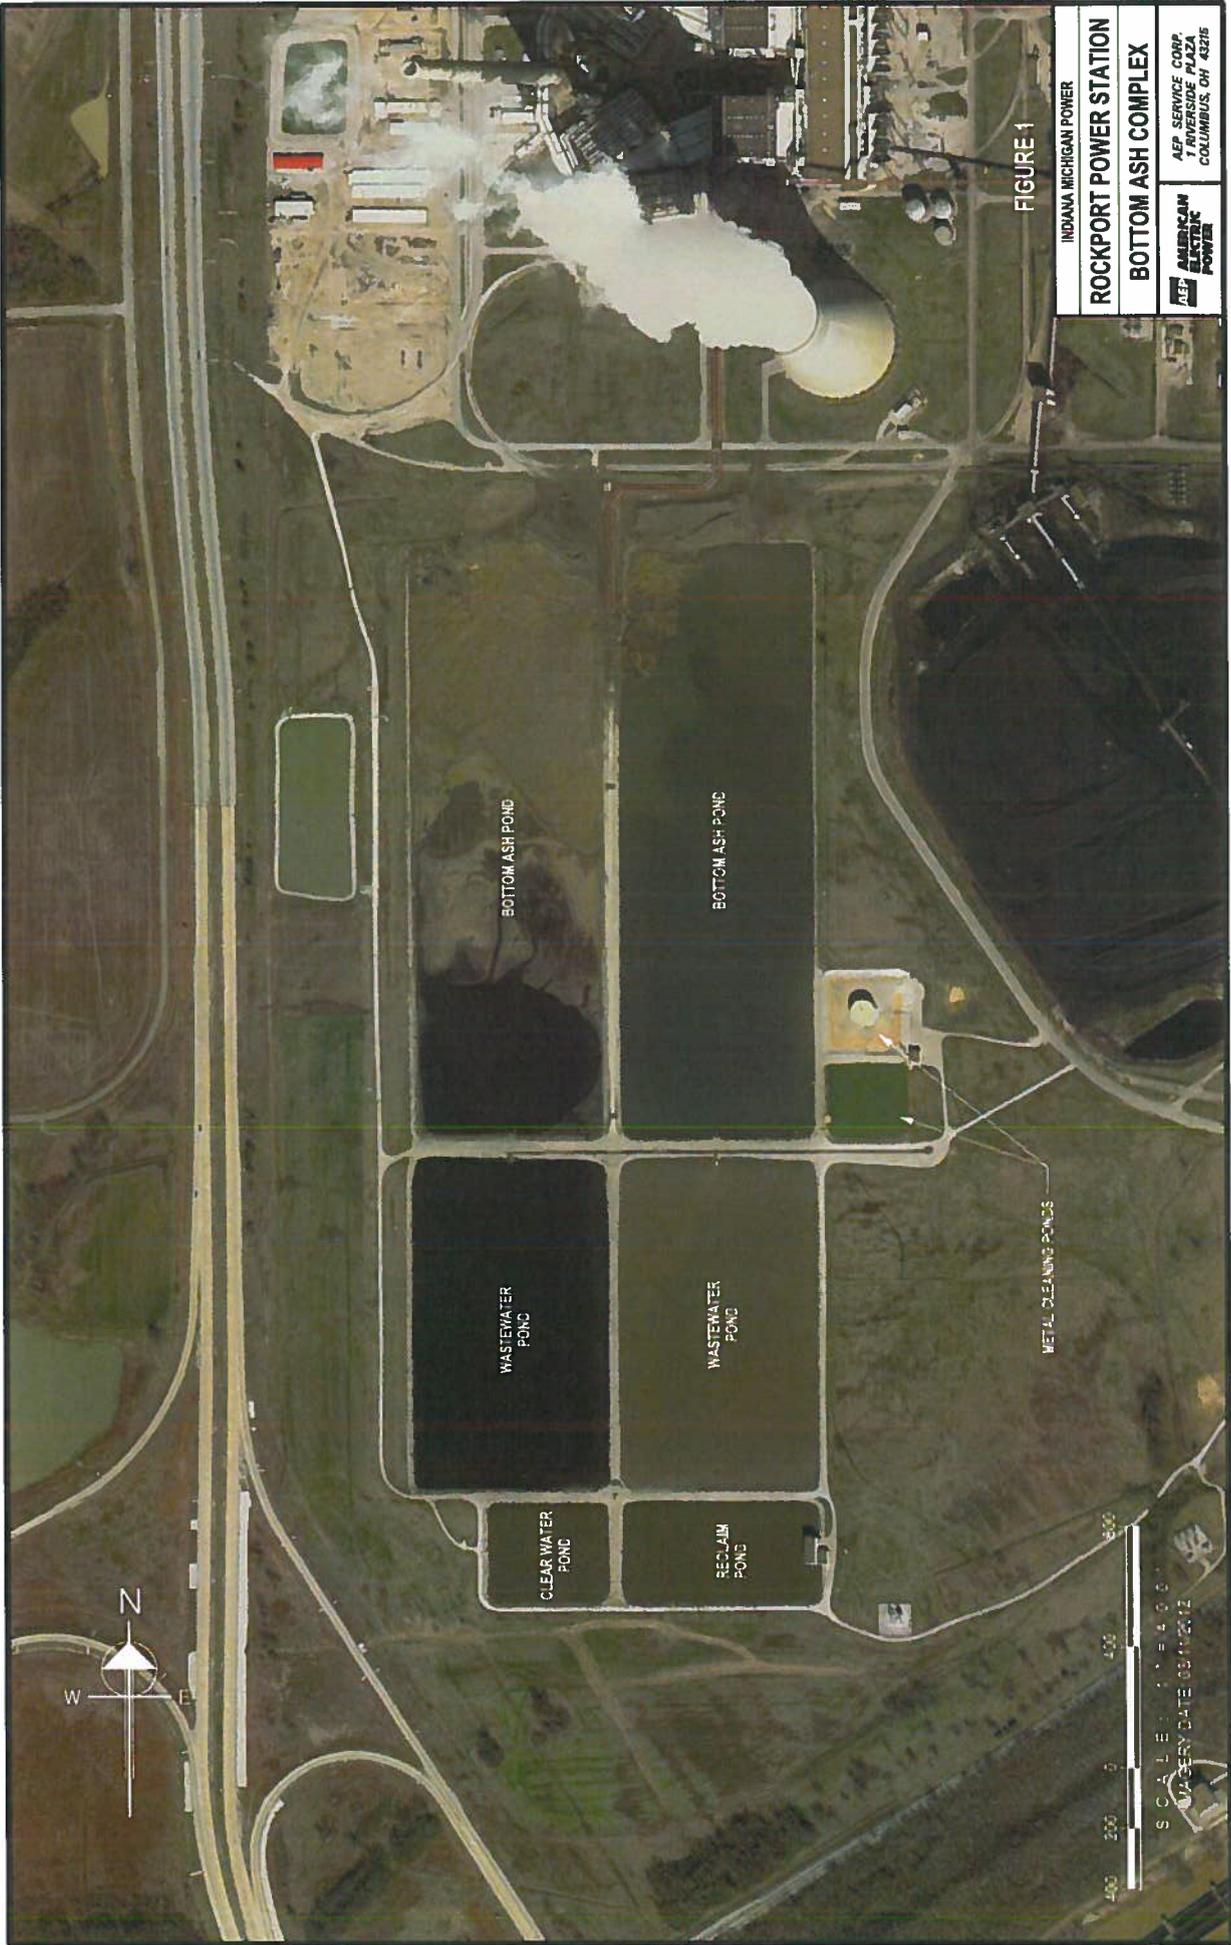
FIGURE 1

The Bottom Ash Pond Complex consists of East Bottom Ash Pond (EBAP) and West Bottom Ash Ponds (WBAP), (Figure 1 of Appendix A). The Bottom Ash Complex is generally a below ground facility with only the west dike of the WBAP extending above grade such that the normal pool elevation is maintained above ground level. The exterior slope is 2.5 Horizontal to 1 Vertical (2.5H:1V) with interior slopes of 2 H:1V.
