**2016 DAM & DIKE INSPECTION  
REPORT  
RECLAIM POND  
ASH POND 1A & 1B  
POND 2**

**CLINCH RIVER PLANT  
CARBO, VA**

**INSPECTION DATE** October 19 & 20, 2016

**QA/QC DOCUMENT NO.**  
GERS-16-157

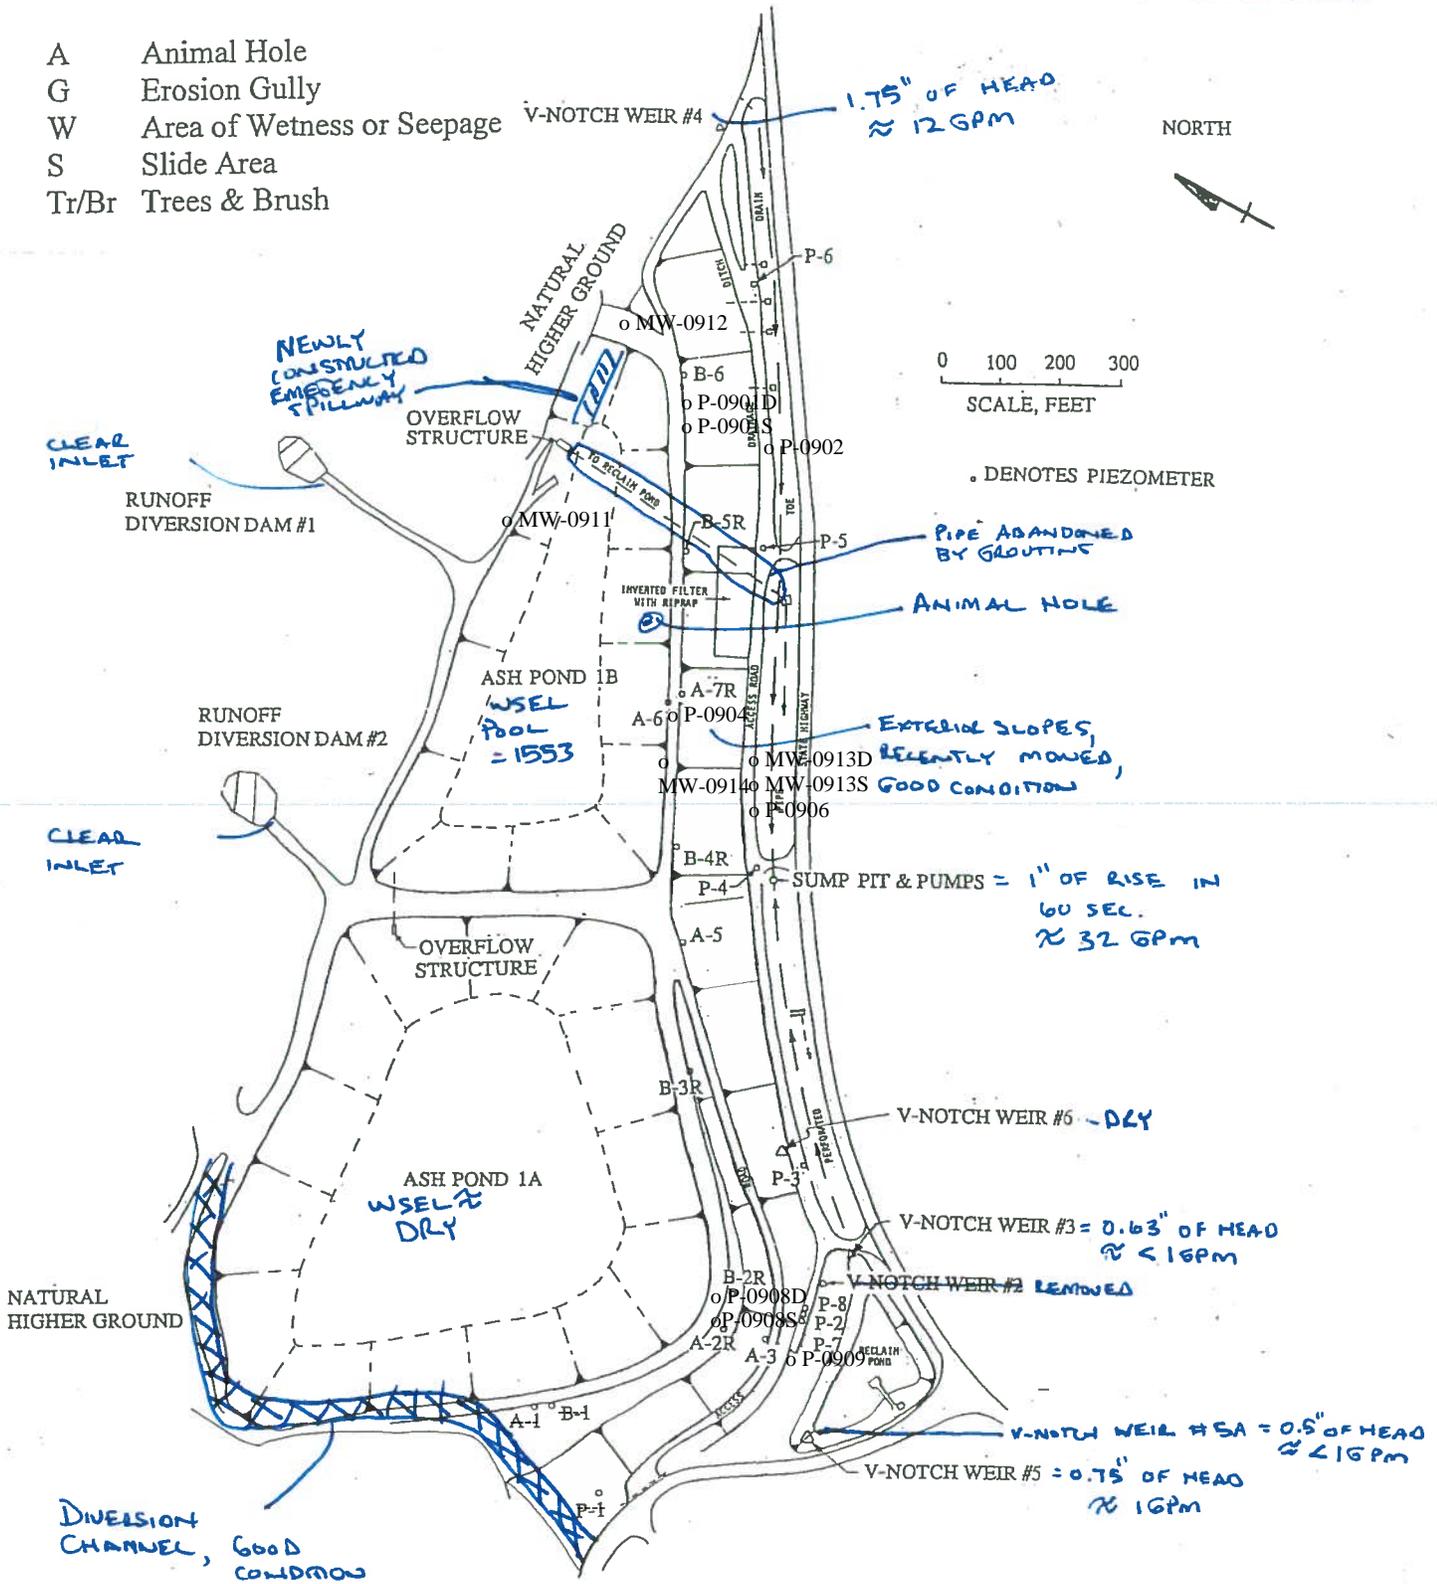
FIGURE 1  
CLINCH RIVER PLANT  
ASH POND 1A AND 1B COMPLEX  
INSPECTION LOCATION PLAN

1. The north slope of the pond is in good condition. The riprap and gravel surface appeared stable. (Photo 1)
2. An erosion gully which has been observed during the past several annual inspections has been repaired. (Photo 1)
3. The V-notch weir boxes referenced as Nos. 3, 5 and 5A were in good condition. Flow was discharging from all three weirs, see table on page 6 for flow rates. Since the plant has stopped sluicing to the pond and the pool level has dropped the flow rates at each weir box have declined from normal levels. All flows were clear. The vegetation around the weir boxes was mowed and did not restrict flow. (Photos 2-4)

1. The exterior slope of the west 1A dike was well vegetated and the cover was recently mowed. In general the slope is in good condition. (Photo 5) The groin ditch at the west abutment was in good condition and recently mowed. The area around the concrete channel, culvert and energy dissipater has good vegetation. The vegetation on the abutment section was clear of woody vegetation within 25 feet of the groin (as per the VA Dam Safety requirements). The abutment was stable and no seepage was observed. An underdrain that collects water under the surface of the diversion channel and outlets into the concrete channel was discharging. (Photo 6)

2. A temporary spillway was recently constructed by using riprap and concrete in the northeast portion of Pond 1B. The spillway was in good condition. (Photo 14-15)

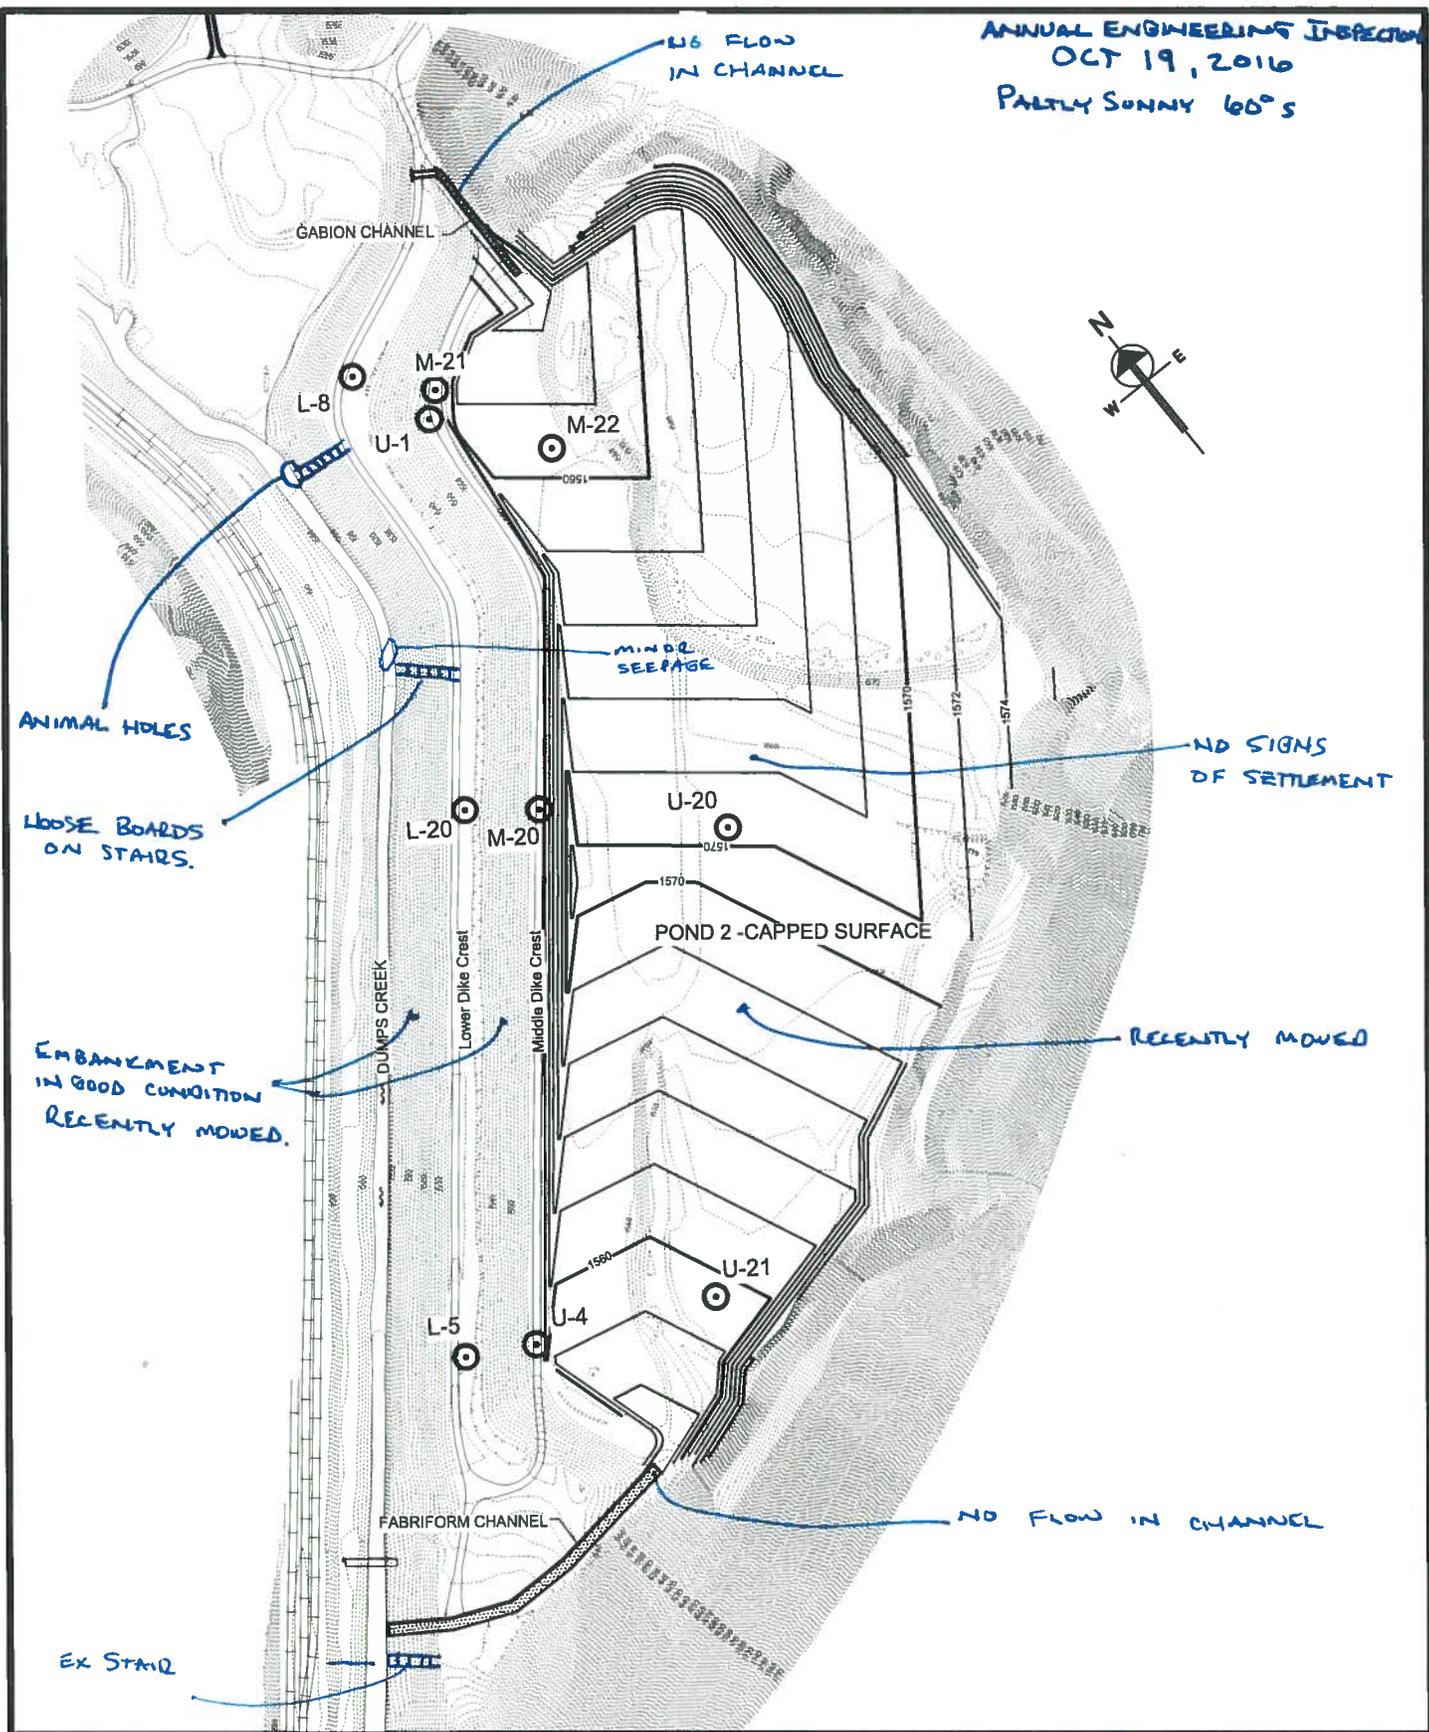
DRN BY: DWP	APPALACHIAN POWER COMPANY	DWG NO: Figure 2
DATE: 11-19-2014	CLINCH RIVER PLANT

10. The outlet downstream of the east gabion discharge channel appears stable. There was no observed erosion of the riprap as observed in previous inspections. There was minor debris at the outlet of the culvert. (Photo 32)

Prior to the cap and closure of Pond 2, nine (9) piezometers were installed and monitored using a vibrating wire sensor and data logger. These reading are currently taken once week and collected every month. Four (4) existing traditional piezometers are also monitored within the Pond 2 on a monthly basis. All readings have been within their normal ranges or have been decreasing since the installation of the cap system. The location of these piezometers is shown on Figure 2.
