2019 Annual Landfill Inspection Report

**Rockport Plant
Indiana Michigan Power Company
Rockport, Indiana**

September 2019

Document ID: GERS-19-023

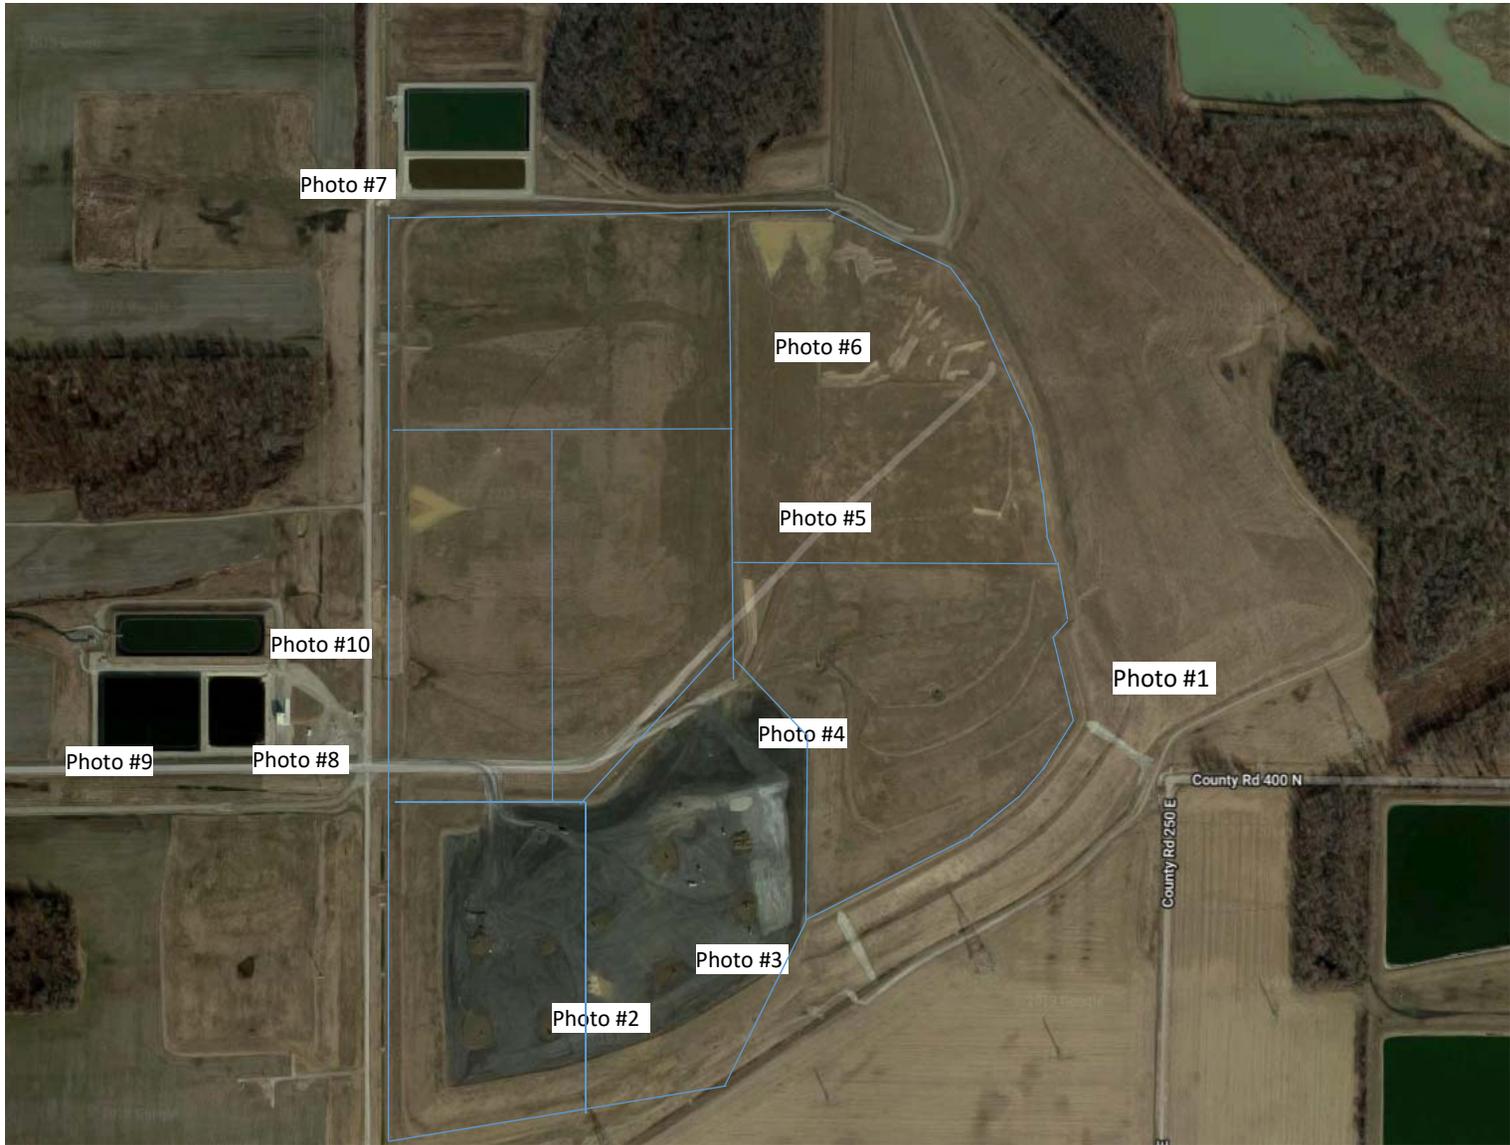
Figure 1. Photo Location

These features, including the approximate limits of each area, are shown on the Figure 1 of Attachment B.

The Closed Landfill Area is located on the north and east sides of the landfill as shown on Figure 1. This area of the landfill was constructed between 1985 and 1987 and was used for disposal of Type II ash. The area was closed and final cover was placed between 2000 and 2007. The final cover consists of twenty-four (24) inch thick compacted clay cover and a six (6) inch thick topsoil cover to support vegetation.
