2020 DAM AND DIKE INSPECTION REPORT GEVR-20-008

BOTTOM ASH POND NORTHEASTERN 3&4 PLANT PUBLIC SERVICE COMPANY OF OKLAHOMA

2020 Annual Dam and Dike Inspection Report

Document Number: GEVR-20-008

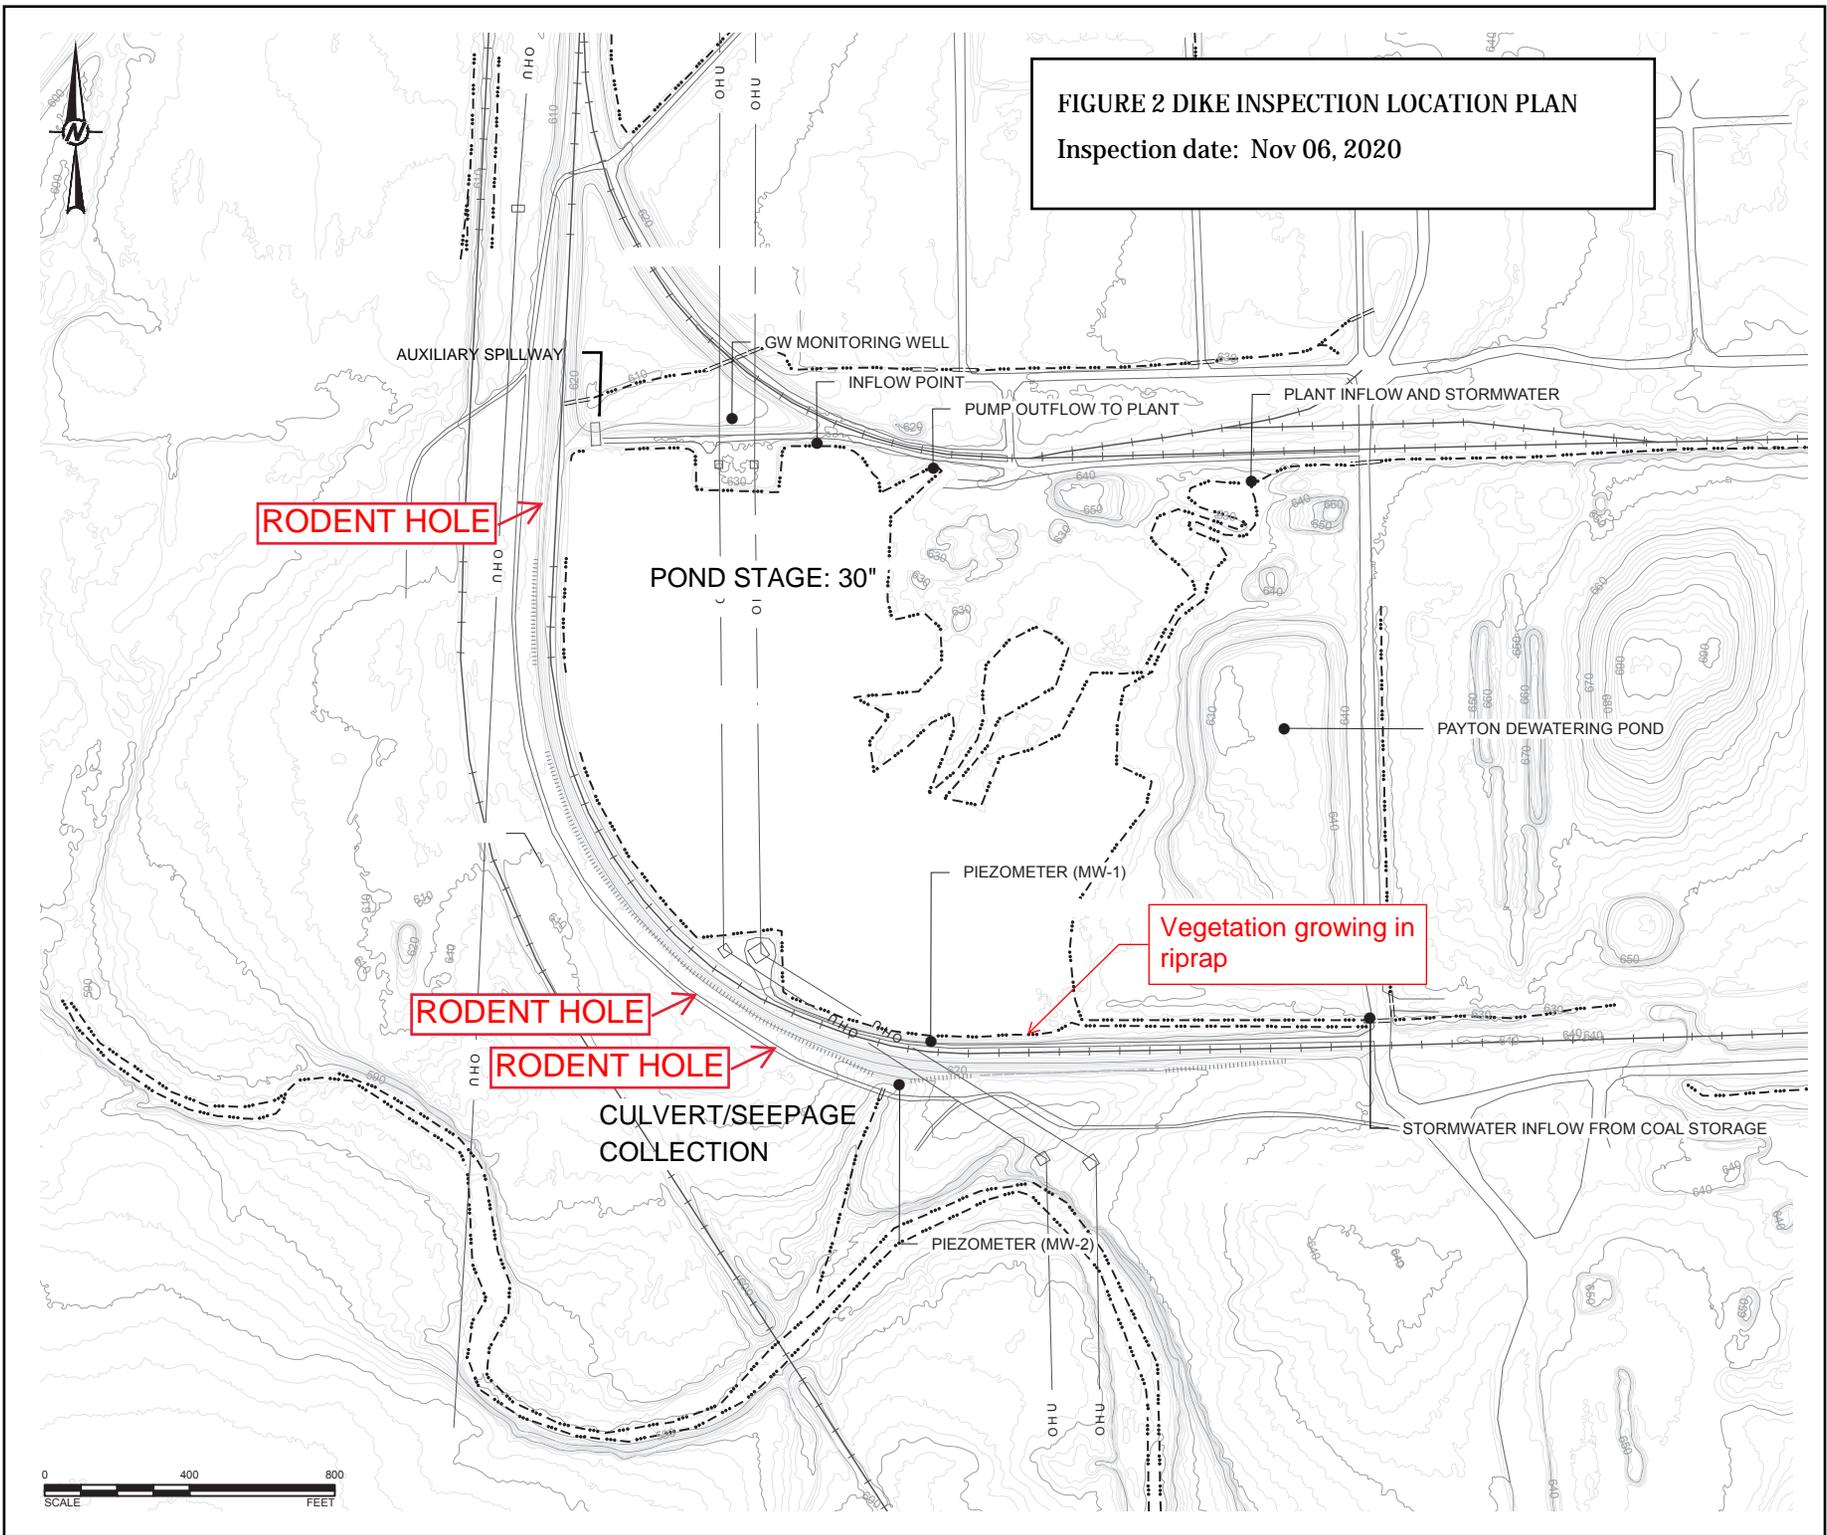
FIGURE 2 DIKE INSPECTION LOCATION PLAN
Inspection date: Nov 06, 2020

There are two piezometers and a seepage collection pipe as part of the instrumentation for this facility. The locations of the instrumentations are shown on Figure 2. The maximum and minimum recorded readings of each piezometer since the previous annual inspection is shown in Table 1 below. The readings collected since the last inspection were all within their normal safe operating ranges. MW-01 is located on the crest of the dam and MW-02 is located at the toe of the dam. The water level in the pond ranged from elevation 624.5 – 622.3.
