2020 Annual Dam and Dike Inspection Report

Clinch River Ash Pond 1A/1B

**Clinch River
Appalachian Power Company
Carbo, Virginia**

Document ID: GERS-20-015

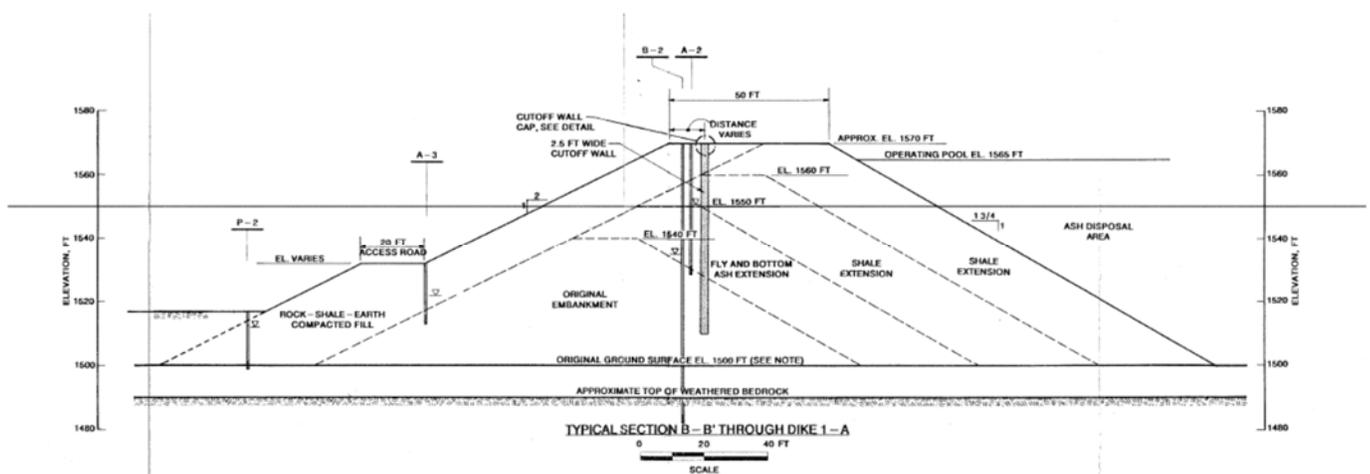
The majority of the downstream slope has an inverted filter that was constructed in 2006-2009. A toe drain system with a single stage drainage media runs along the downstream toe. The toe drain system was retrofitted to drain into a seepage pump station near the center of the dam. The seepage is pumped and drains by gravity into the reclaim pond, near the southern end of the Ash Pond 1A/1B Dam.

Typical cross section taken from AEP Drawing SK-CL-62290A.
