LOCATION RESTRICTION EVALUATION

BIG SANDY FLY ASH POND

LOUISA, KENTUCKY

LOCATION RESTRICTION EVALUATION BIG SANDY FLY ASH POND LOUISA, KENTUCKY

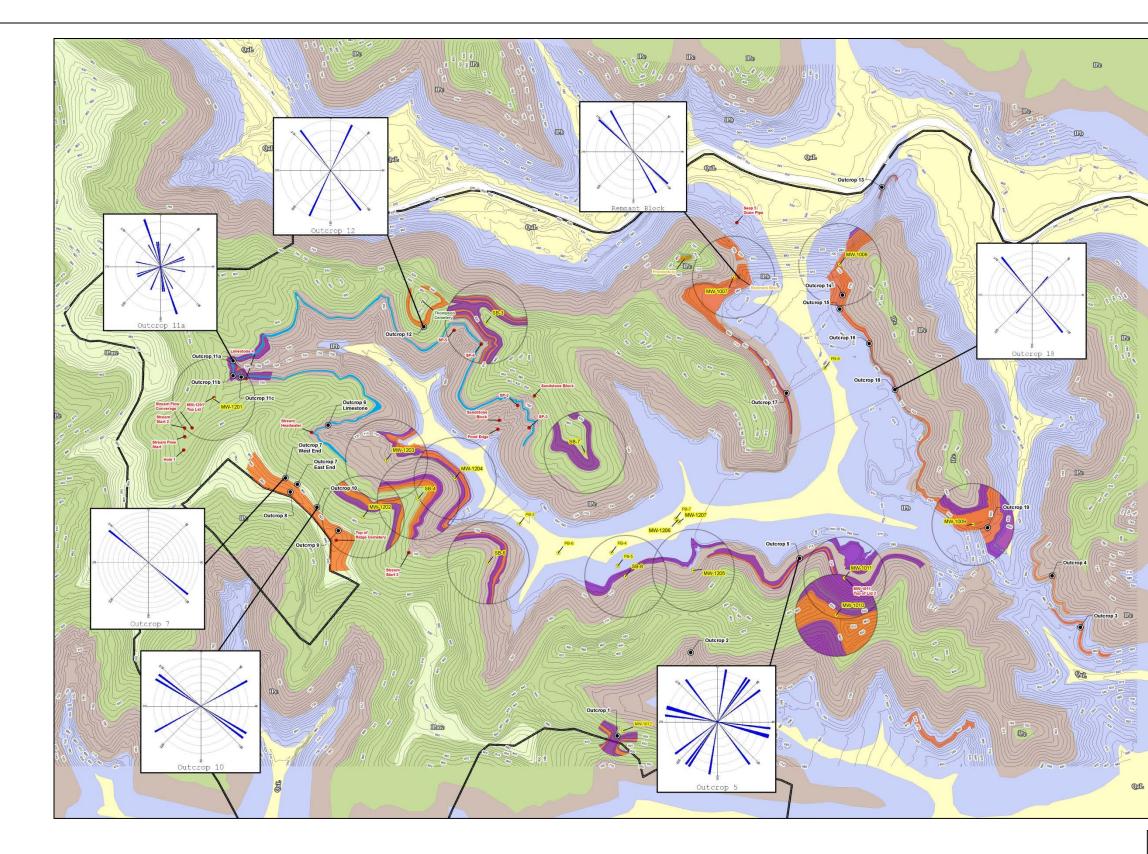
Geologic Units digitized from Geologic Quadrangle Map: Fallsburg and Prichard Quadrangles, KY.-W.VA. Sharpe, 1967.

Figure was originally presented as Figure 3.1 in Hydrogeologic Site Investigation: AEP Big Sandy Horseford Creek. URS, 2013.

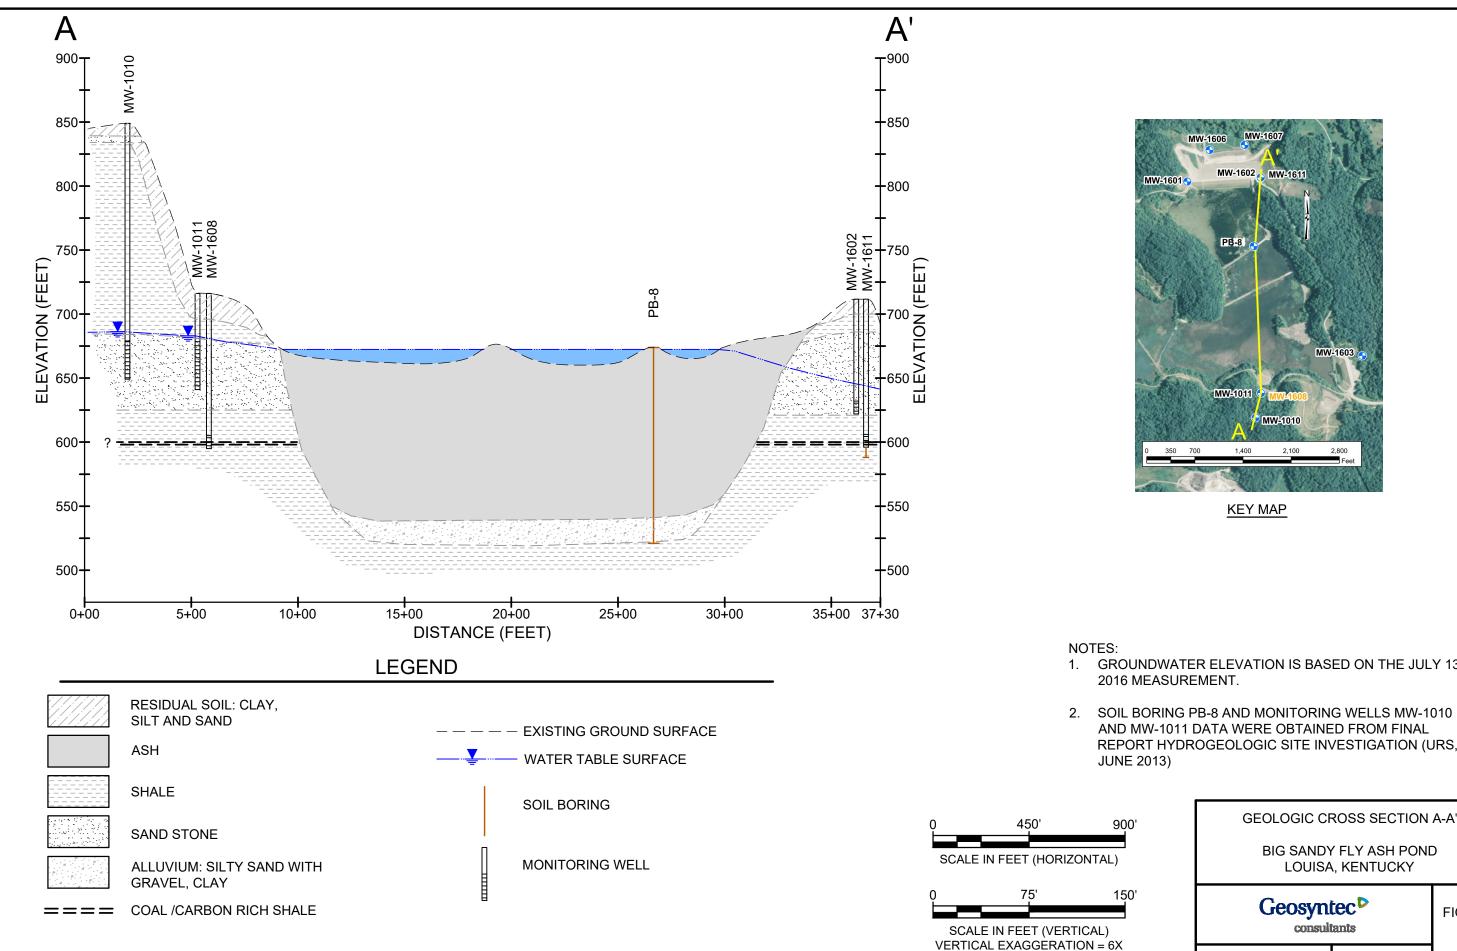
00'	GEOLOGIC CROSS SECTION A-A'									
9	BIG SAND LOUISA	D								
50' 9	Geosyn consul		FIGURE							
<u>.</u>	PROJECT NO: TX0510	OCTOBER 2016	I

1. GROUNDWATER ELEVATION IS BASED ON THE JULY 13,

AND MW-1011 DATA WERE OBTAINED FROM FINAL REPORT HYDROGEOLOGIC SITE INVESTIGATION (URS,
