2020 Annual Dam and Dike Inspection Report

Fly Ash Pond

**John E. Amos Plant
Appalachian Power Co.
Putnam County, West Virginia**

Document Number GERS-20-022

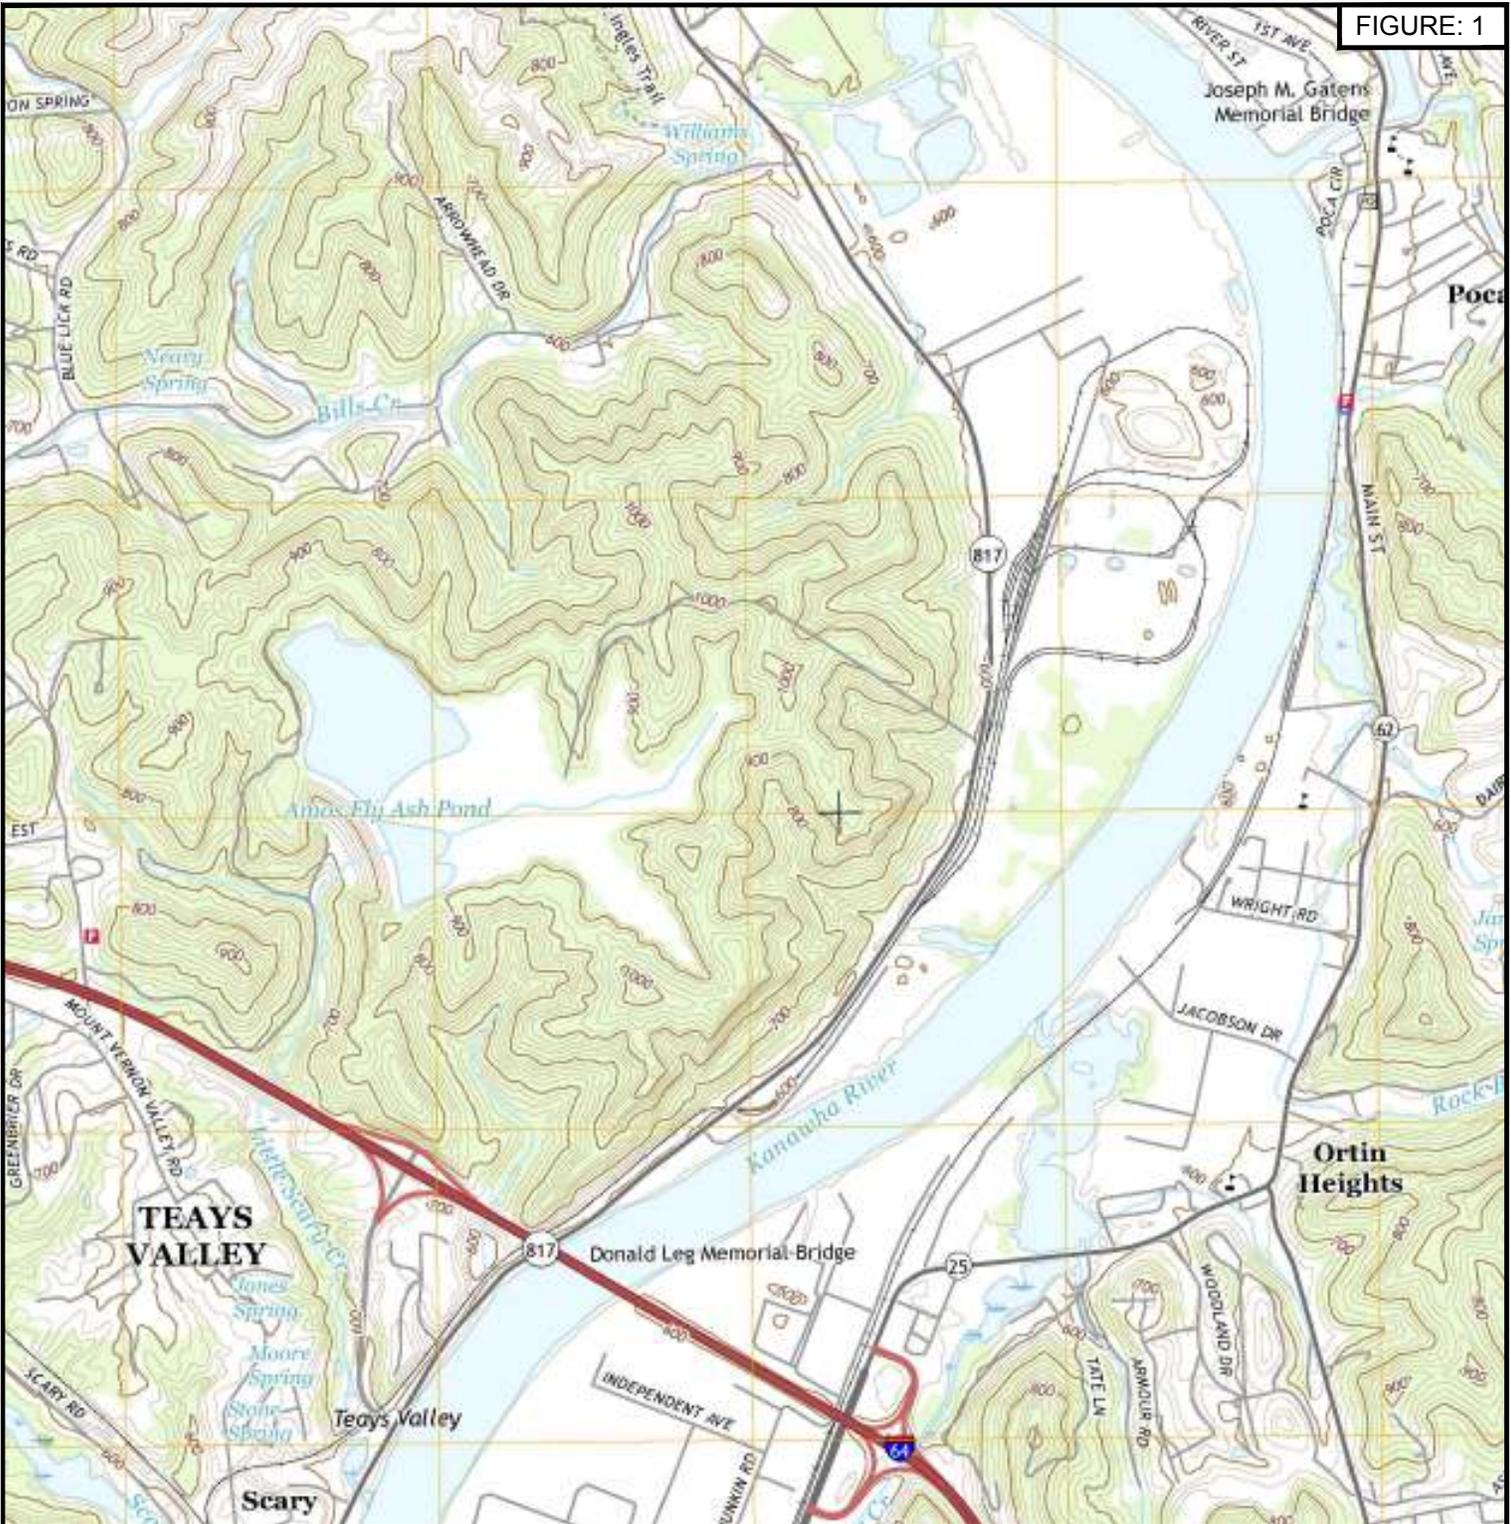
FIGURE: 1

The fly ash pond is located in Putnam County, West Virginia southwest of the John E. Amos (JEA) Power Plant between State Route 817 and Interstate I-64. The watershed for the fly ash pond drains to the Kanawha River (Figure 1). The JEA fly ash pond was used for sedimentation and storage of fly ash produced as a waste product in burning pulverized coal at the JEA Power Plant.

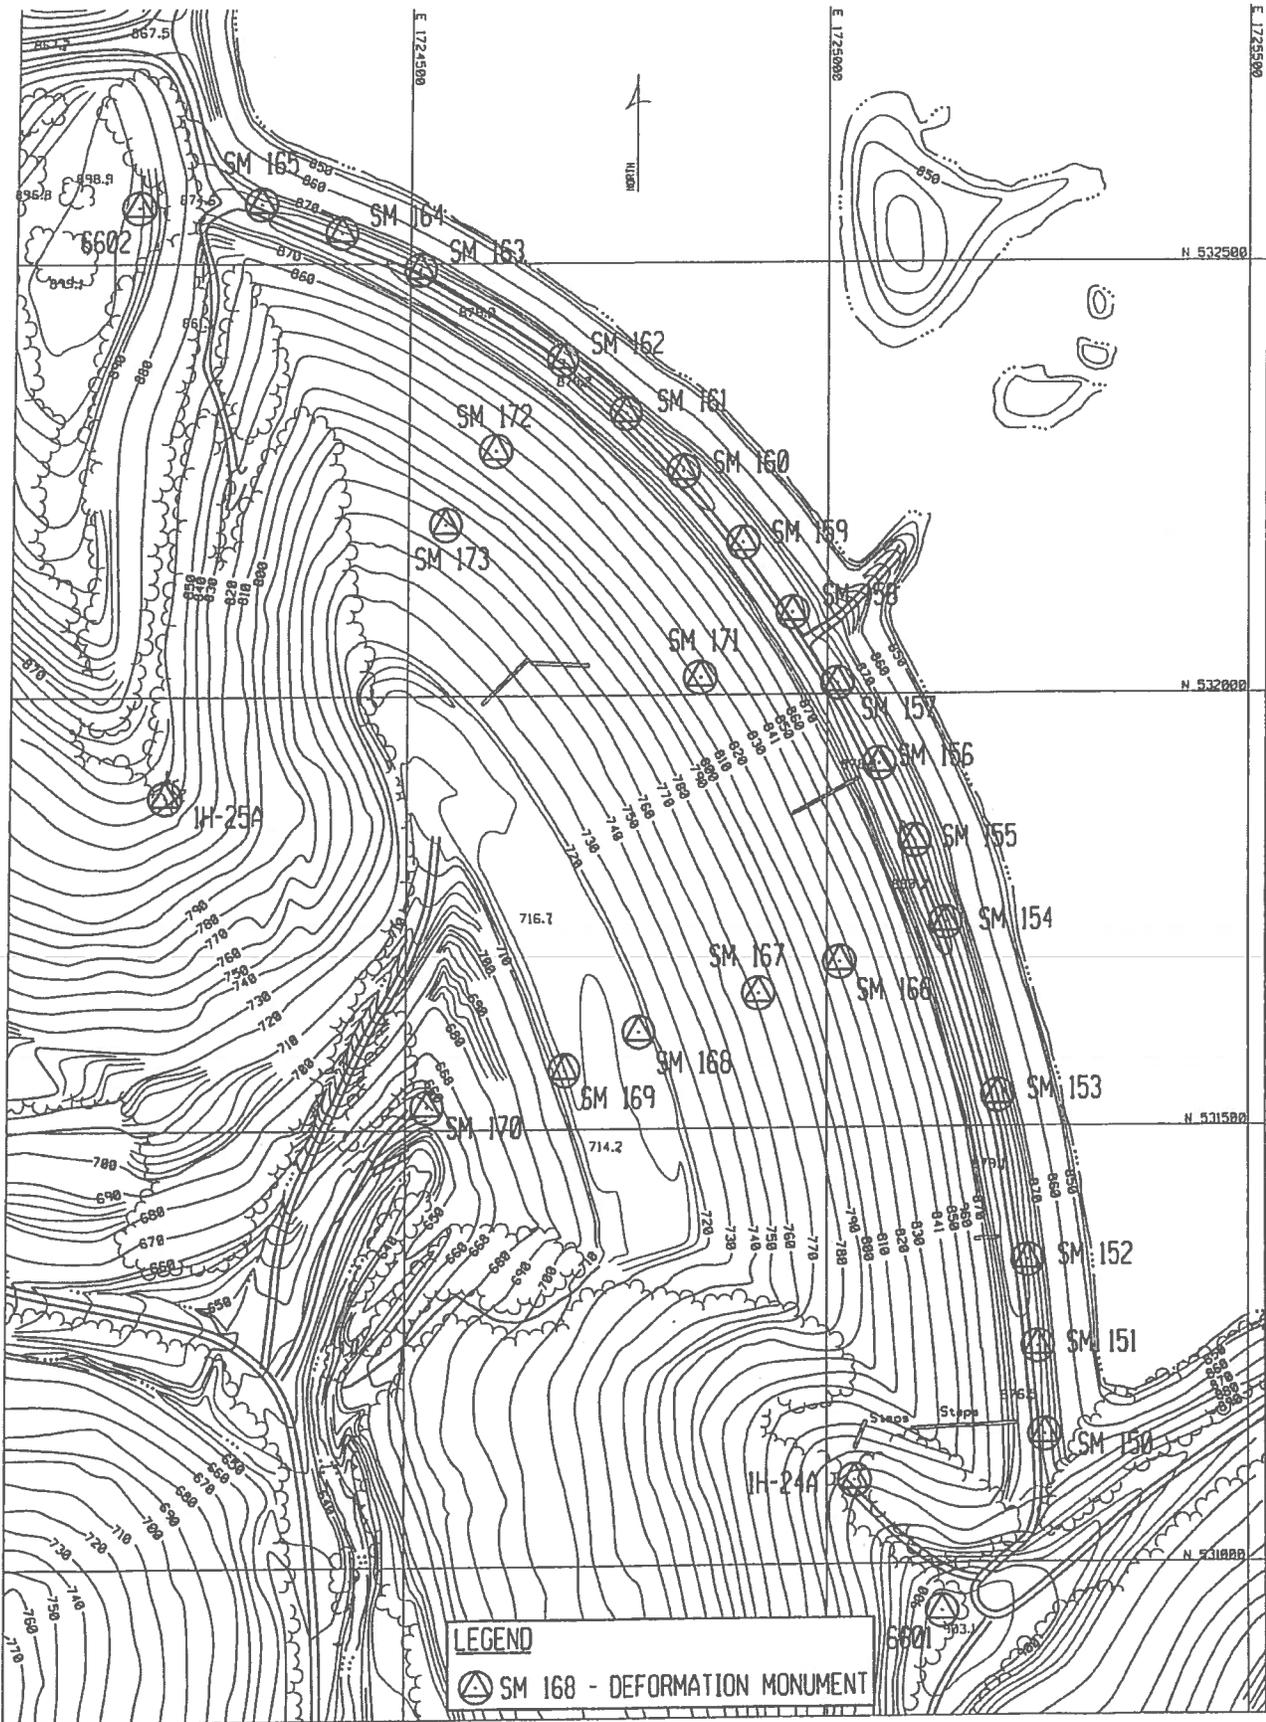
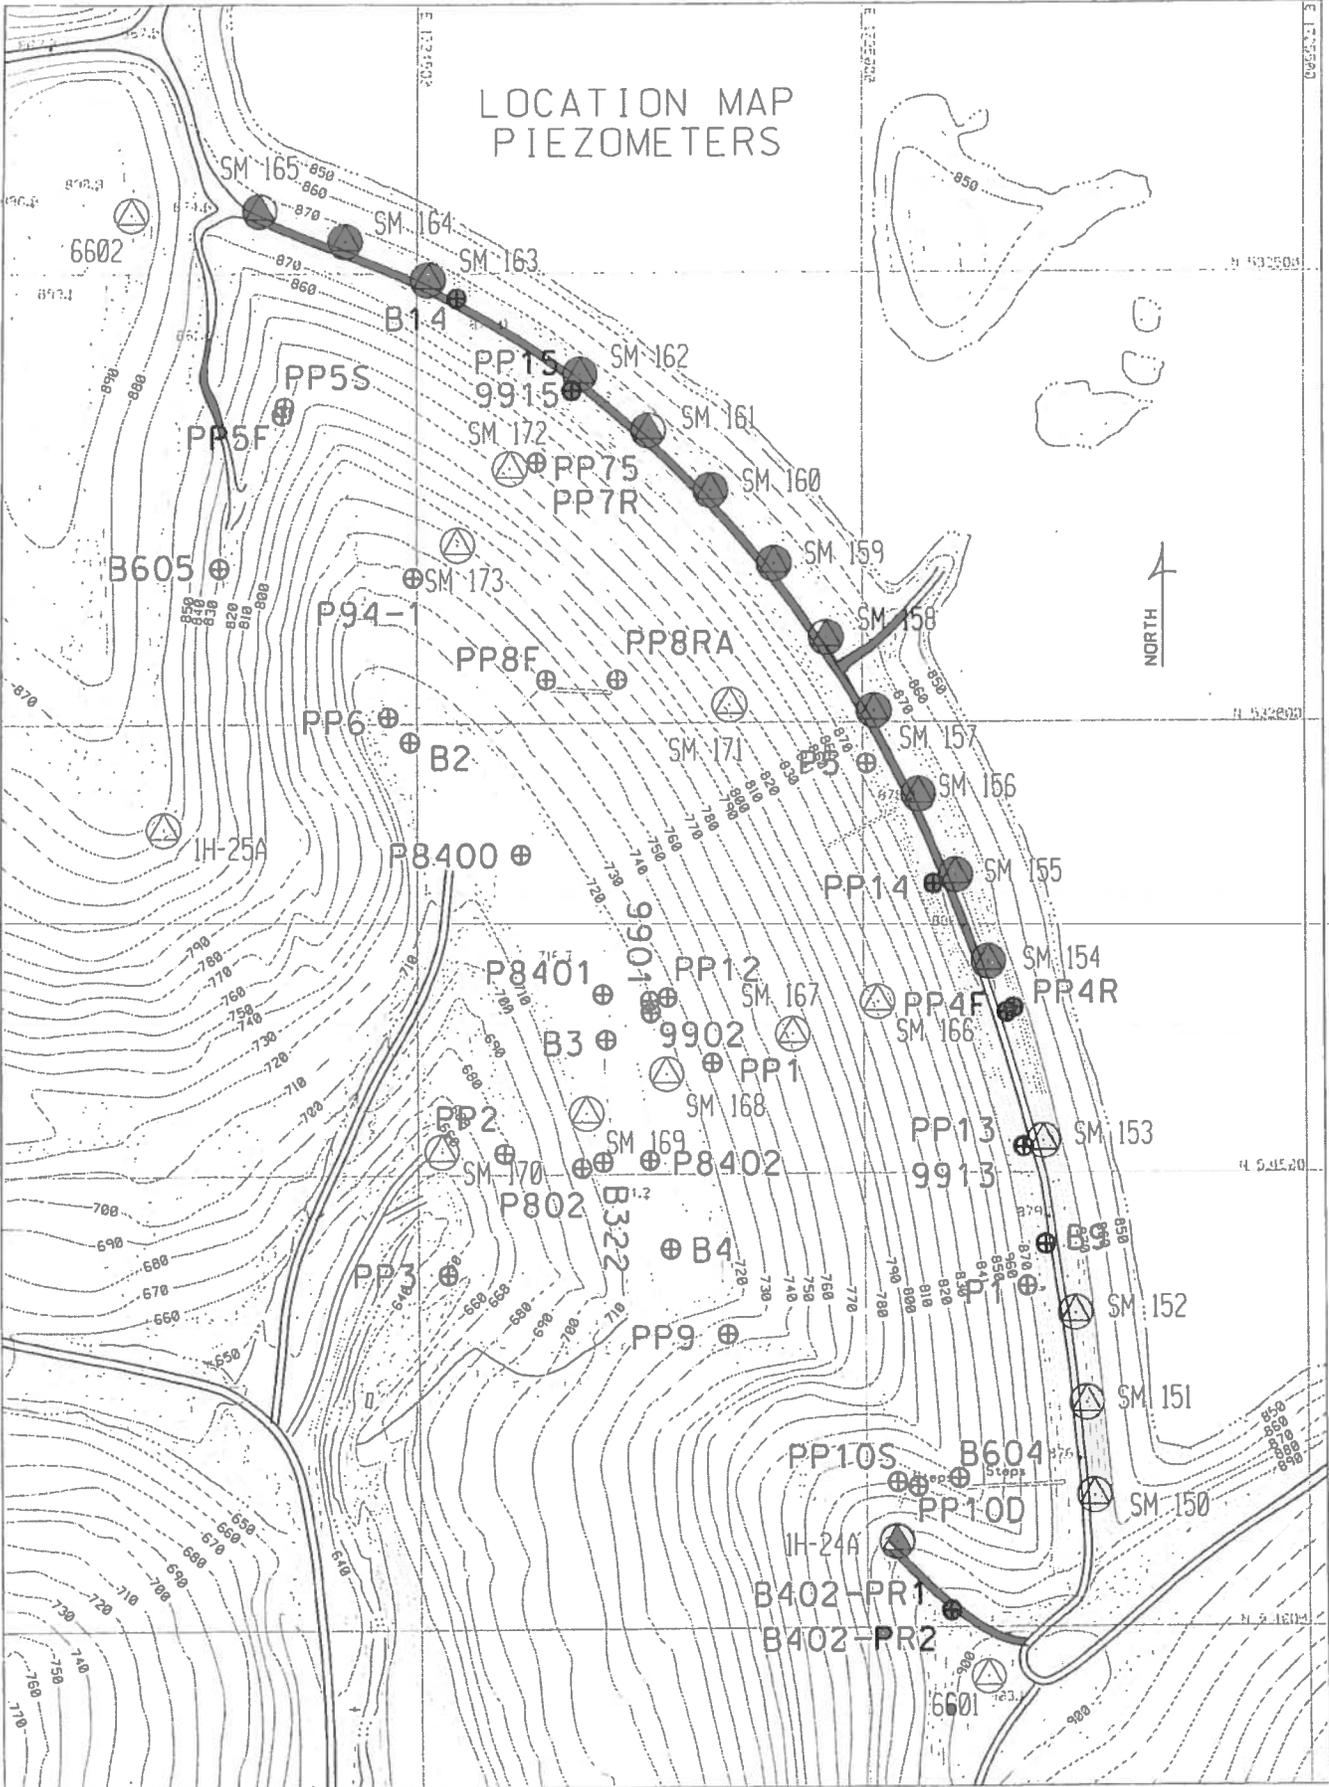
LOCATION MAP DEFORMATION MONUMENTS

LOCATION MAP PIEZOMETERS

of all the monuments have been reviewed as a part of this annual inspection and no unusual or unexpected behavior has been observed.

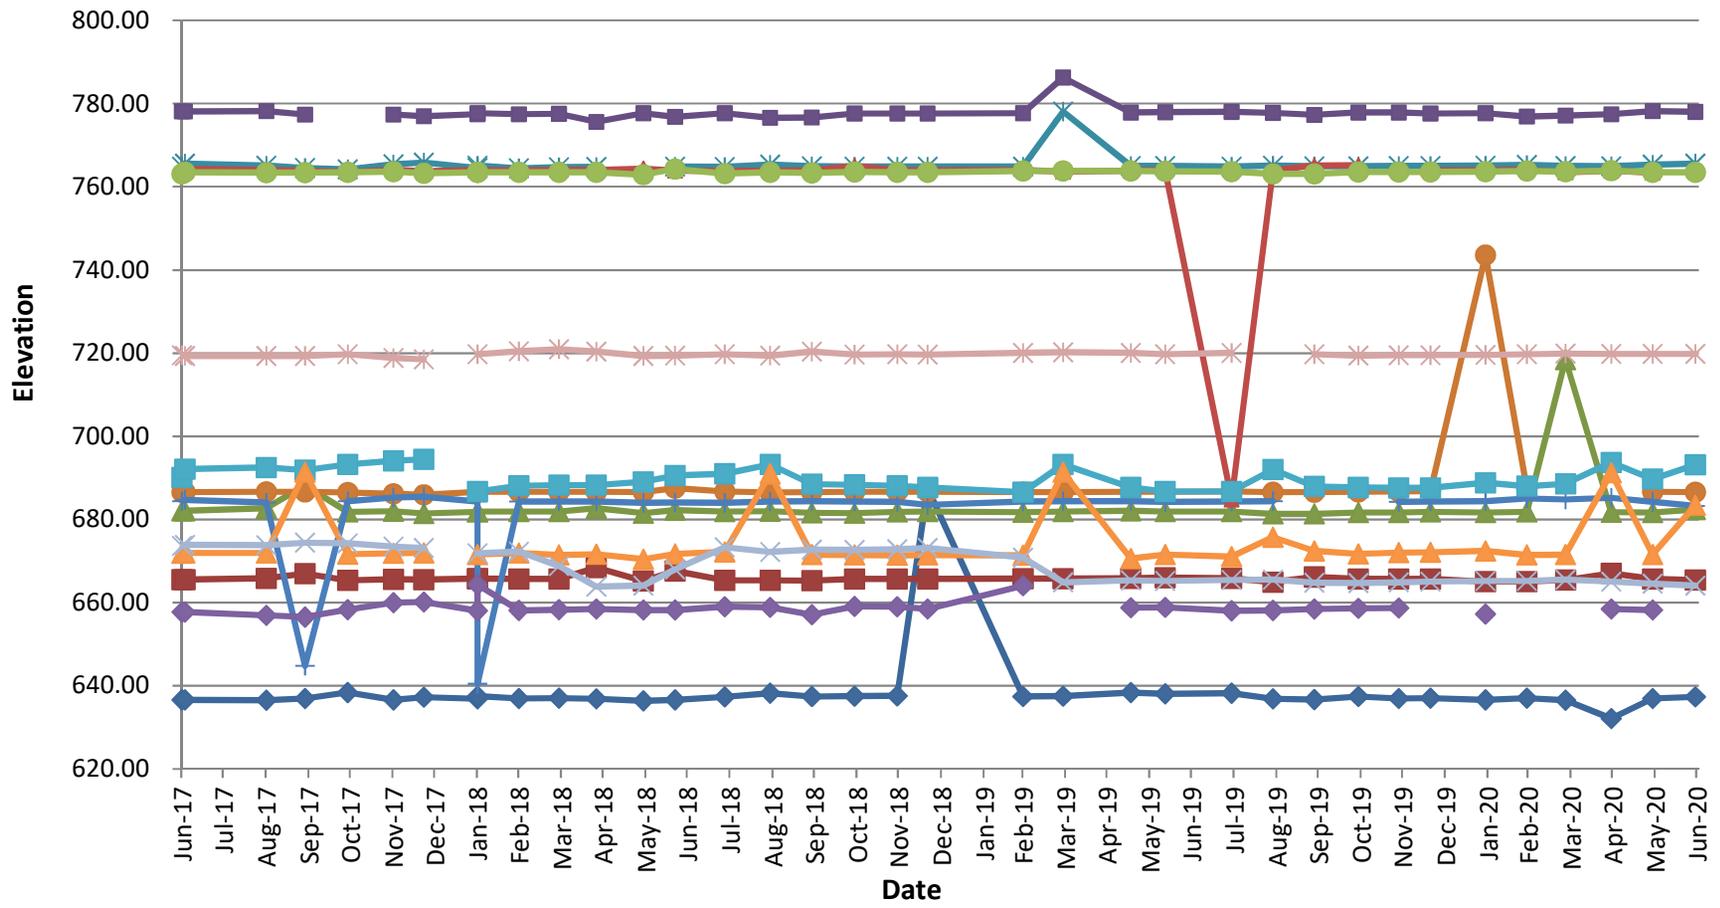
John E Amos Plant Piezometer Readings Fly Ash Pond

Most of piezometers readings continue to show consistent water elevations in the dam. Piezometers 8400, 8401, and 8402 have historically shown wide swings in water elevations and those observed since the last inspection are consistent with those trends. A graph of the piezometer readings is included in Attachment C. A notable departure is also recorded at PP4R, PP8RA, and PP75 and may represent erroneous measurements since subsequent measurements appear to have returned to normal conditions.

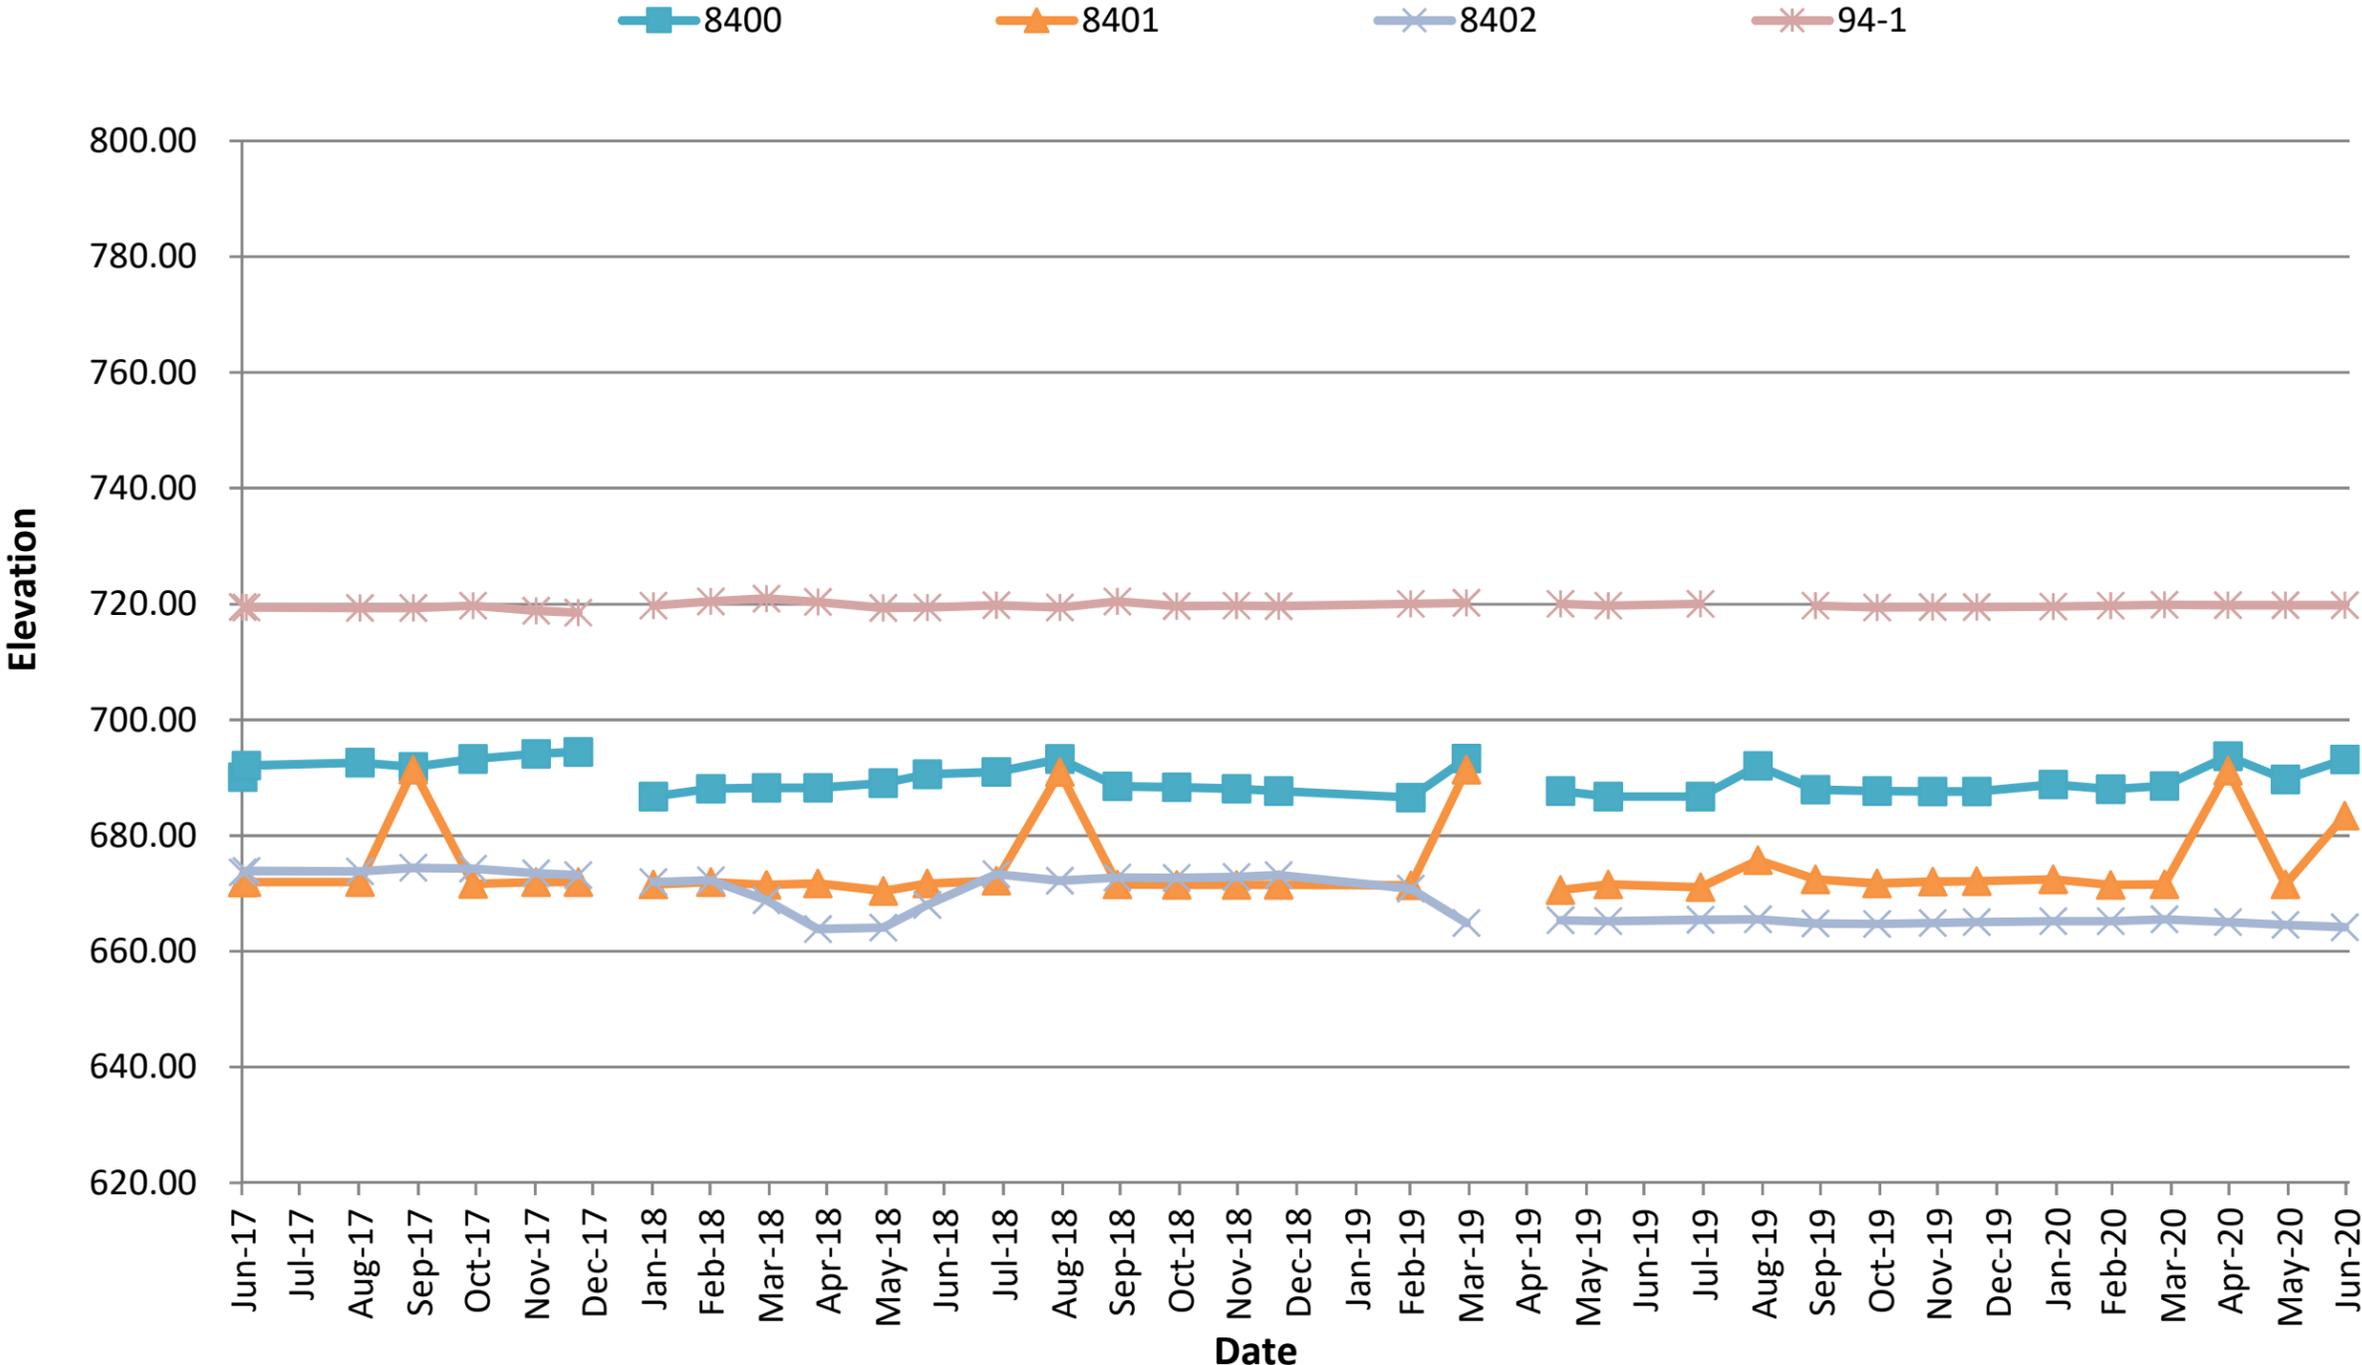
John E Amos Plant Piezometer Readings Fly Ash Pond
