**Initial CCR Inspection  
H.W. Pirkey FGD Stackout Area  
Hallsville, Harrison County, Texas**

Akron Consulting, LLC (Akron) performed the initial CCR inspection of the Pirkey FGD Stackout Area at the H.W. Pirkey Power Station on January 18, 2016. This report summarizes our observations of the stackout area during the site inspection.

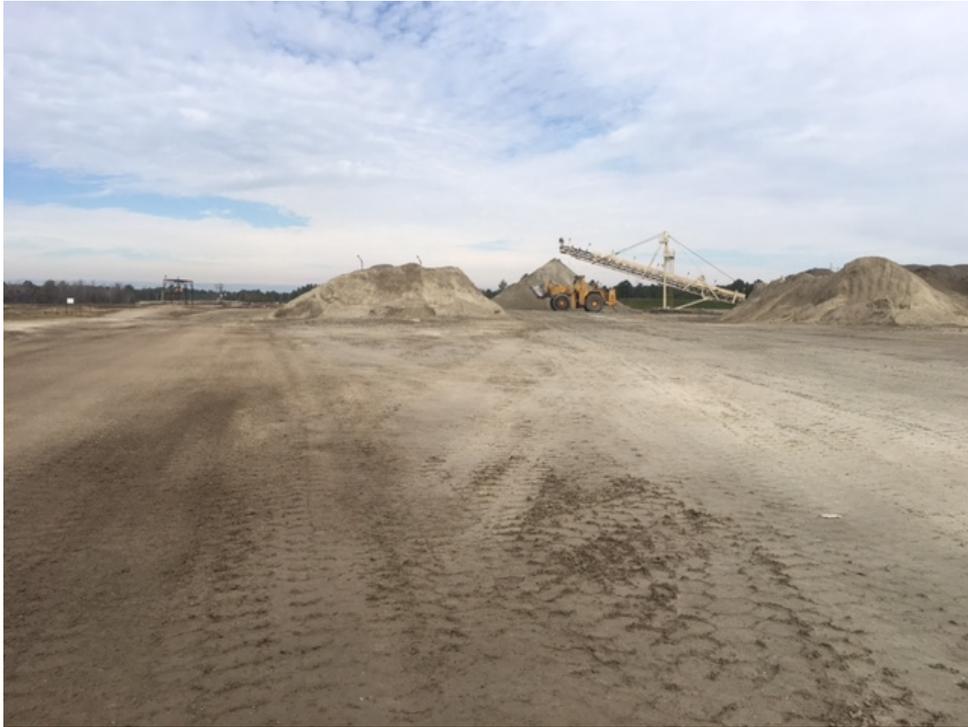
**Photograph 1. Stackout Area Looking North**

At the time of the inspection, the CCR in the Stackout Area appears to be structurally stable. There was no evidence of slides, erosion gullies, or rills.

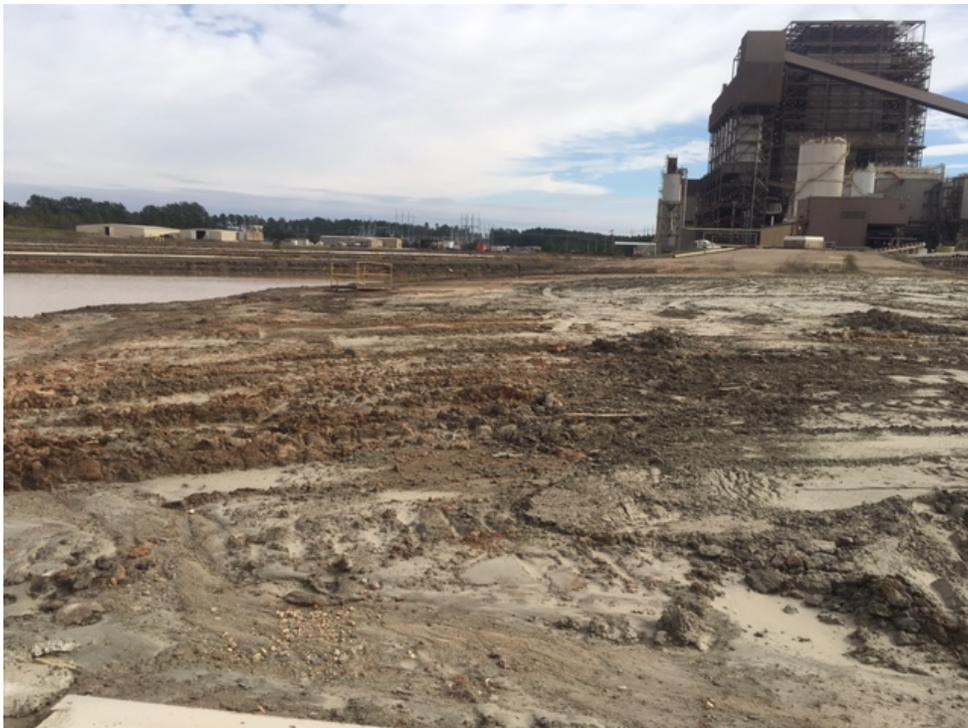
**Photograph 2. Sheet Flow into Surge Pond Looking East**

The Stackout Area appears to be functioning as designed. The active CCR placement areas were graded in a manner to promote drainage into the appropriate drainage controls and prevent ponding. All runoff was directed to the Surge Pond through surface sheet flow directly to the pond or via a perimeter ditch that is located on the west side of the Stackout Area. There is a small pipeline that is located in this ditch that does not appear to negatively affect the function of the ditch.

- Clean out the perimeter drainage ditches to survey and verify they have adequate hydraulic capacity.
- Survey and verify that all grading in the Stackout Area is such that there is positive drainage to the Surge Pond.
