Annual Coal Combustion Residuals (CCR) Landfill Inspection Report

H. W. Pirkey Power Plant
2400 FM 3251
Hallsville, Texas

Project B1606473
December 27, 2016

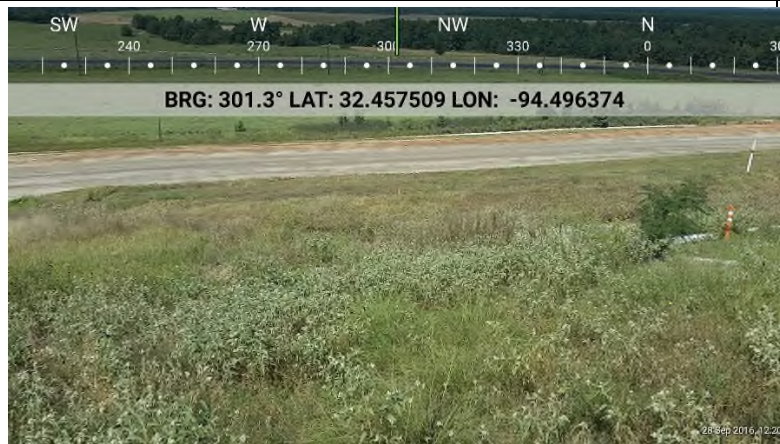
| Photograph #1 | September 28, 2016 |

| Description: | SW corner of the 2005 cell permanent cover. |

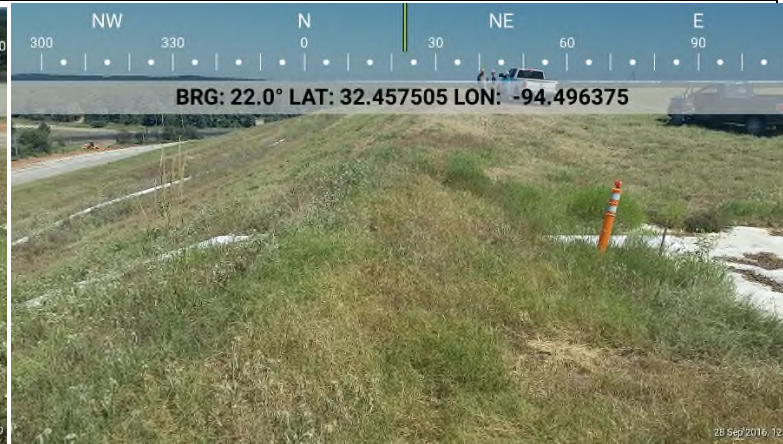
| Photograph #2 | September 28, 2016 |

| Description: | Berm slope along west edge of 2005 cell permanent cover. |

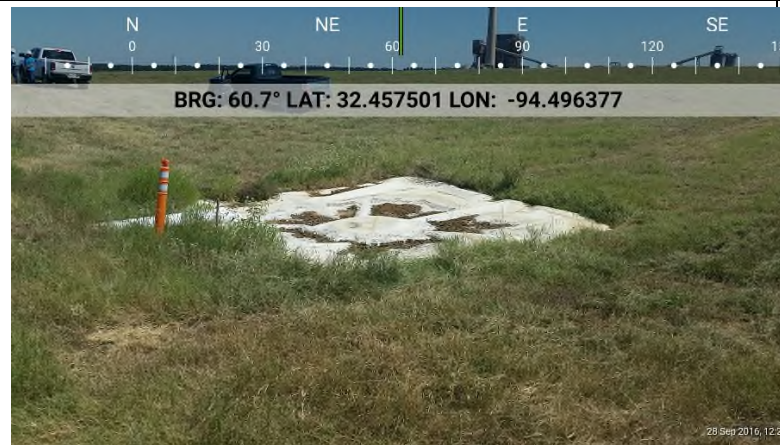
| Photograph #3 | September 28, 2016 |

| Description: | Let-down inlet and vegetative cover on 2005 cell. |

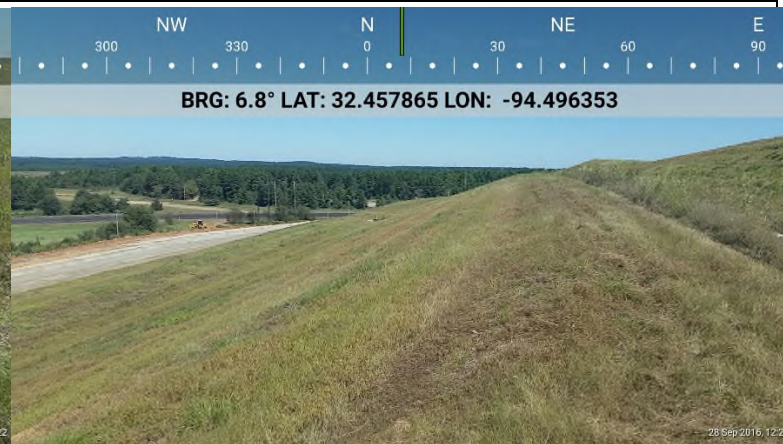
| Photograph #6 | September 28, 2016 |

| Description: | Western slope of 2005 cell. |

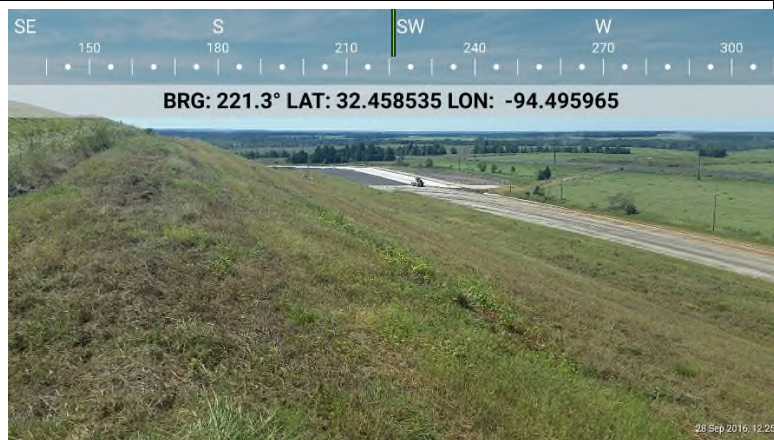
| Photograph #7 | September 28, 2016 |

| Description: | Western slope of 2005 cell. |

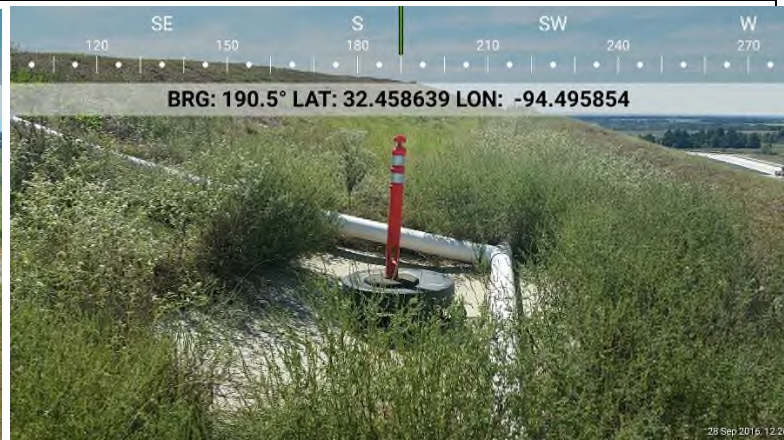
| Photograph #8 | September 28, 2016 |

| Description: | Let-down piping and inlet on western slope of 2005 cell. |

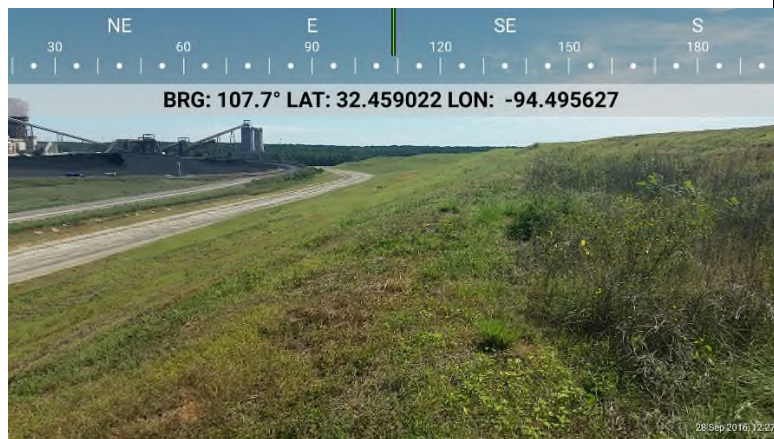
| Photograph #9 | September 28, 2016 |

| Description: | Toe of the northern slope of 2005 and 1999 cells. |

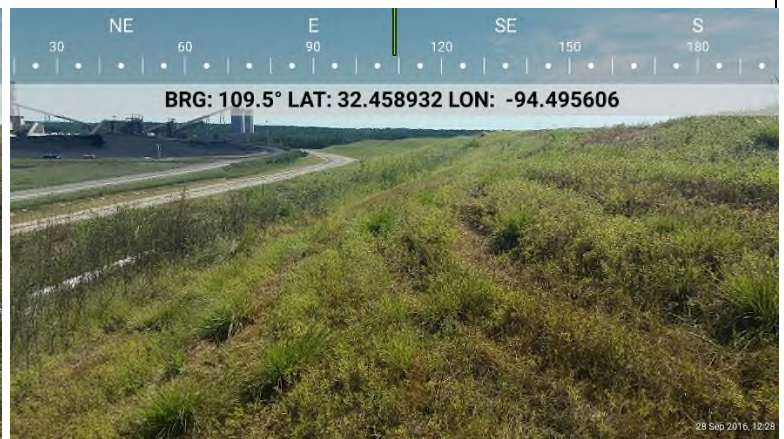
| Photograph #10 | September 28, 2016 |

| Description: | Northern slope of 2005 and 1999 cells. |

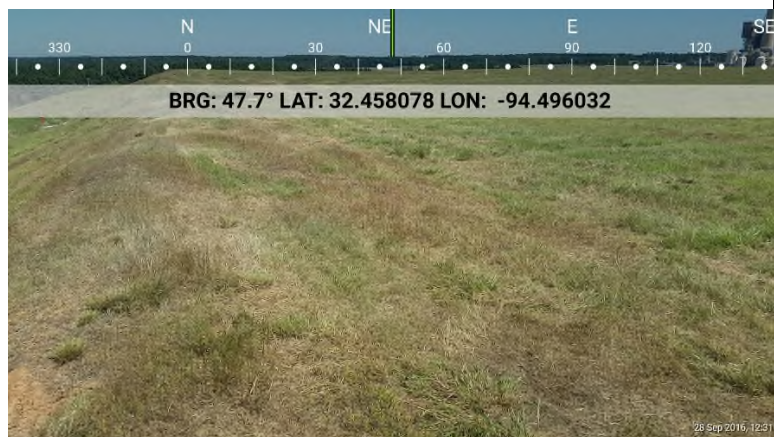
| Photograph #11 | September 28, 2016 |

| Description: | Vegetation on top of 2005 cell. |

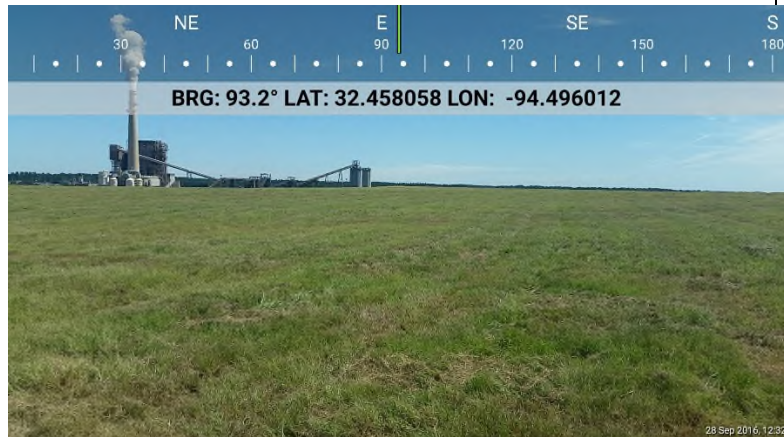
| Photograph #12 | September 28, 2016 |

| Description: | Vegetation on top of 1999 cell. |

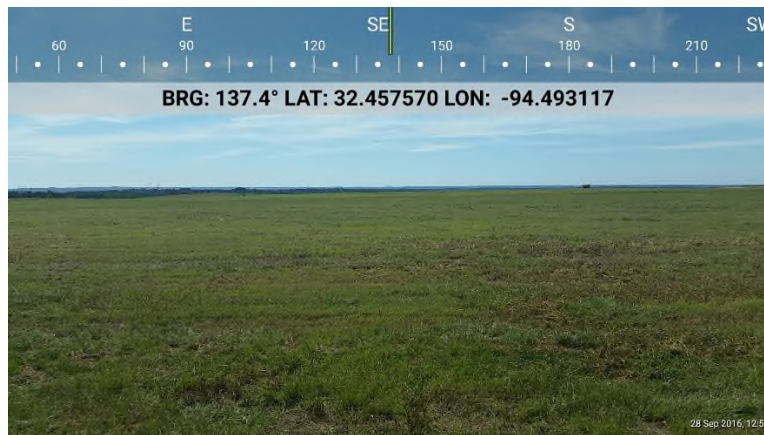
| Photograph #17 | September 28, 2016 |

| Description: | Top of 1995, 1997, and 1987 cells. |

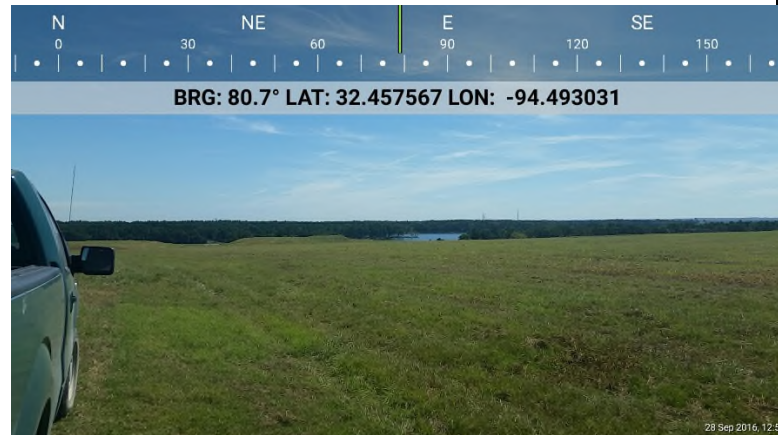
| Photograph #18 | September 28, 2016 |

| Description: | Top of 1984 and 1987 cells. |

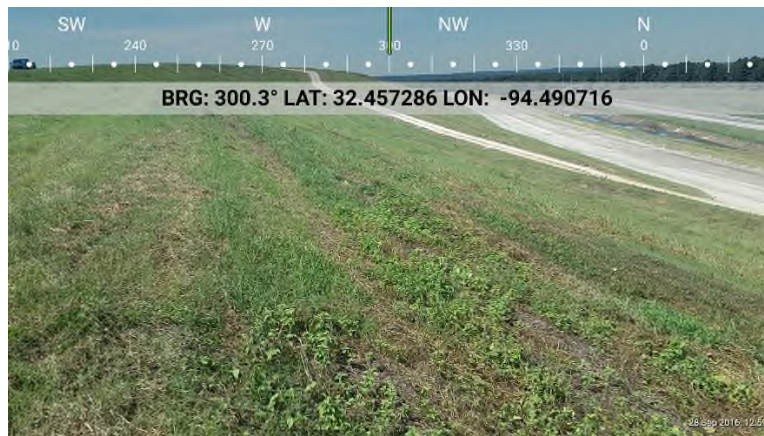
Photograph #19 September 28, 2016
Direction: Facing west northwest
Description: Northern slope of 1995 cell.

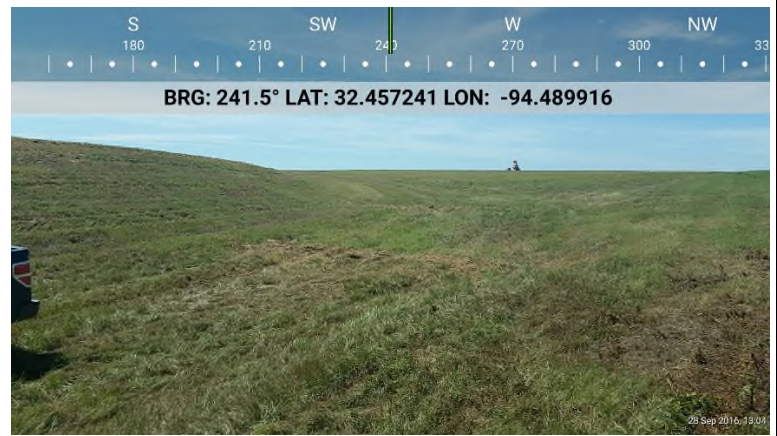
Photograph #20 September 28, 2016
Direction: Facing southwest
Description: Top of 1984 cell.

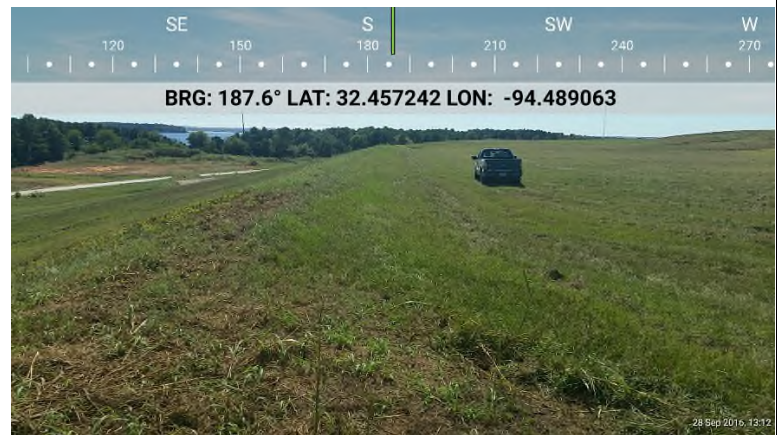
Photograph #22 September 28, 2016
Direction: Facing south
Description: Eastern slope and top of 1984 cell.

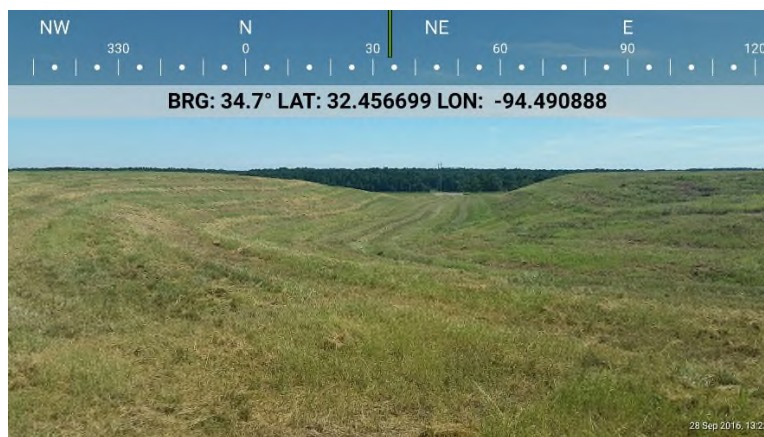
Photograph #23 September 28, 2016
Direction: Facing northeast
Description: Top of 1984 and 1987 cells.

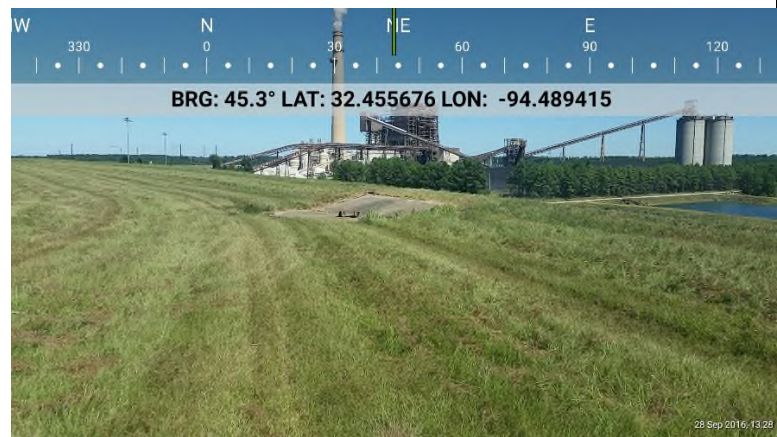
Photograph #24 September 28, 2016
Direction: Facing east
Description: Top of 1984 cell with let-down inlet.

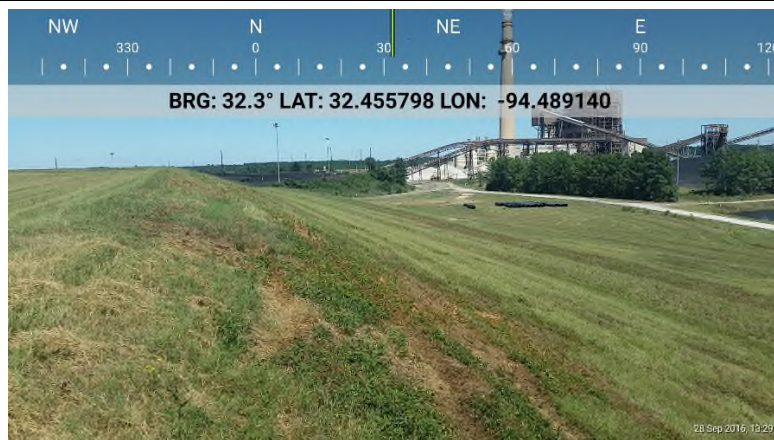
| Photograph #25 | September 28, 2016 |

| Description: | Eastern slope of 1984 cell. |

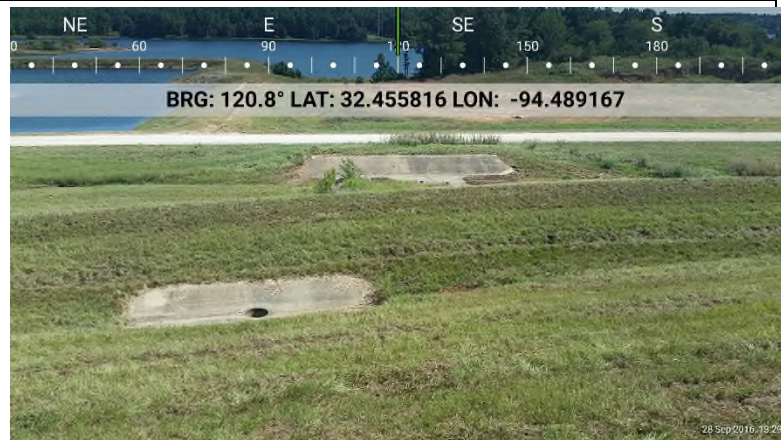
| Photograph #26 | September 28, 2016 |

| Description: | Eastern slope of 1984 cell with a slope drainage let-down inlet and let-down outlet. |

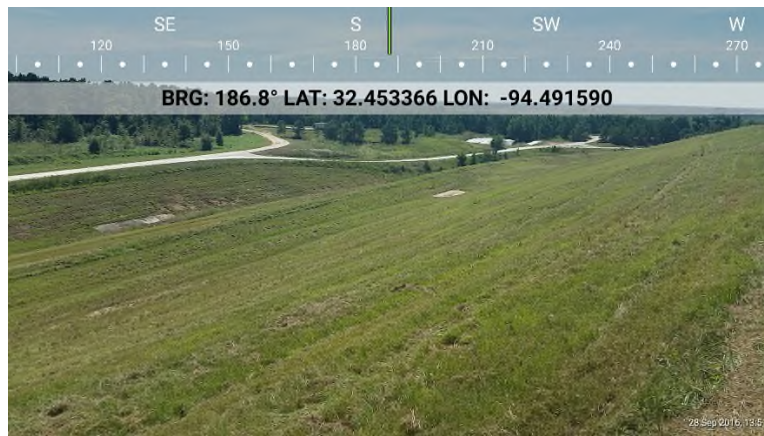
Photograph #37 September 28, 2016
Direction: Facing south
Description: Eastern slope of the southern section of 1987 cell with let-down inlet.

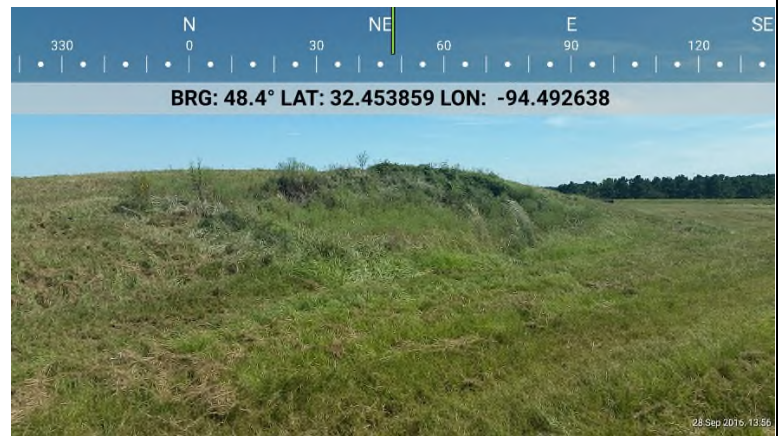
Photograph #38 September 28, 2016
Direction: Facing northeast
Description: Mounded area on southern section of 1987 cell.

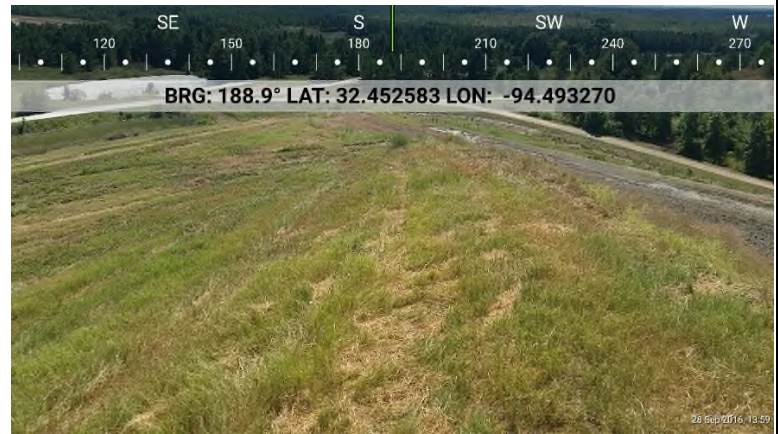
Photograph #40 September 28, 2016
Direction: Facing south
Description: South tip of 1993 cell. Permanent cover and active area.

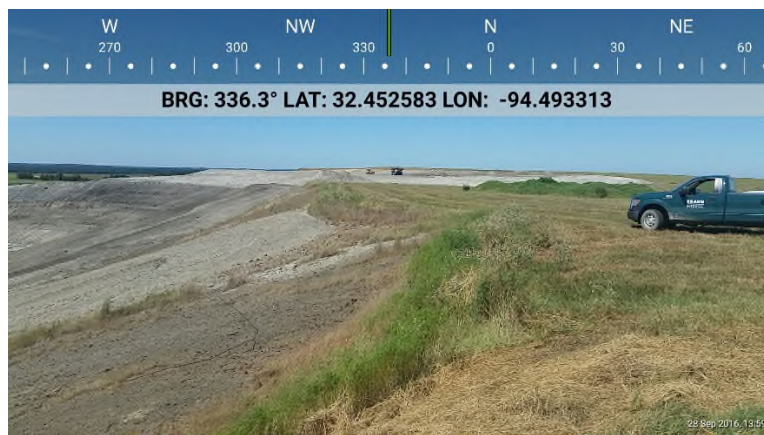
Photograph #41 September 28, 2016
Direction: Facing north northwest
Description: Active area and permanent cover on 1993 cell.

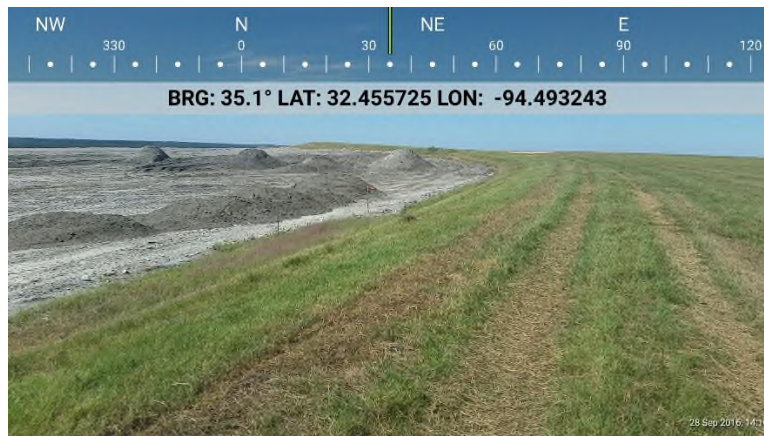
| Photograph #43 | September 28, 2016 |

| Description: | Active area and permanent cover on 1987 cell. |

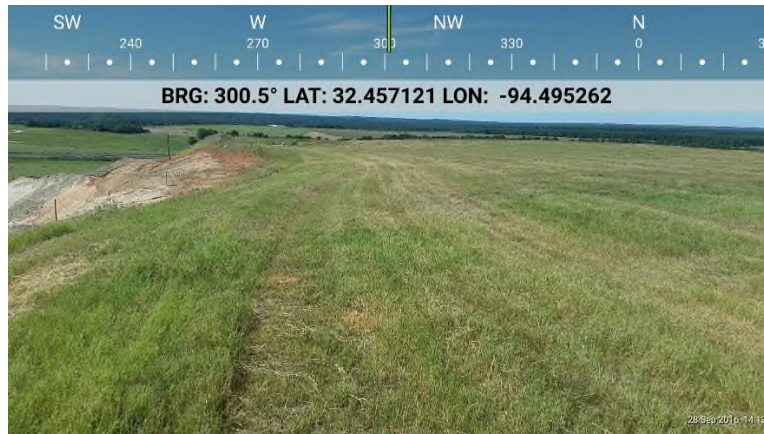
| Description: | Active area and permanent cover on 1997 and 1999 cells. |

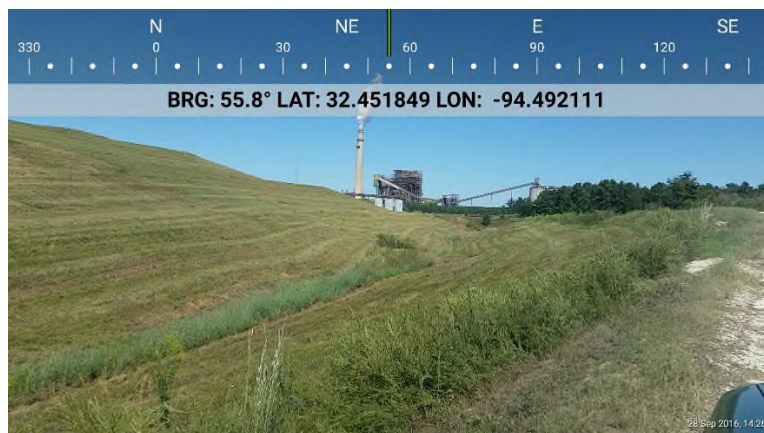
| Photograph #46 | September 28, 2016 |

| Description: | Active area and permanent cover transition on 1993 cell. |

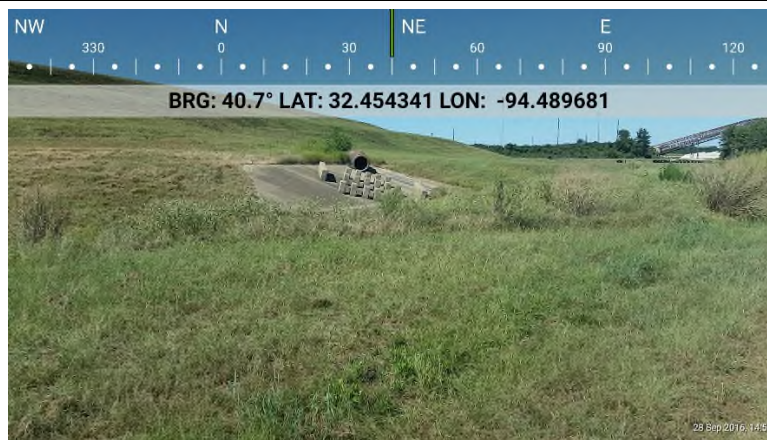
| Description: | Toe east slope and let-down outlet on southern section of 1987 cell. Woody vegetation evident. |

It is recommended that normal maintenance include a vegetation control program to mow and maintain the vegetative cover grasses on the permanently covered areas. Undesirable "woody" vegetation such as trees and shrubs need to be removed. Denuded areas as well as areas where erosional features have been repaired need to be covered with topsoil and reseeded with grasses.

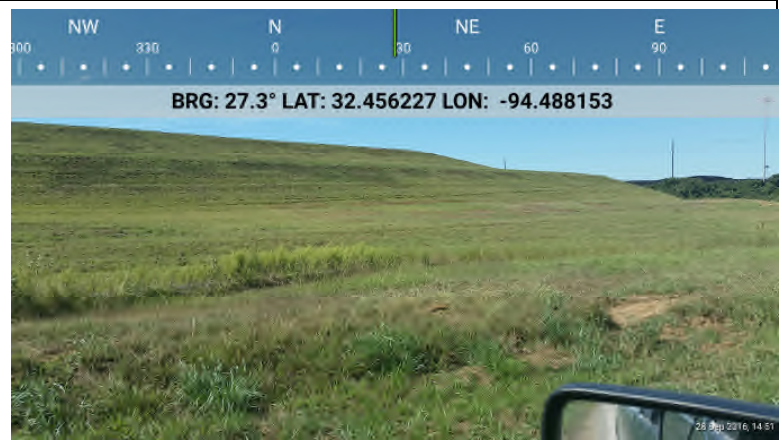
| Photograph #49 | September 28, 2016 |

| Description: | Let-down outlet and toe of east slope of 1984 cell. |

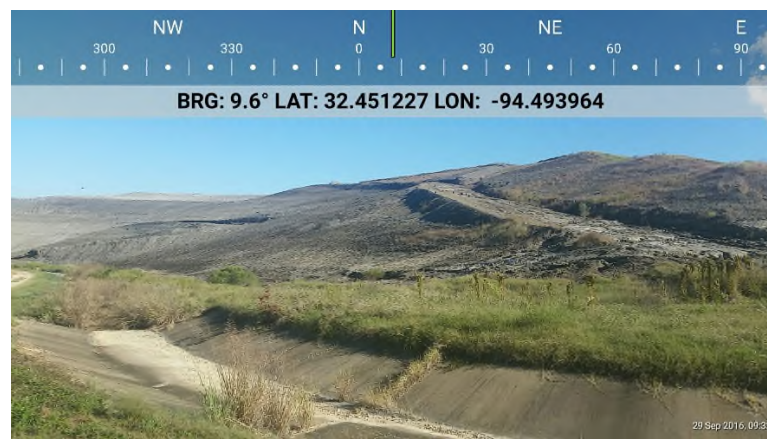
| Photograph #50 | September 28, 2016 |

| Description: | Berm slope along east edge of 1984 cell. |

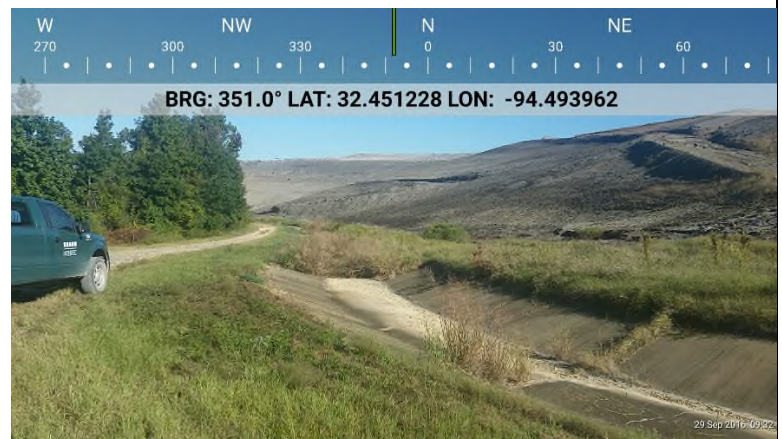
| Photograph #51 | September 29, 2016 |

| Description: | Southern slope of active areas of 1993 and 1985 pond cells. |

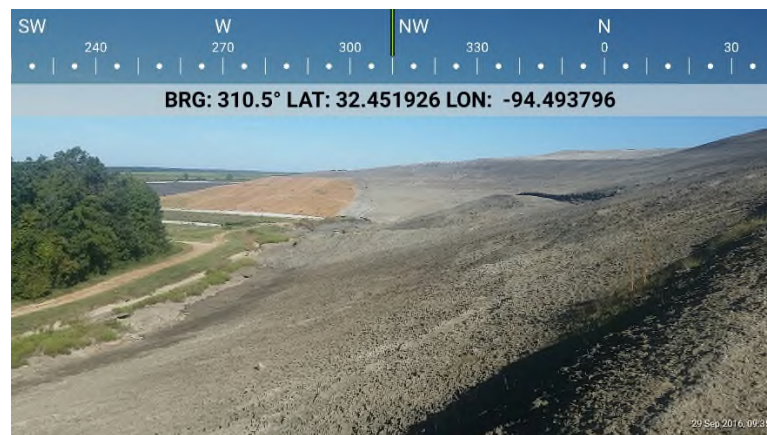
| Photograph #52 | September 29, 2016 |

| Description: | Southern slope of active areas of 1993 and 1985 pond cells. |

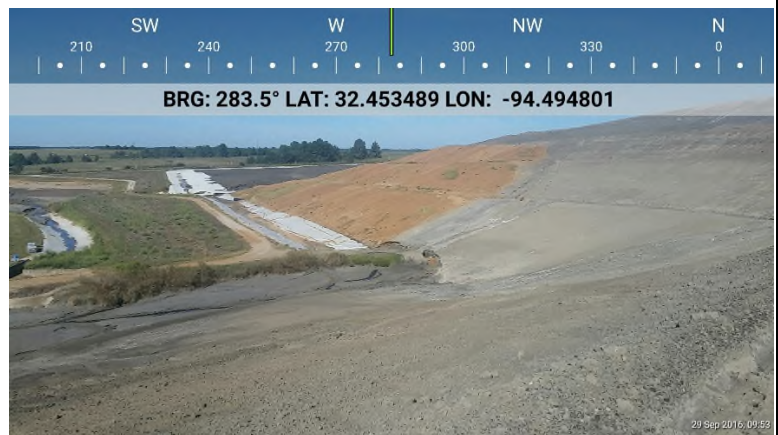
| Description: | Hardened CCR and erosion at toe of 1993 slope. |

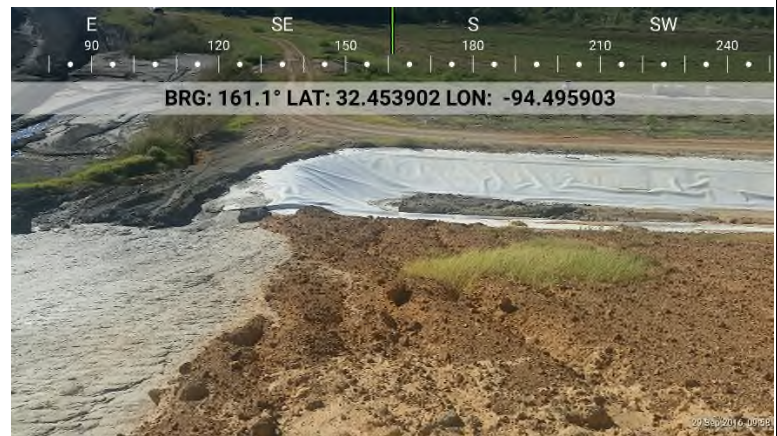
| Description: | Hardened CCR and erosion on slope of 1985 pond cell. |

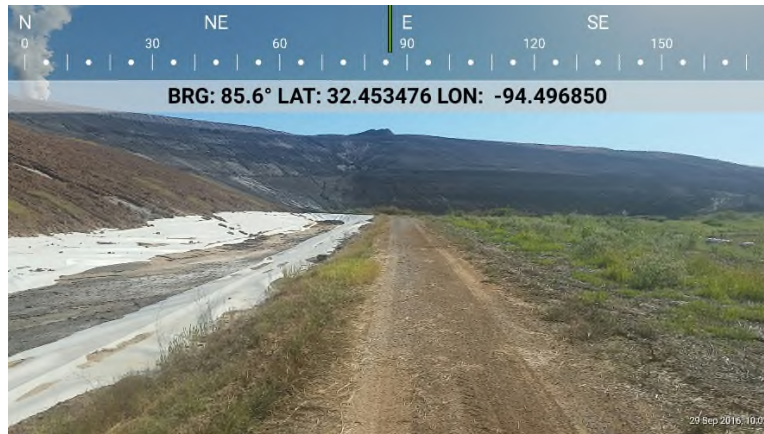
| Photograph #62 | September 29, 2016 |

| Description: | Drainage swale liner at toe of 2012 cell. |

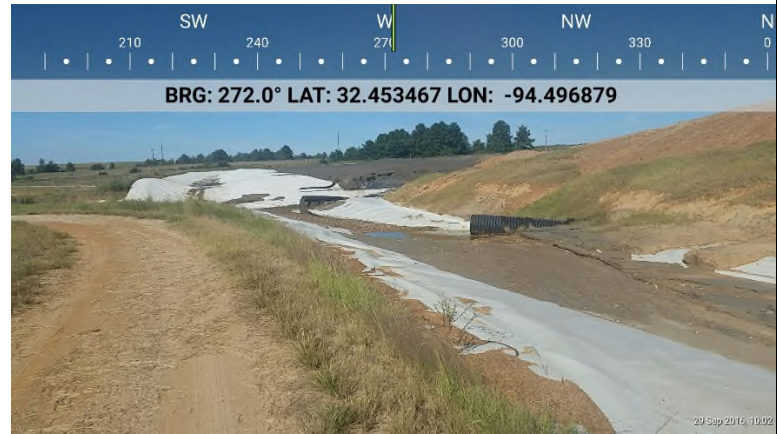
| Photograph #63 | September 29, 2016 |

| Description: | Drainage swale liner at toe of 2012 cell and southern slope of 1985 pond cell. |

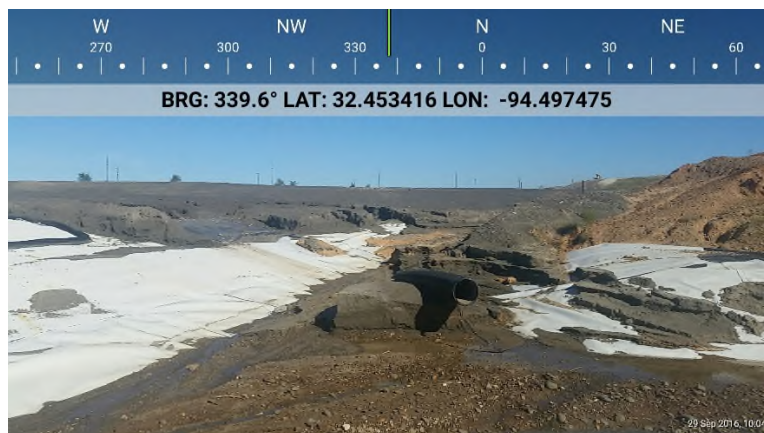
| Photograph #64 | September 29, 2016 |

| Description: | Leachate collection outlets from 2012 cell. |

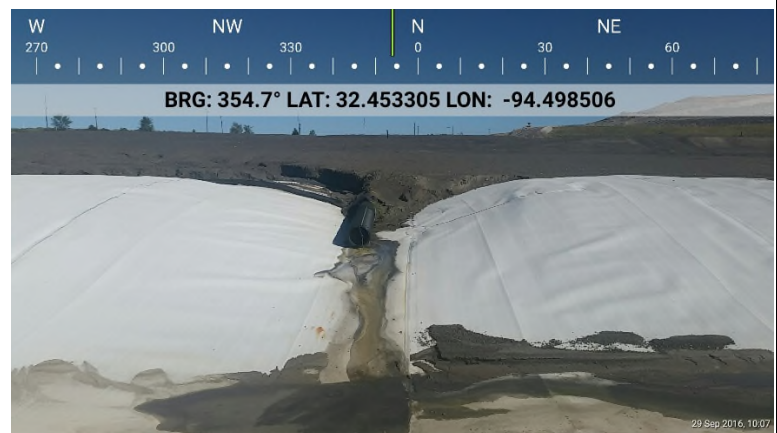
| Photograph #65 | September 29, 2016 |

| Description: | Drainage between 2012 and 2015 cells with an abandoned pipe. |

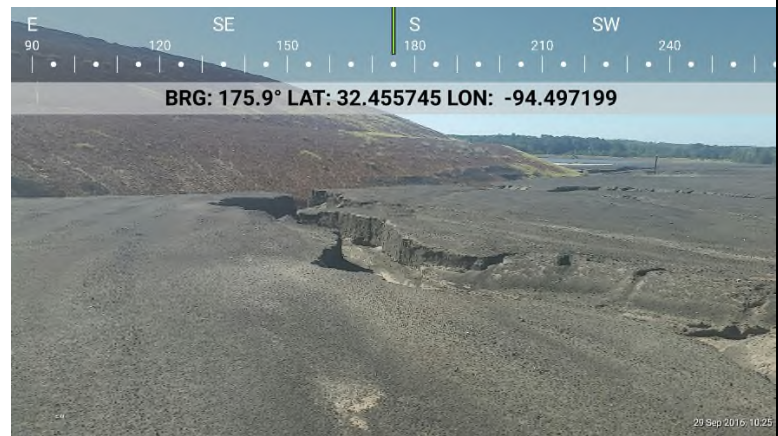
Photograph #67 September 29, 2016

Description: 2015 and 2012 cells.

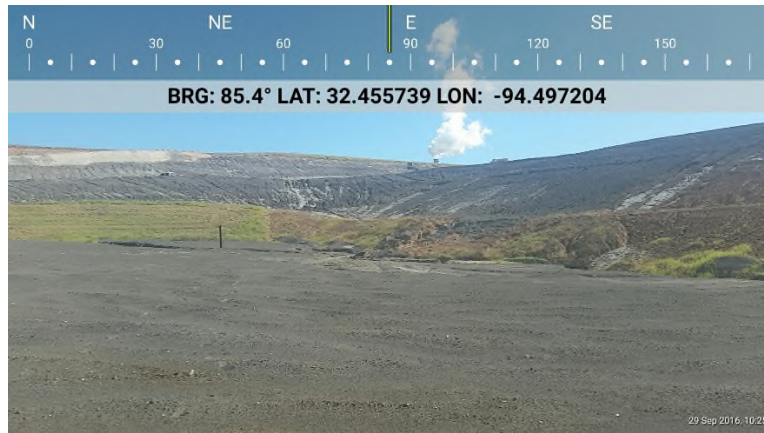
Photograph #68 September 29, 2016

Description: Erosion on 2015 cell and slope of 2012 cell.

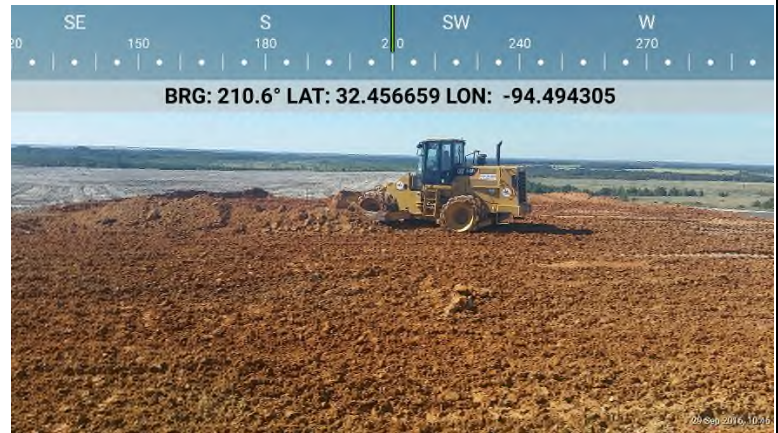
Photograph #69 September 29, 2016

The "2015" Cell is in the active portion of the landfill and is not covered (Photograph #69). The "2015" Cell is shown on **Figure 2**. The cell is relatively flat and is under construction or being utilized to stage CCR. No concerns or issues with erosion besides those noted in the active landfill (hardened CCR material) were noted.

Description: Active areas of 2015, 2012, 2005, and 1999 cells.

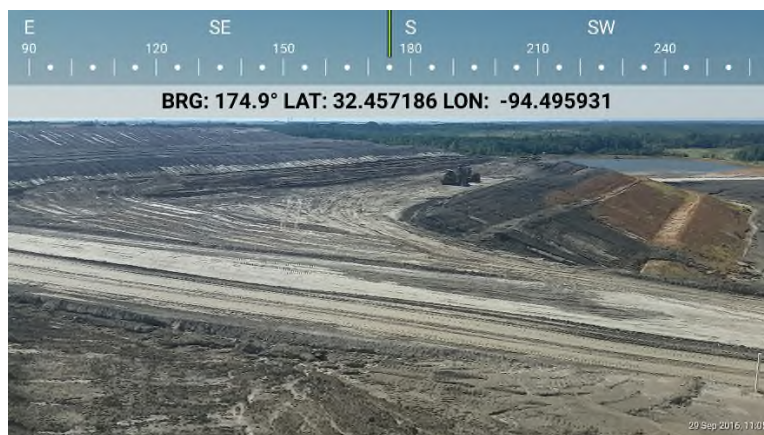
Photograph #70 September 29, 2016

The "1997" Cell is in the middle of the landfill. The "1997" Cell is shown on **Figure 2**. The majority of the cell is not covered and is in the active area of the landfill (Photograph #70) while the northern portion is under permanent cover and in good shape with a well-established grassy vegetative cover. The northern section of the cell is on the landfill plateau and is relatively flat and slopes off to the east while the rest of the cell slopes to the south. The installation of permanent cover was being completed during the time of inspection. No concerns or issues with erosion were noted (Photograph #17).

Description: Permanent cover being installed on 1997 cell.
